**Camp Heyburn (10BW207)
Description and Evaluation**

by
Mitzi Rossillon

Renewable Technologies, Inc.
511 Metals Bank Building
Butte, MT 59701

February 3, 2005

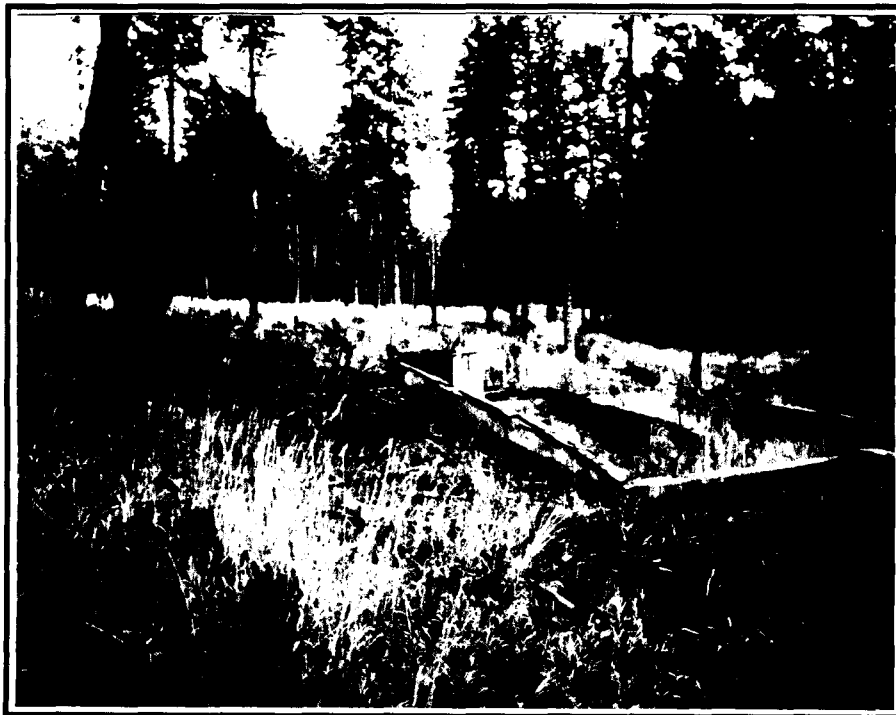
Ground visibility at the time of survey was less than 1% due to heavy duff and to a lesser extent grass and brush. While the ponderosa, douglas-fir, and balsam fir(?) overstory had been thinned recently, the understory species are healthy and numerous (Figure 2). The latter plants include grasses, oregon grape, alder, a fern, thistle, and a large amount of brush of unknown type. Even though ground visibility was poor, RTI was able to recognize historic features by their boxy appearance under the heavy growth of moss and ferns. The crew rarely observed historic artifacts, although there was no particular expectation of many CCC-era items anyway given the clean condition of camps during occupation.

Figure 2. Overview of survey area showing thinned overstory and dense ground cover.

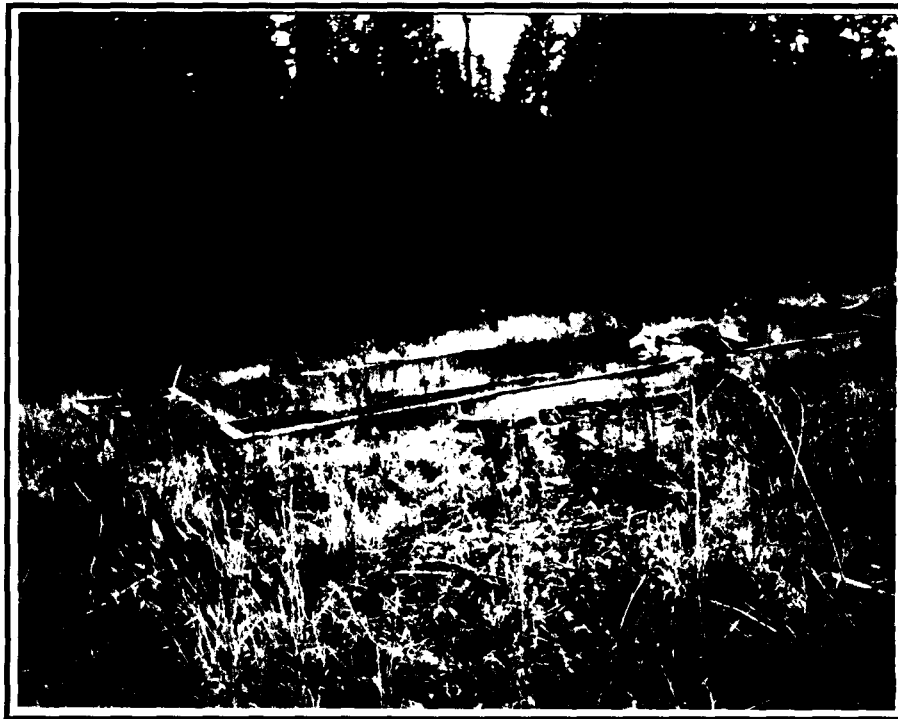
Feature 6 is a large concrete building foundation measuring 63 feet 6 inches northeast-southwest x 33 feet 9 inches northwest-southeast (Figure 5). The building is bisected between its long northwest and southeast sides at the northeast end by a concrete wall 35 feet long. The foundation walls are 8 inches thick and stand up to 7 feet 2 inches tall (on the northwest side).

Figure 5. Feature 6 concrete foundation, facing south.

Feature 6 is a large concrete building foundation measuring 63½ feet northeast-southwest x 33 feet 9 inches northwest-southeast. The building is bisected between its long northwest and southeast sides at the northeast end by a concrete wall 35 feet long. The wall lays 15 feet 10 inches from the southeast wall. The foundation walls are 8 inches thick and stand up to 7 feet 2 inches tall (on the northwest side). There is a concrete slab floor in the northwest half of the building. In the north corner of the building is a small room set outside the wall line and measuring 3 feet x 4 feet 8 inches. It has a 4-inch thick concrete slab roof through which was put a 8-inch red tile collar. This configuration is suggestive of a stove or vent pipe. Also, there is a set of three concrete steps at the southwest wall and two steps along the northwest wall toward the "fireplace" end. Finally, there is a tall concrete retaining wall at the south corner of the building, possibly once leading to a garage door type entrance. Today, Feature 6 is filled with broken concrete slabs, water softener tanks, fireplace grills (CCC and modern), barbed wire, a backhoe bucket, and lockers.
