# Hydrogeologic Analysis of the Water Supply for Bancroft, Caribou County, Idaho

Michael J. Martin  
Allan H. Wylie  
Bruce R. Otto

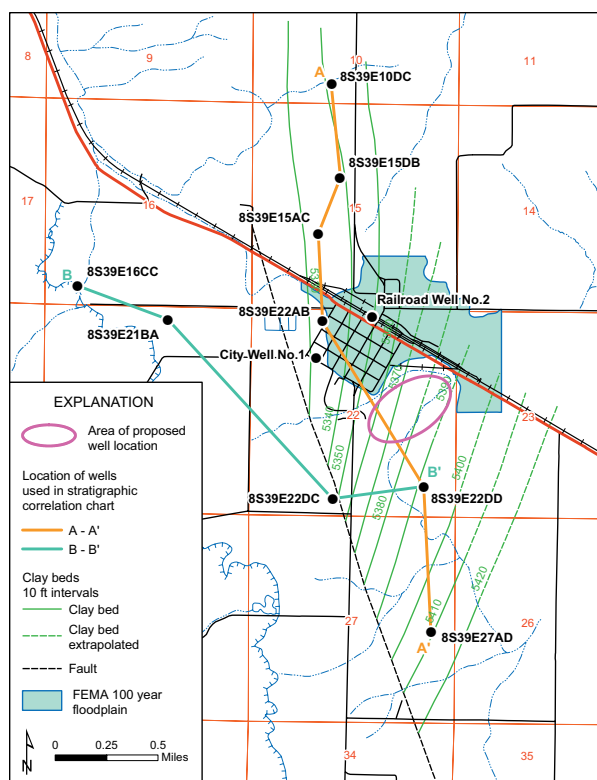
Figure 2. Underlying clay bed, location of wells used in the stratigraphic correlation chart, and proposed well location for Bancroft.

Figure 3 correlates the geologic units identified in these wells. Section lines A-A' and B-B' shown in Figure 2 indicate the locations used in Figure 3. Figure 3 shows the correlation of the clay-rich confining layer between the wells, and Figure 2 shows the geographic extent of this bed. Since City Well No. 1 and Railroad Well No. 2 lack adequate data, we omitted these wells from the correlation analysis. These wells lie between wells 8S39E22BA and 8S39E22DD. A correlation of the clay bed between the latter two wells implies that City Well No. 1 should penetrate the bottom of the clay layer approximately 107 feet below ground surface. Railroad Well No. 2 should intercept it approximately 108 feet below ground surface. The clay layer probably protects surface contamination from infiltrating into the underlying basalt aquifer.

The presence of fecal coliform and elevated nitrate concentrations pose problems to the long-term viability of the existing wells. Figures 2 and 3 show that Bancroft is above a clay-rich confining layer interbedded between basalt flows. This layer probably reduces vertical movement of any locally contaminated water, protecting the underlying ground water by forcing contaminants to migrate horizontally. Poor construction of the two town wells likely explains how contaminants enter the Bancroft water supply system.

We recommend the town drill south of town within the area of the new park (Figure 2). The clay-rich confining layer overlying the aquifer will provide protection from contamination if the town adopts proper well construction techniques. A high-solids bentonite grout or hydrated bentonite chips and pellets will provide the best seal and prevent ground-water contamination (Christman and others, 2002). The sealant must reach a depth below the confining layer to prevent contamination. In the recommended target area, the projected depth onto line A-A' (Figure 2 and 3) to the bottom of the clay-rich confining layer is 68 feet. The specific depth, however, should be determined by the depth to the clay layer when drilled.

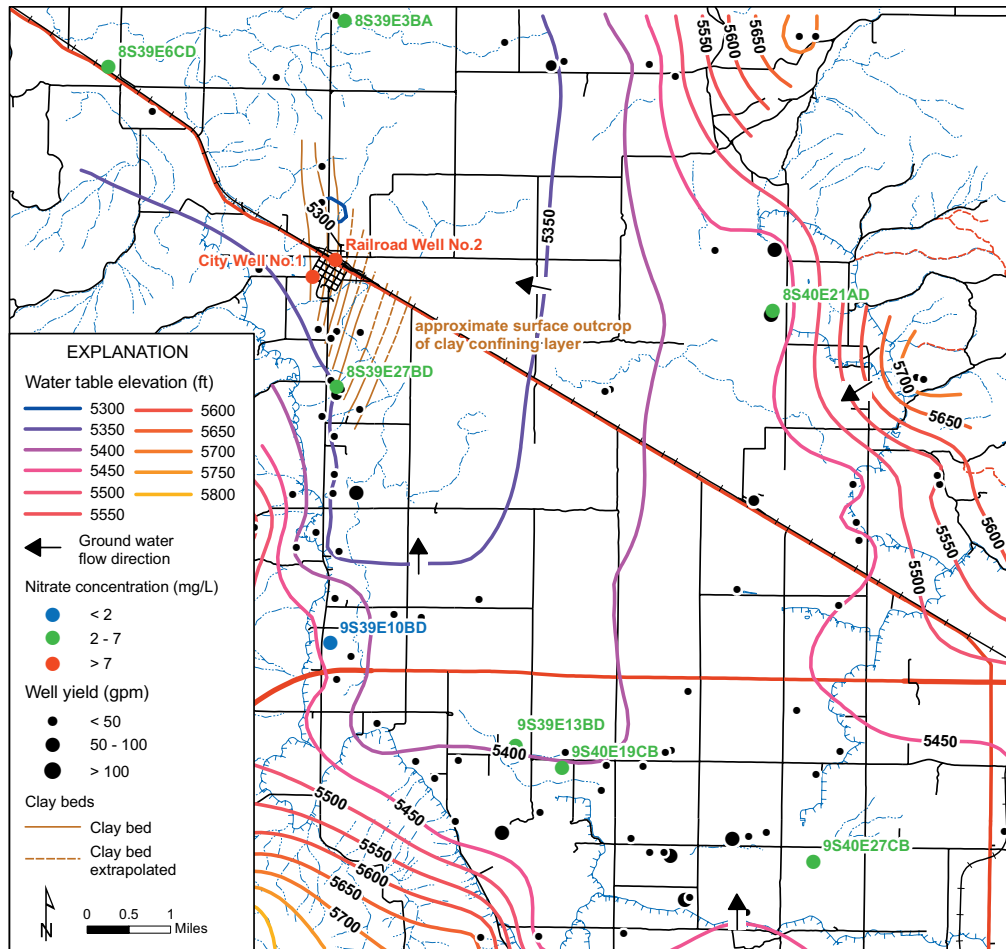
Figure 5. Water table, ground-water flow direction, and most recent nitrate concentrations in the Gem Valley area.

The USGS provides data on water quality and static water levels for wells in Gem Valley. Elevated nitrate levels occur throughout the aquifer. Both City Well No. 1 and Railroad Well No. 2 measure close to the maximum contaminant level (MCL) of 10 mg/L and have higher concentrations than surrounding wells in the northern half of Gem Valley. Figure 5 shows locations of the USGS monitoring wells, the Bancroft wells, and the most recent nitrate concentrations. According to water-table contours, the USGS wells are located upgradient

from City Well No. 1 and Railroad Well No. 2, and water flows toward the Bancroft wells. An analysis comparing USGS monitoring wells with those at Bancroft suggests the problem is well construction rather than nitrate contamination in the entire aquifer (Figure 7). Figure 7 suggests that both wells originally contained nitrate concentrations around the elevated background values of the aquifer. In recent years, however, nitrate concentrations increased in the town's wells, while other wells remained relatively constant.

contaminants could travel down poorly sealed wells through the clay layer and pollute the basalt aquifer. The agricultural business southeast of town is another potential source of contamination not mentioned in the source water assessment report. Nitrate from this possible source would likely follow the flow path described above. The part of town northeast of the railroad uses septic tanks rather than the municipal sewer system. These septic tanks lie upgradient and may play a role in the nitrate contamination observed in the municipal wells. Contaminants residing southeast of the surface exposure of the clay beds pose concern because they may flow beneath the clay toward the proposed well (Figure 5). These sources include State Highways 30 and 30N, railroads, and agricultural lands.

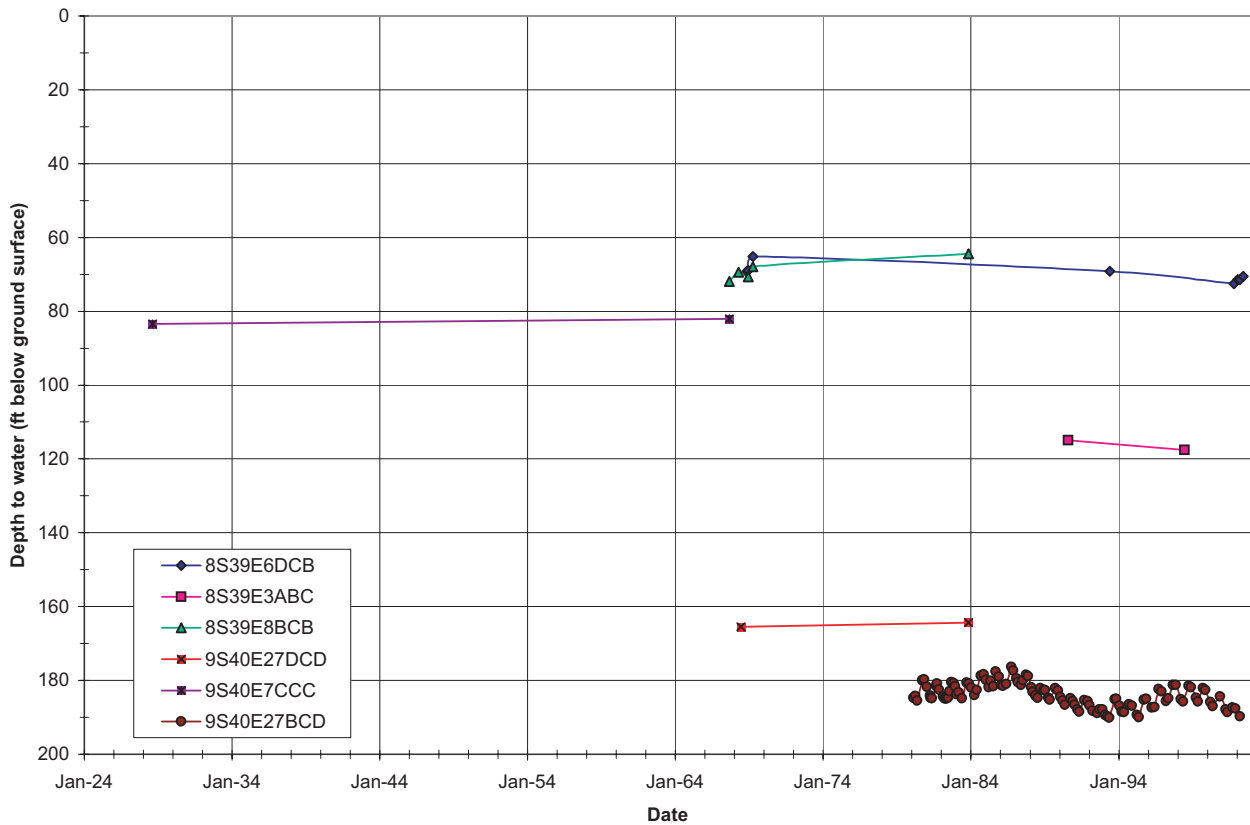
Figure 6. Ground-water levels for USGS monitoring wells within the Gem Valley area <<http://idaho.usgs.gov/>>.

Although the two supply wells lack sufficient data for analyzing the aquifer, the Idaho Department of Water Resources (IDWR) and the USGS provide static water levels for other nearby wells in the northern half of Gem Valley. Several wells monitored by the USGS indicate that water levels have remained constant over the past 74 years, thus providing evidence of adequate recharge for a sustained water supply (Figure 6). In addition to adequate recharge, well yields within the basalt aquifer, obtained from IDWR well logs, range from 20 gallons per minute (gpm) for individual domestic use to greater than 1,000 gpm for irrigation use (IDWR records; Figure 5). City Well No. 1 and Railroad Well No. 2 currently yield an adequate volume of water for Bancroft. These data provide evidence that a properly constructed well in the basalt aquifer can supply sufficient water to Bancroft.

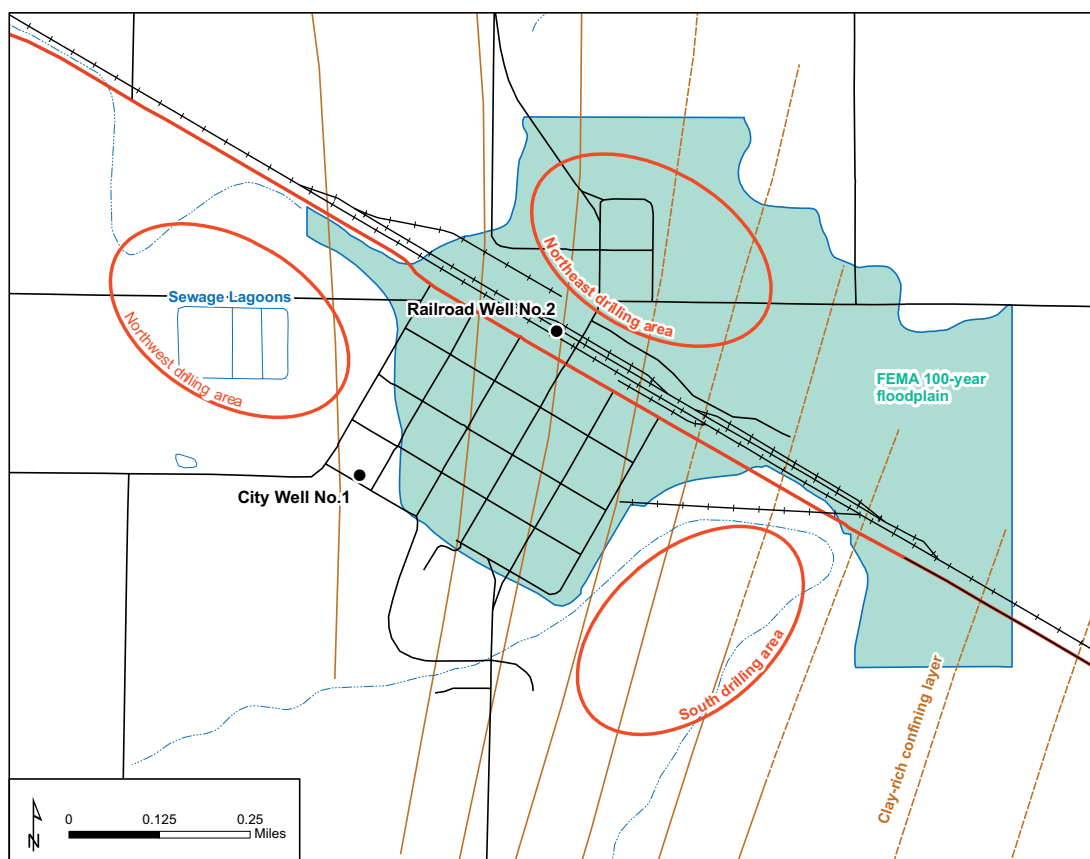
Figure 8. Three potential drilling areas for Bancroft.

We partitioned the Bancroft region into three potential areas for ground-water development to determine the best location for water from the only viable aquifer. These sites are northwest of town, northeast of the railroad, and south of town (Figure 8).

Contamination from the town that leaks through the confining clay layer, or leakage from sewage lagoons, may impact the quality of water in the aquifer northwest of town. These factors make this a high risk area for maintaining water quality. The extent of the clay-rich confining bed to the northwest is also unknown because of the lack of well data.

A well located northeast of town may encounter several problems. This unincorporated part of town lacks central water or sewage lines, and residents there use septic tanks. Drain fields from the septic tanks may leach contaminants that could enter the aquifer. Most of the area is within the FEMA 100-year floodplain. Locations within the floodplain are more susceptible to contamination by surface water. The cost of constructing a pipeline under the railroad grade and Idaho highway 30N may be a major drawback.

There are several advantages to this area. Any contamination generated in town will have minimal influence because of the northwestward ground-water flow direction. The new well location is outside of the FEMA 100-year floodplain, reducing the impact of contamination from surface events. The town already owns and plans to develop a park in this area, so there is no cost associated with purchasing the land.
