RECLAMATION PLANS FOR ABANDONED MILL TAILING IMPOUNDMENTS
IN THE SOUTH FORK COEUR D'ALENE RIVER BASIN

A Thesis

DEGREE OF MASTER OF SCIENCE

MICHAEL ROBERT GROSS

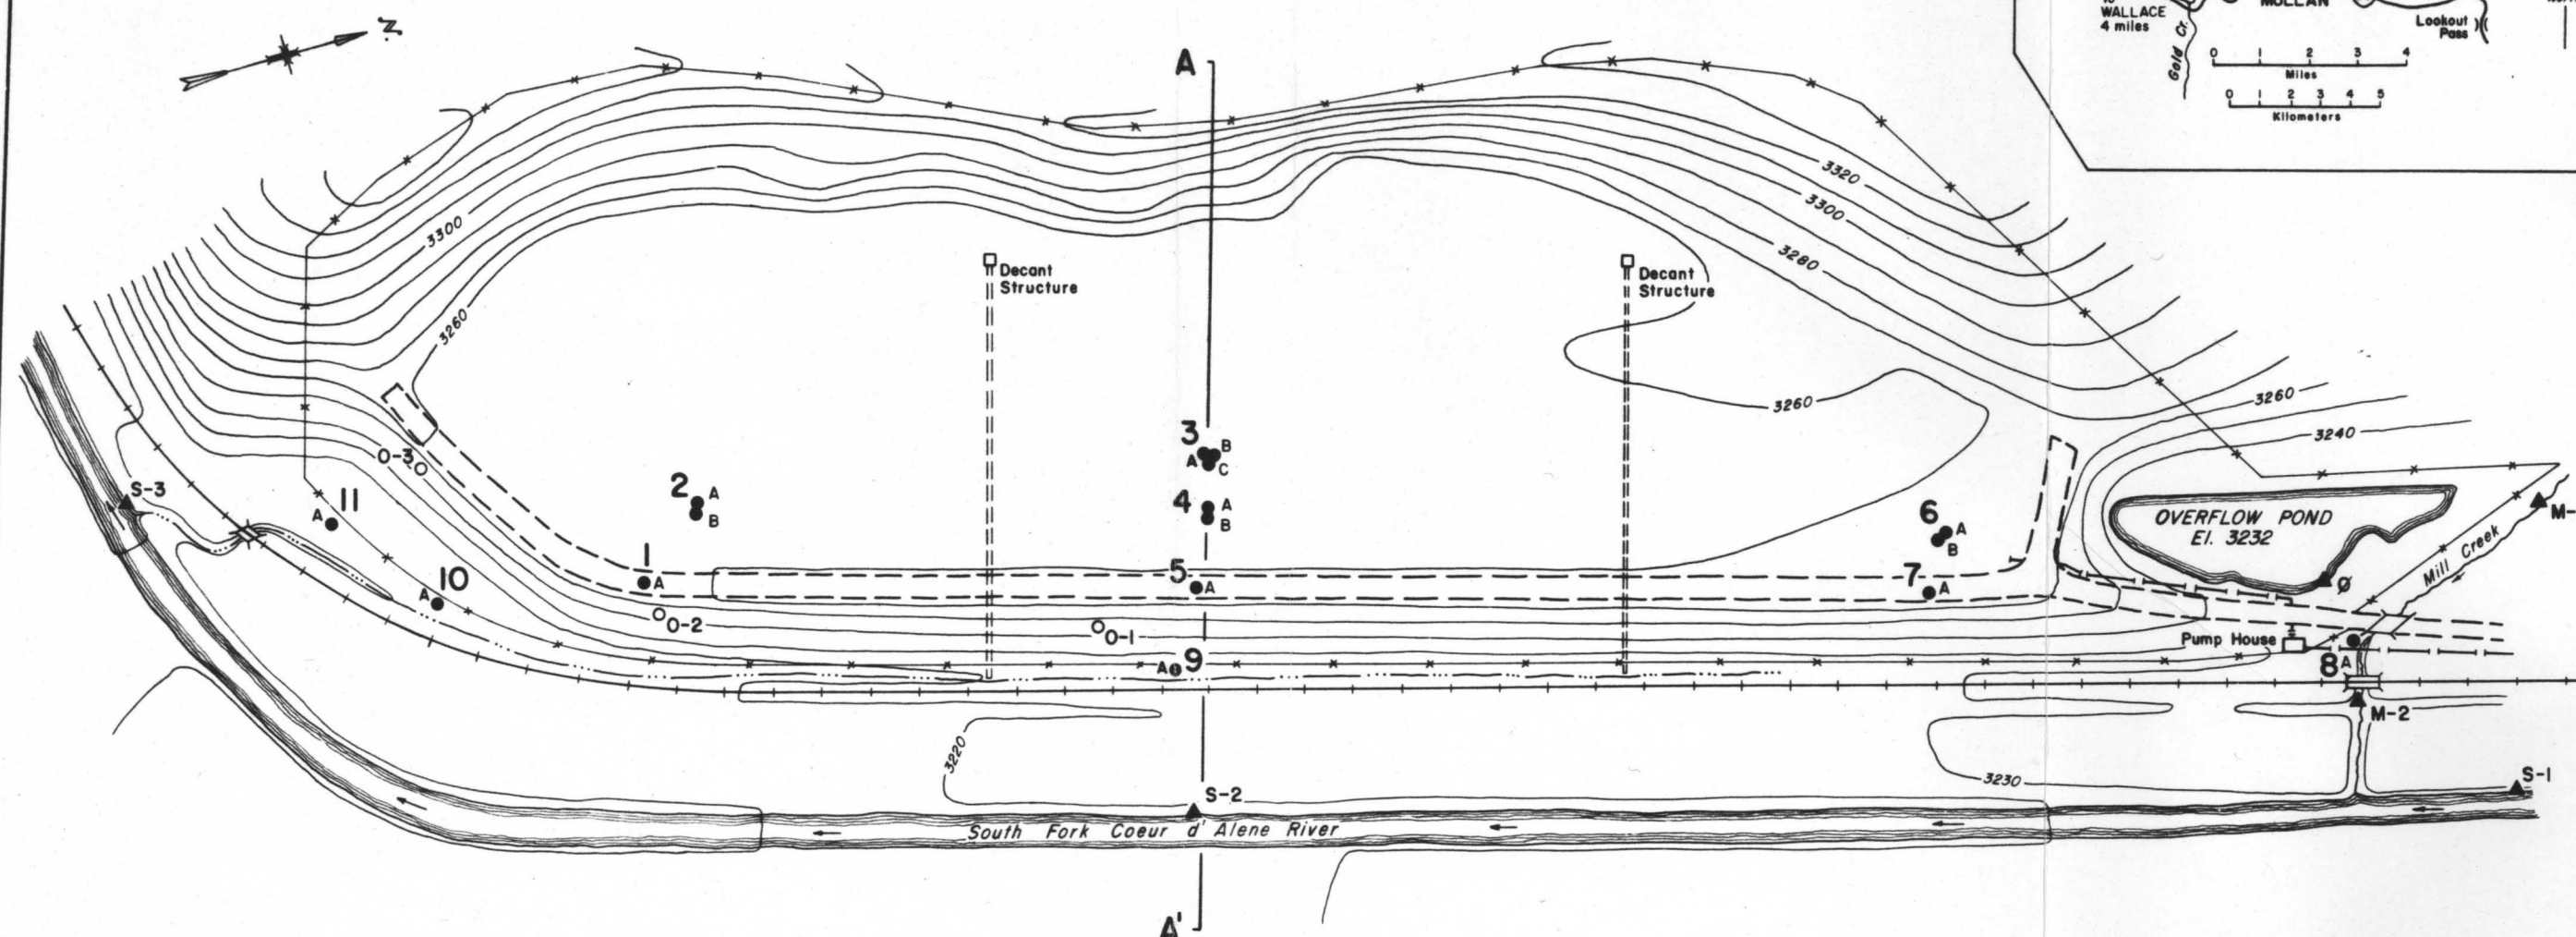
LUCKY FRIDAY TAILING IMPOUNDMENT No. 1

Physical Conditions. The abandoned Lucky Friday No. 1 tailing impoundment is well protected against direct erosion by surface streams. Protective embankments of the pile are complete and structurally sound. The small tributary area above the pile surface and the relatively higher hydraulic conductivity of material closer to the embankments greatly reduce any danger of dike overtopping by collected surface runoff. Blowing silt is a problem on the unvegetated pile surface, and the dust reaches residences in Mullan.

Chemical Conditions. Tailing composition and water quality within the abandoned tailing impoundment and in nearby surface streams indicate that leaching of metals from tailing material is probably occurring at a rate which does not pose a threat to water quality in the South Fork. Ground water is moving down through the pile and into the alluvium, but the metals load is very small. Complete gravity drainage of the pile has not occurred. Nutrients necessary for adequate plant growth are apparently lacking on the pile surface. Growth of grasses has been successful where mulch, fertilizer, and irrigation have been applied.

Esthetic Conditions. The impoundment is highly visible, both to residents of Mullan and travelers on the interstate highway. Trees planted along the embankment toe have been very successful, and good vegetation is present on the lower half of the slope. Establishing plants on the section of embankment constructed in 1975 has not worked as well. It appears that there is not enough moisture-retaining topsoil to keep the grasses healthy.

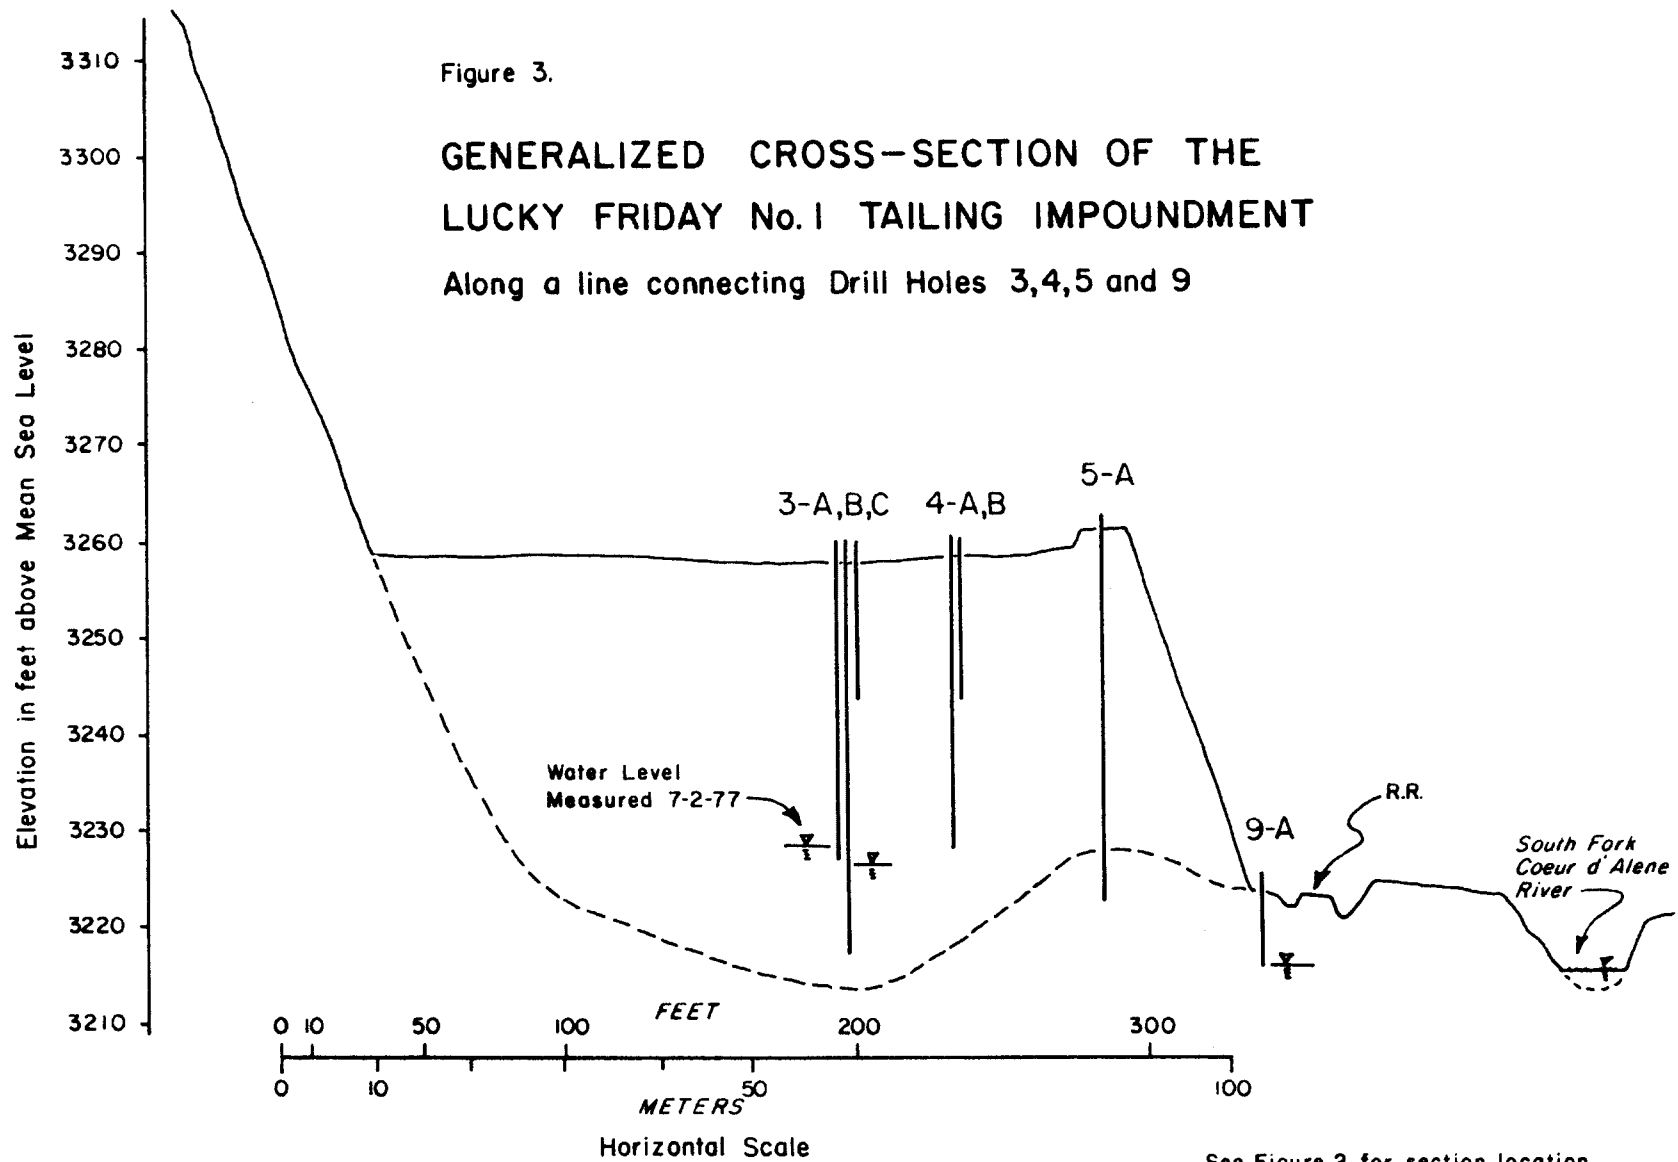
GENERALIZED CROSS-SECTION OF THE LUCKY FRIDAY No.1 TAILING IMPOUNDMENT

The presence of water within the pile does not pose structural or horizontal seepage problems. No evidence of post-abandonment seeps were found around the embankments, and the large percentage of sand-size tailing deposited along the compacted rock-fill embankment seems to keep the phreatic surface low in the dike area. Movement of water ponded on the surface would be down through the pile and toward the embankments, then into the permeable alluvial gravel and boulders underlying the site.

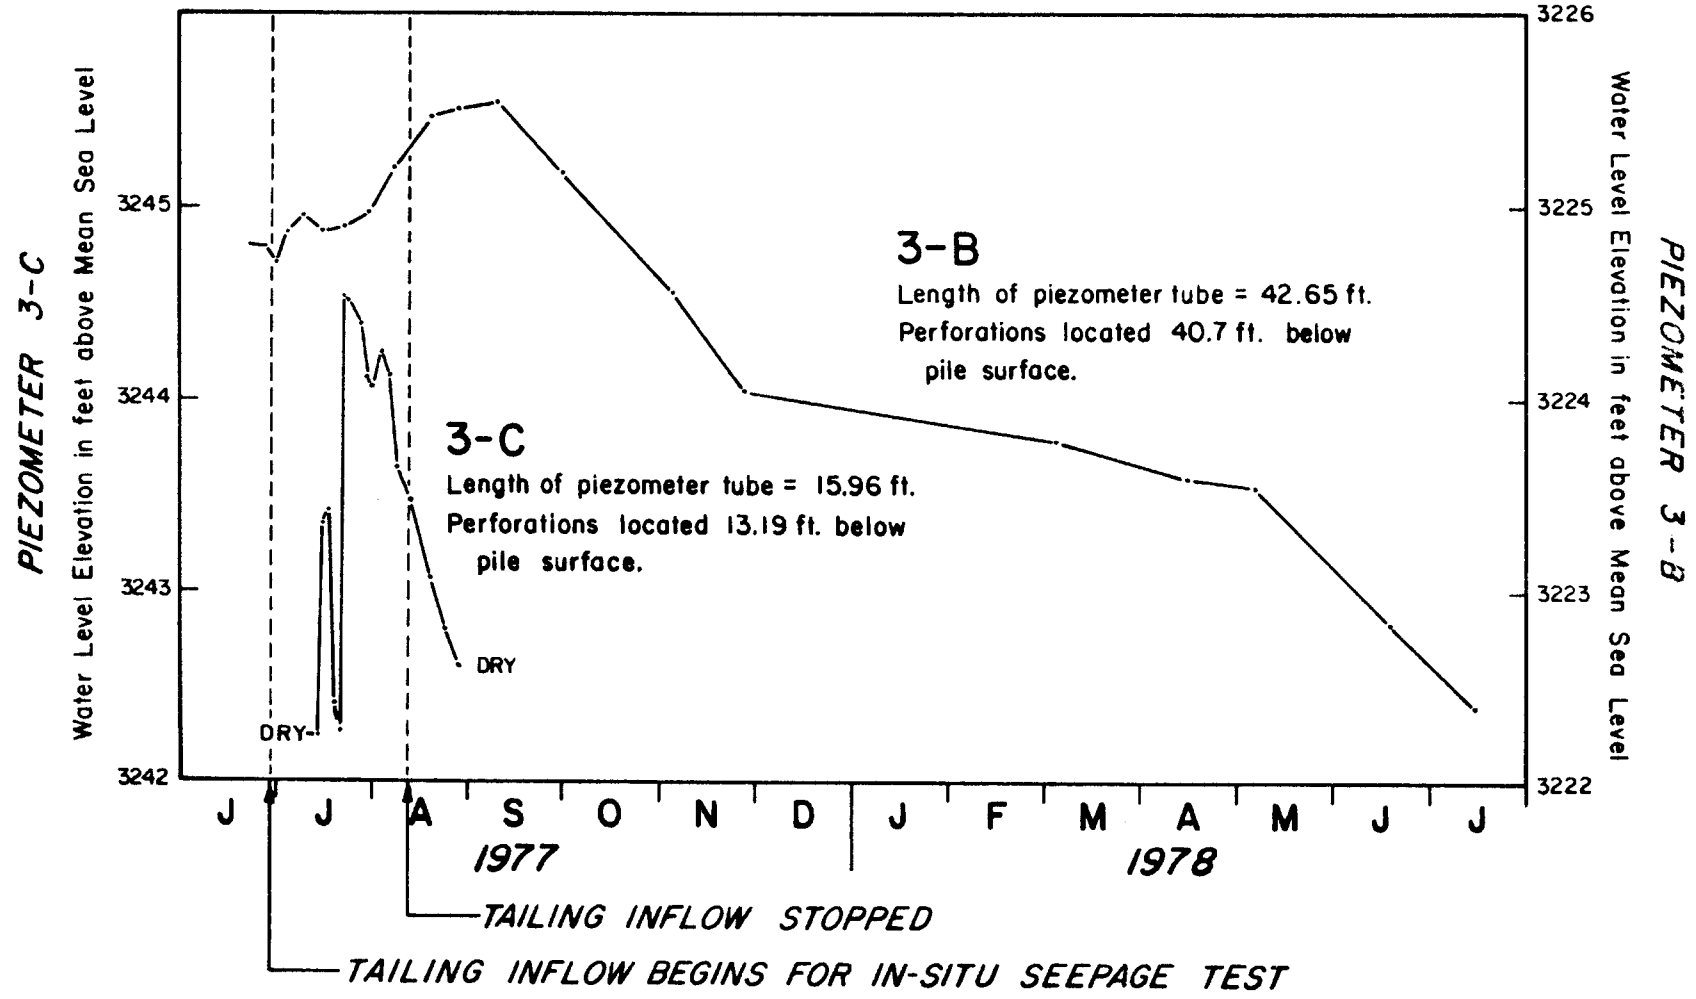
Figure 4. GROUND-WATER HYDROGRAPHS FOR TWO PIEZOMETERS IN DRILL HOLE No. 3, Lucky Friday No.1 Tailing Impoundment

general downward trend can be seen in the data from piezometer 3-B, indicating water continued to drain from the tailing pile after its abandonment. A muted seasonal water level fluctuation can be seen, with a high in April and lowest levels in December and January.

If the pile had remained truly abandoned, this cyclic downward trend would continue until the maximum gravity drainage of the tailing pile occurred. Seasonal fluctuation would have occurred, reflecting the small amount of annual recharge from precipitation to the pile and the general water level fluctuation in the underlying alluvium.

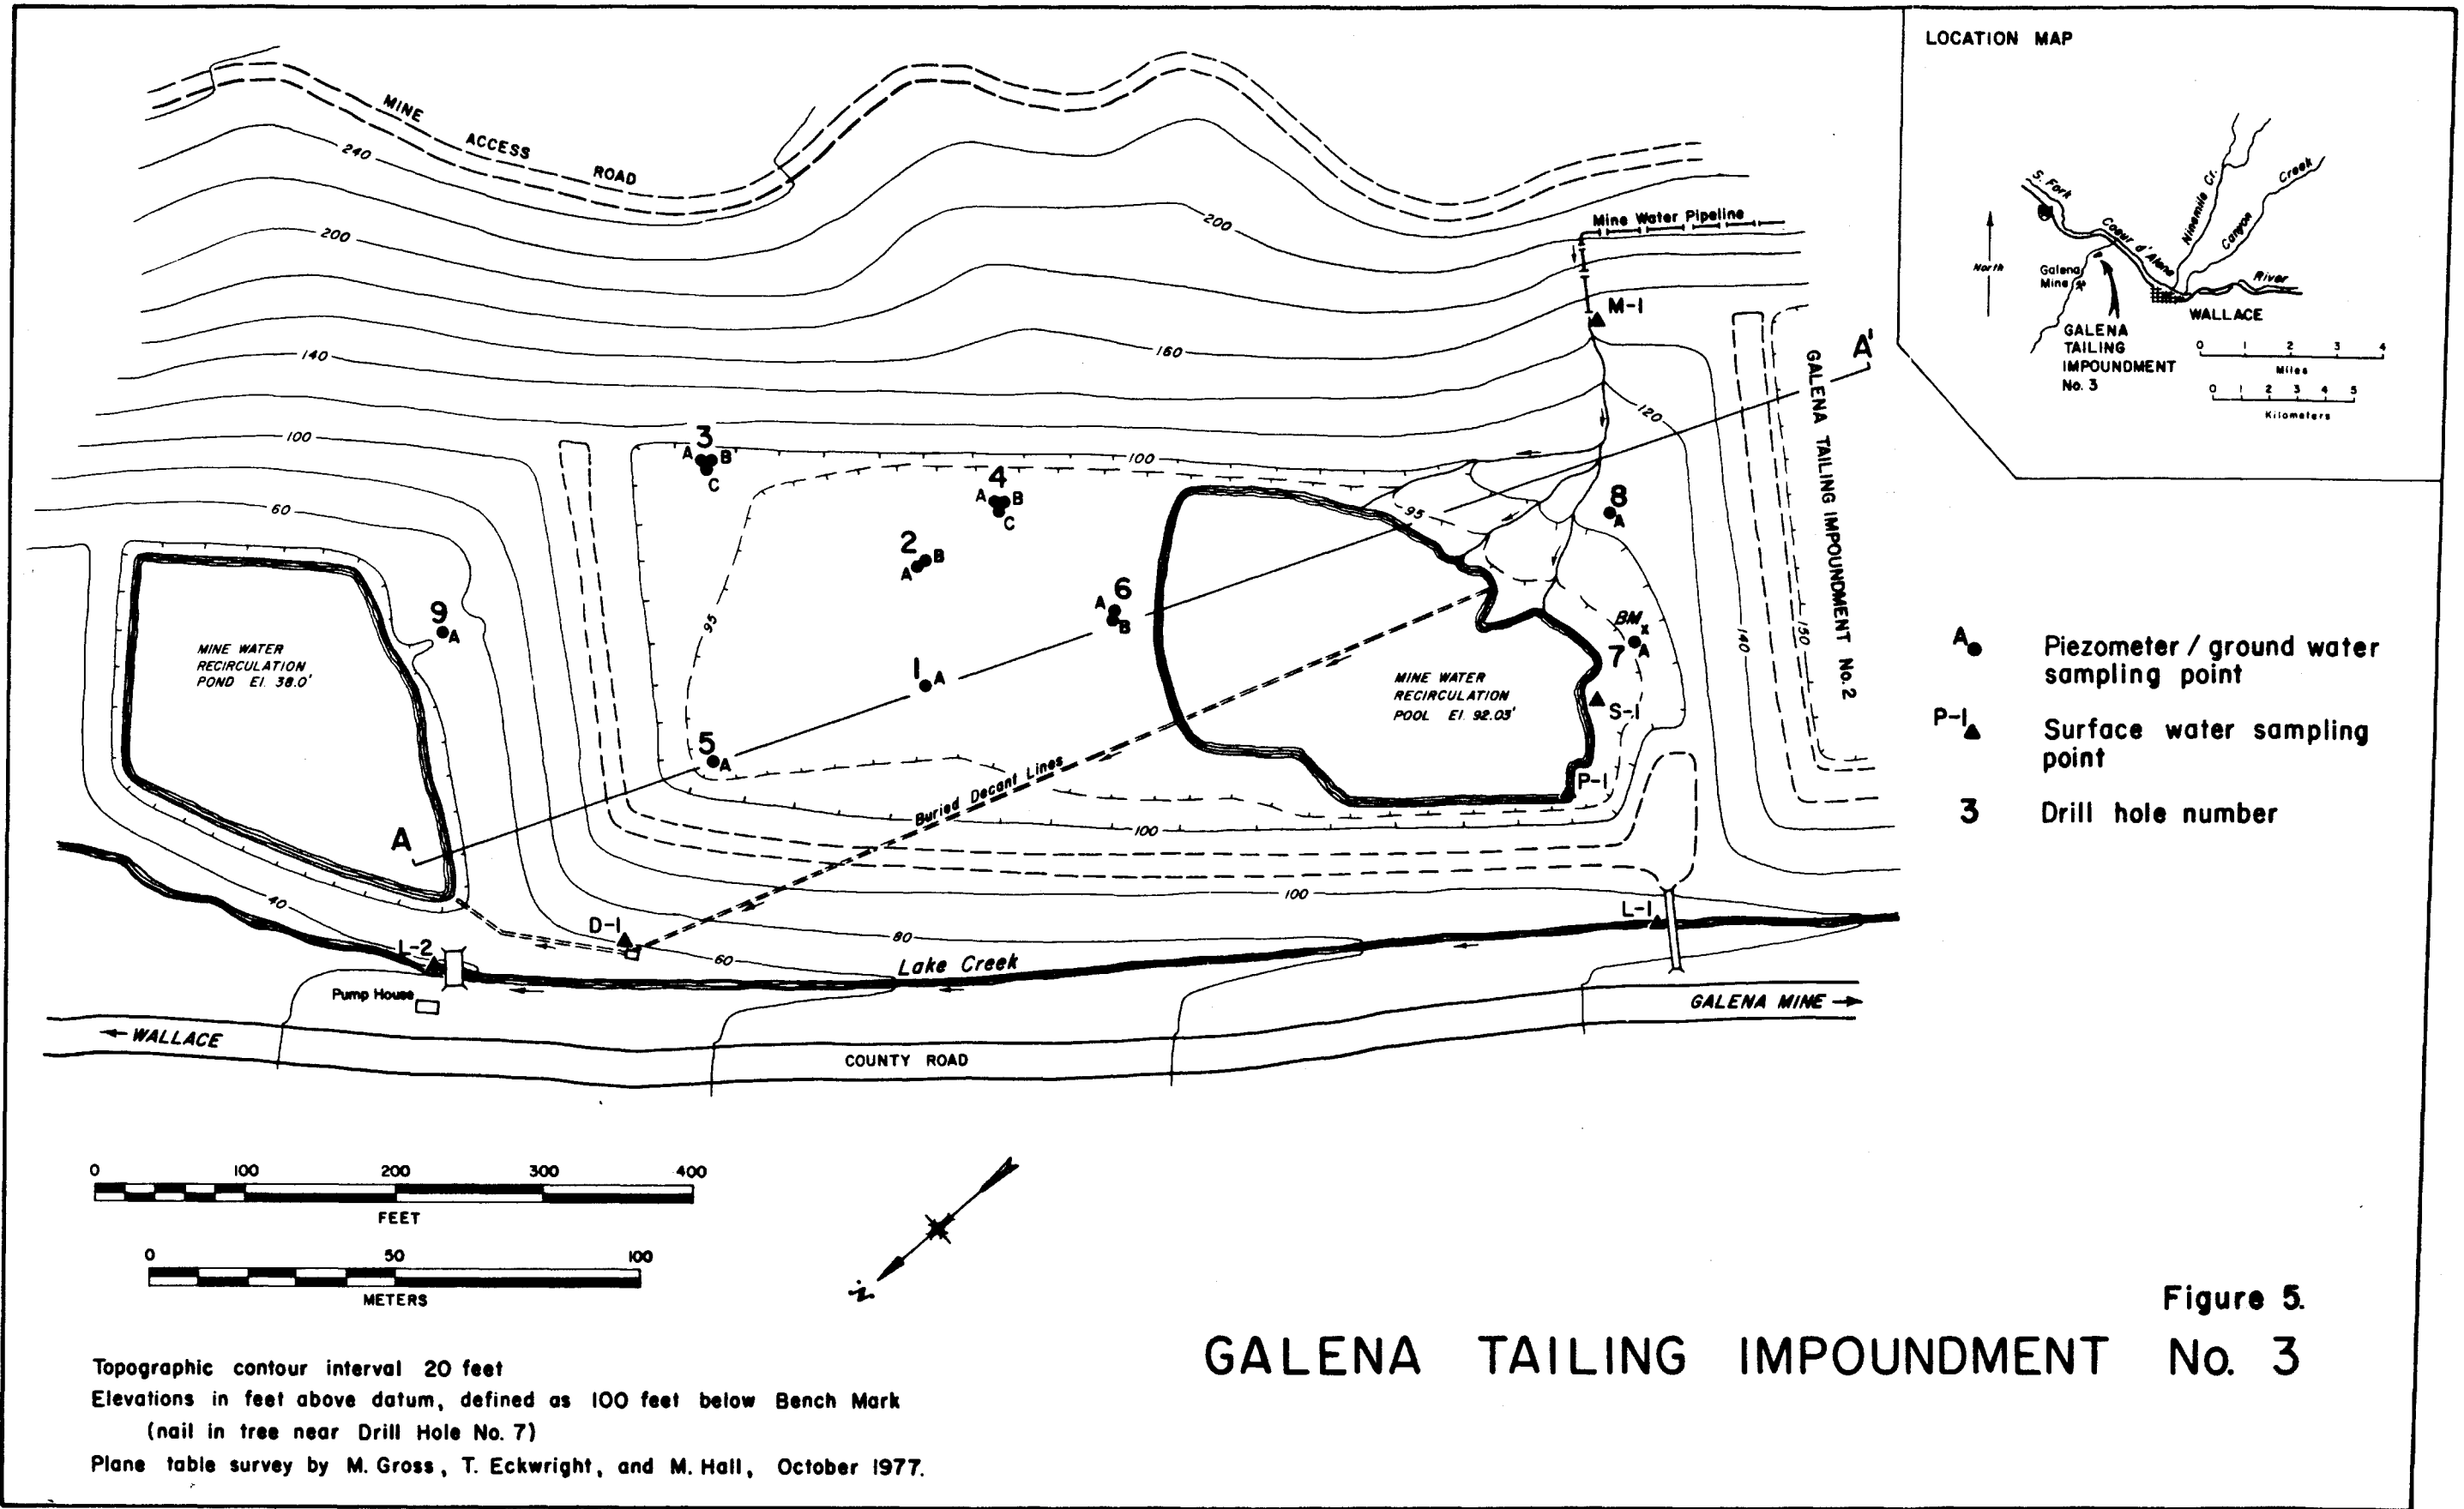
Figure 5.
GALENA TAILING IMPOUNDMENT No. 3

Physical Conditions. Direct erosion of tailing by moving surface water is not a serious problem at the Galena No. 3 site. Heavy ripping at the embankment toe and channelization of Lake Creek between the pile and road effectively protect the site. Wind erosion of the fine-grained tailing surface does occur, but the remoteness of the site makes public impact minimal. High embankments of the last ten-foot (3.3 meter) lift tend to keep blowing tailing material confined to the pile area and away from surface streams. Major failure of the pile after abandonment is not considered a serious problem; the existing decant system is adequate to carry both mine drainage water and surface runoff reaching the pile. If use of the pile for mine water circulation were discontinued, the decant system could serve as a drain for ponded surface runoff.

Chemical Conditions. Ground water moves through the tailing pile, with the phreatic surface exhibiting the expected seasonal fluctuations. This would provide a mechanism for the movement of oxidation products from heavy metal leaching into ground and surface waters below the pile. The spring-time rise in water levels within the tailing is due to recharge from snowmelt originating on the hillside above the pile and appears to be unrelated to the pool of mine drainage water maintained on the pile surface. Some ground water in the pile appears to originate as surface water farther upstream along Lake Creek.

Water quality and tailing material composition data gathered as part of this study were inconclusive in determining the site's potential for chemical problems. Should further sampling indicate that remedial action is necessary, isolation of the pile from ground water moving down the Lake Creek valley is not likely to be a recommended procedure. Steep-

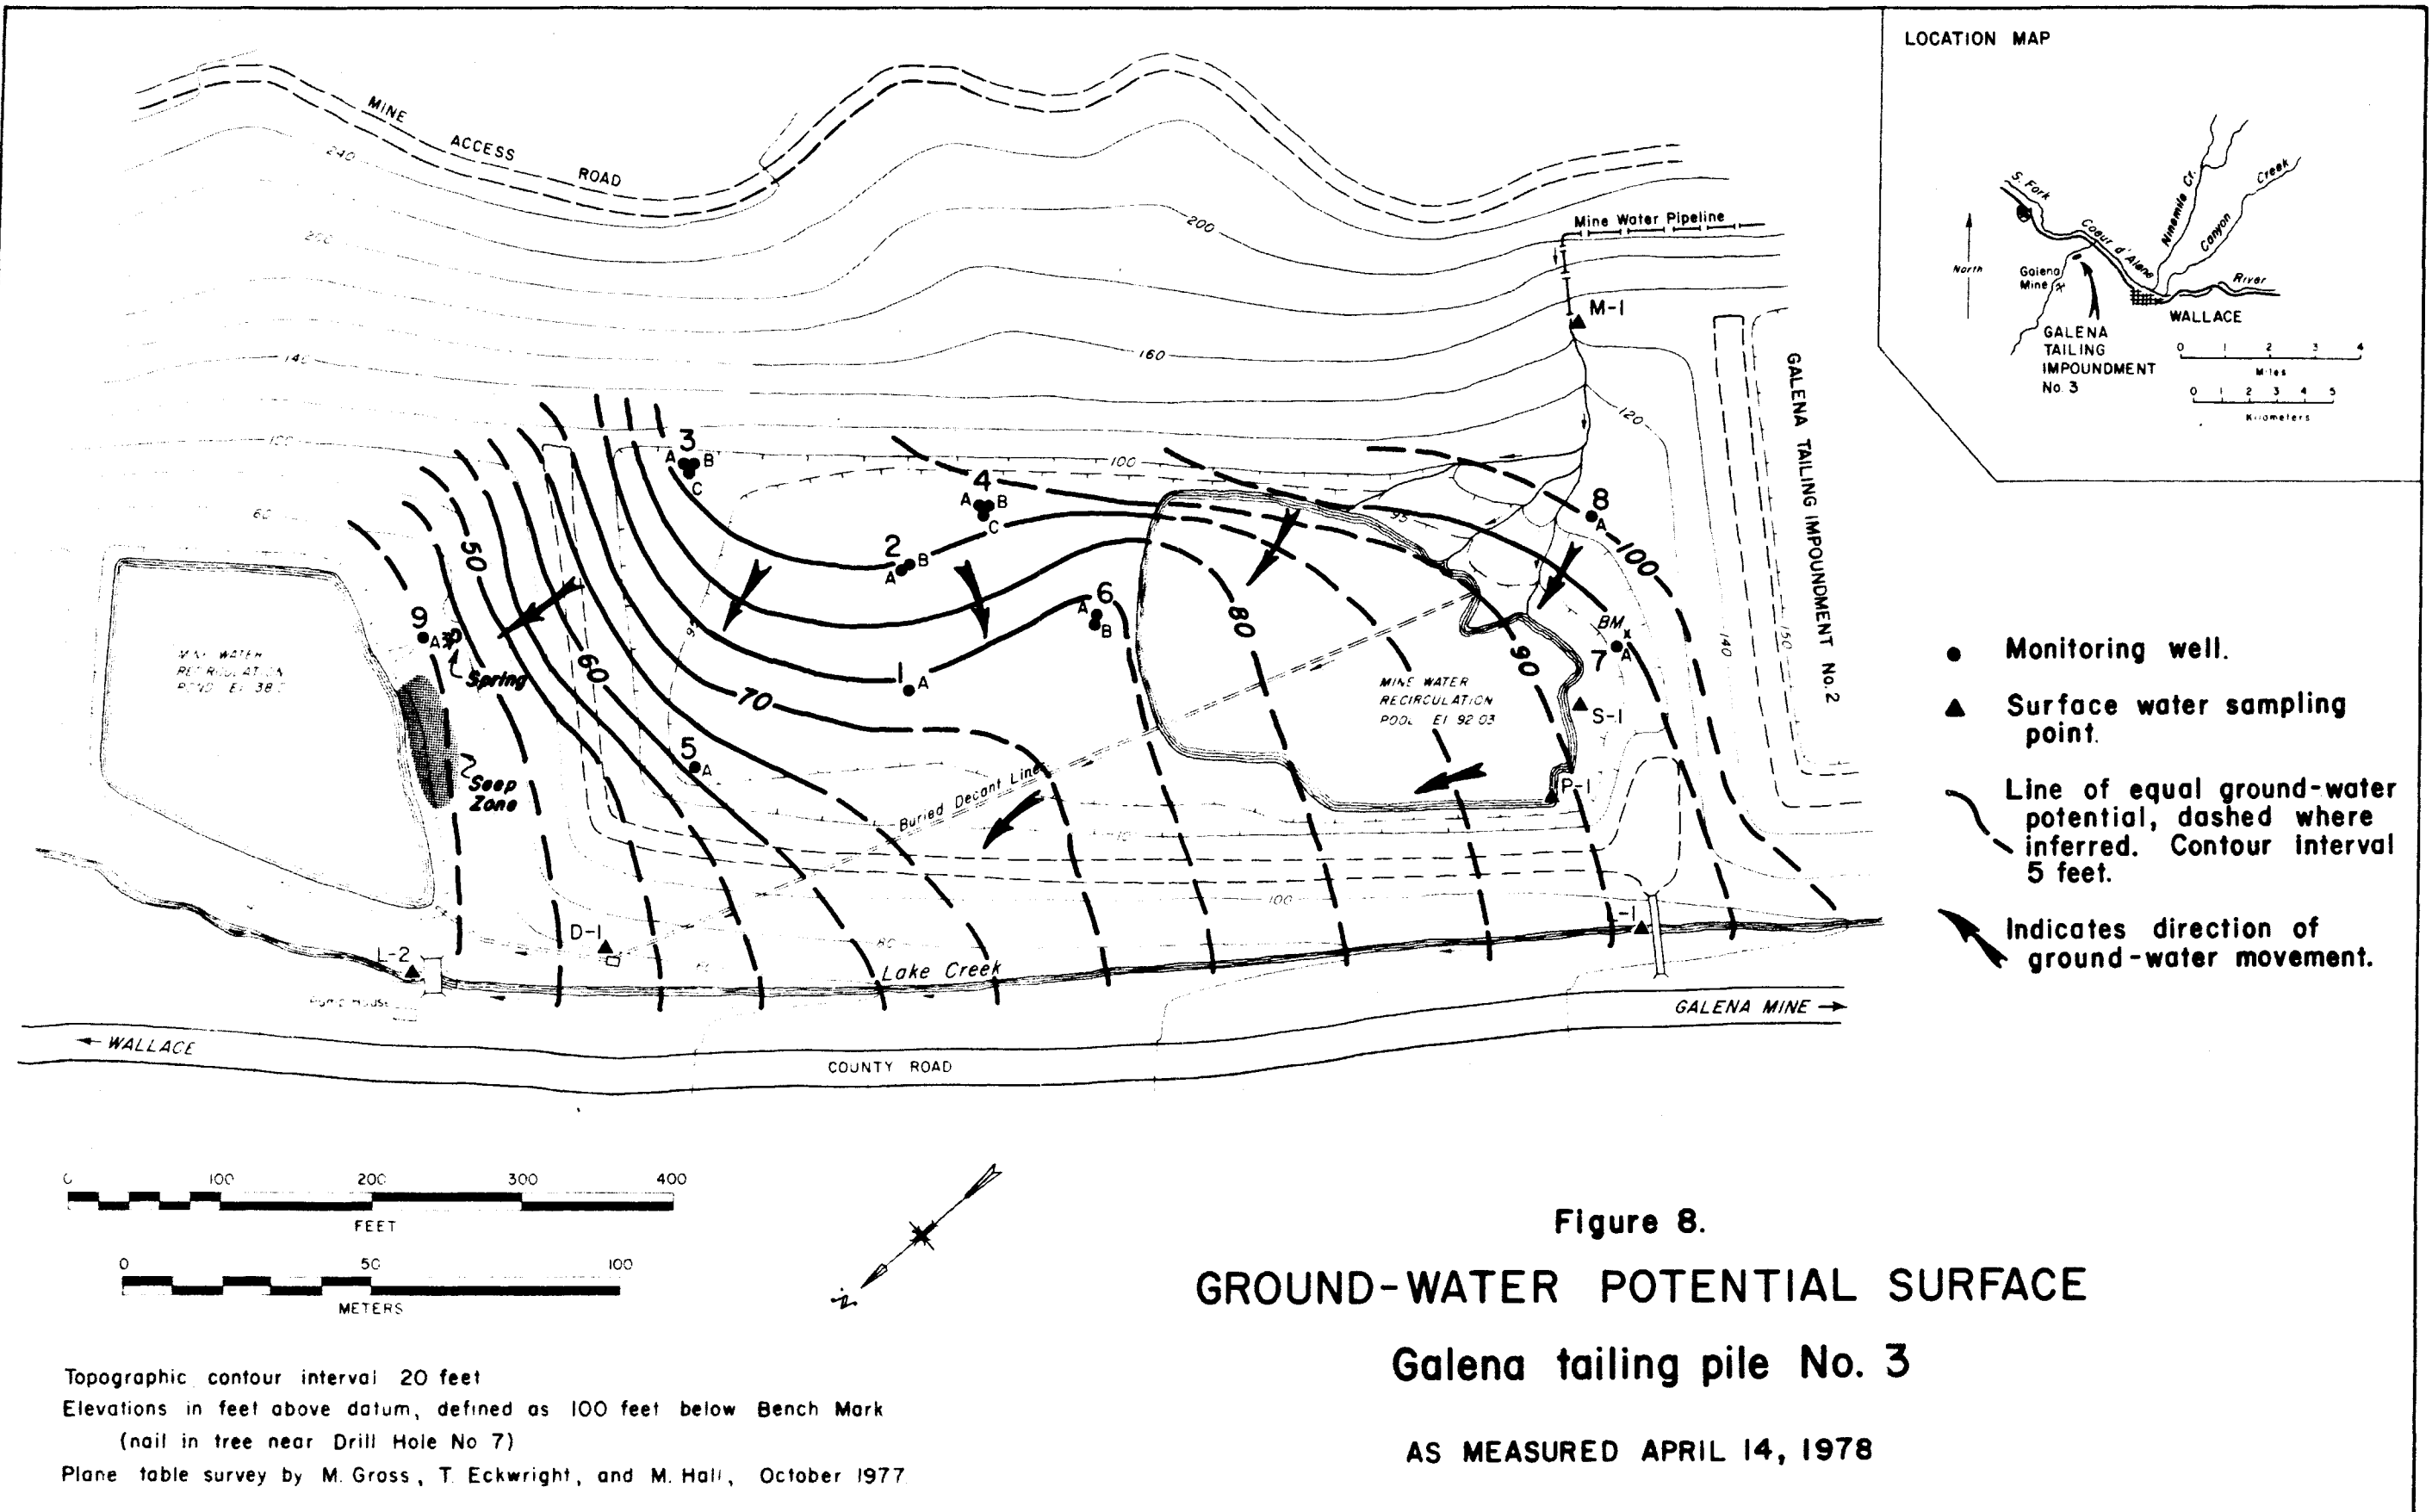
Figure 8.
GROUND-WATER POTENTIAL SURFACE
Galena tailing pile No. 3

Infiltration of snowmelt and rainfall have caused the mound in the northeast section of the pile, and water from Lake Creek is shown as moving beneath and within the pile from southwest to northeast.

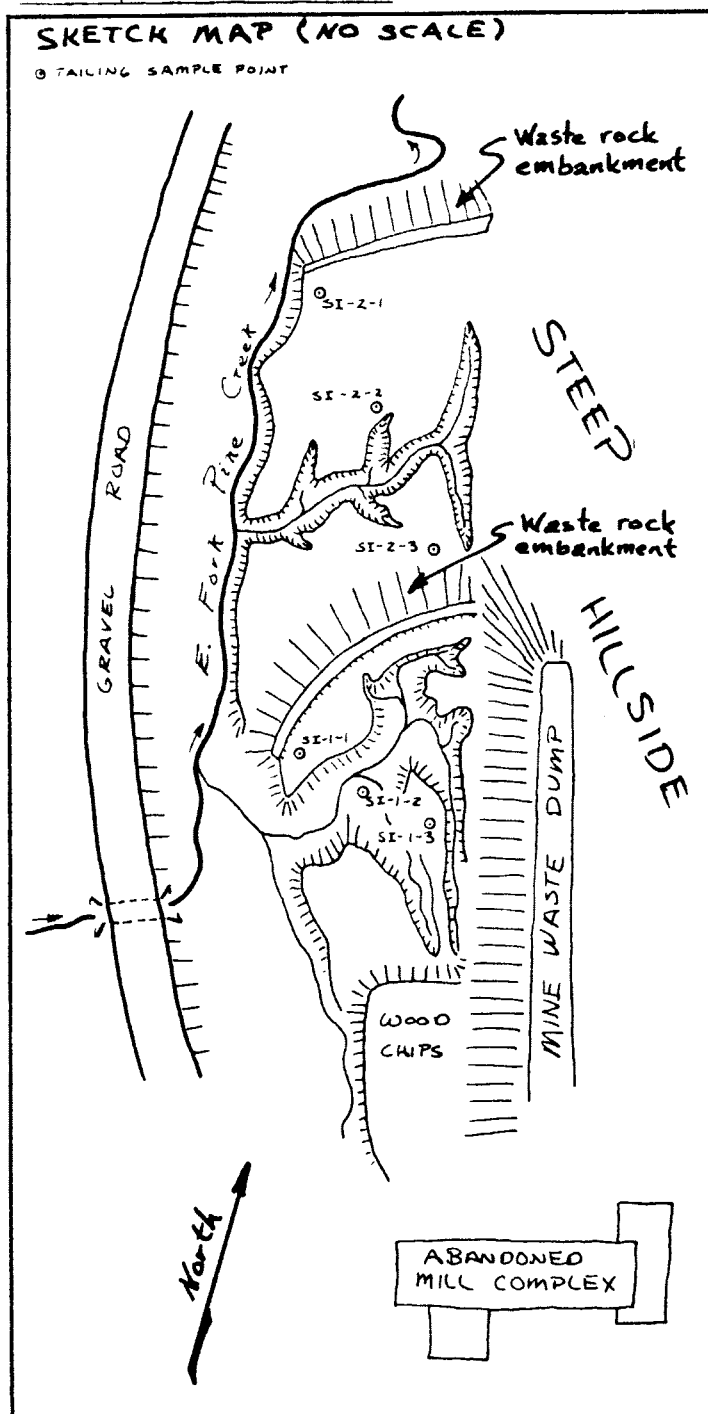
shaped deposit of flotation tailing approximately 500 feet long and 180 feet wide between a steep hillside and the East Fork of Pine Creek. The nearest dwelling is 3 miles downstream. A gravel county road just west of the East Fork confines the flow of the stream between the road embankment and the tailing pile. Two distinct impoundments are present, both of which exhibit remnants of crushed-rock embankments constructed to impound the tailing for dewatering. Both impoundments have failed structurally, apparently along the original wooden decant structures. The lower embankment and tailing deposit has been eroded extensively by the creek, as well as through runoff from the hillside tributary to the pile surface.

Flotation tailing material was deposited behind constructed embankments along the east margin of the floodplain. Clarified water was decanted through wooden conduits laid beneath the embankments. Both sand-size tailing and slimes are dark gray in color when wet, weathering to a nearly white color when exposed on land surface. Chemical analysis of tailing samples (see Appendix B) reveals no unusually high concentrations of dangerous elements. Iron concentrations are unusually low, indicating that pyrite oxidation may not be a problem.

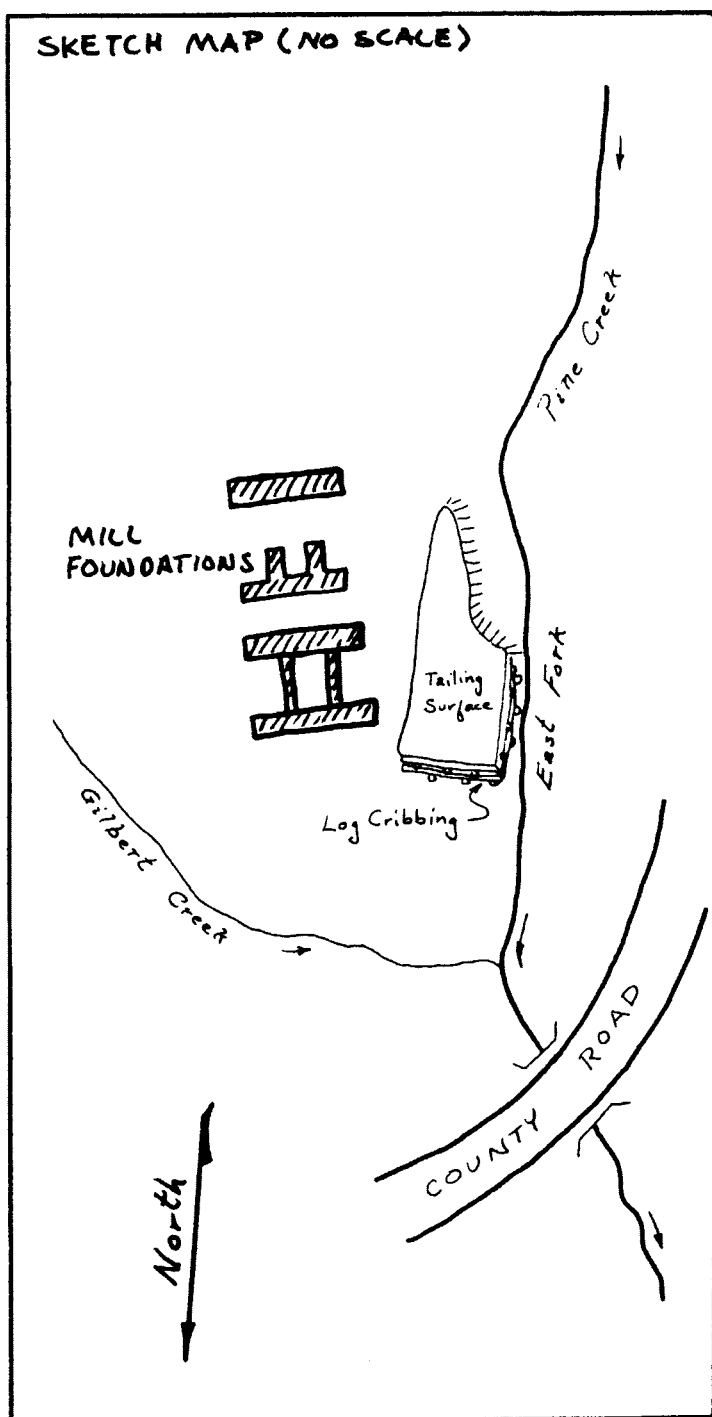
is located on the east bank of the East Fork of Pine Creek, just above the mouth of Gilbert Creek. Part of the remaining tailing material is still protected by its original embankment of log cribbing. The southernmost section of the site has been eroded so that a vertical bank approximately 8 feet high of tailing sands and slimes is exposed at the stream's edge.

Tailing material at Site No. 2 varies from gray slimes to dark brown and orange sand. No chemical analysis was made at this site. Reddish stain was present on rocks in the lower reaches of Gilbert Creek, but the source for low-quality water is probably mine drainage higher in that watershed. Almost no vegetation is established on the tailing surface.

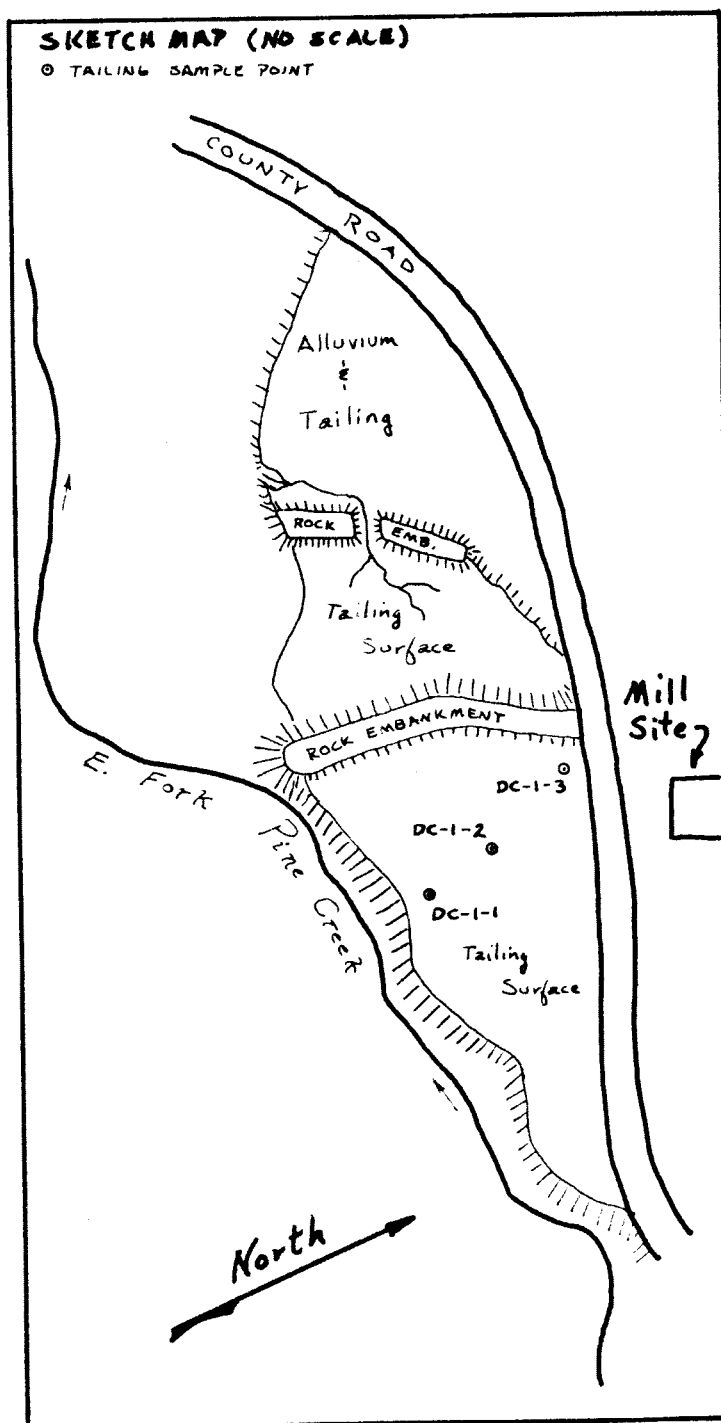
Pine Creek and is confined between the creek and county road, which appears to have been built at least partially on the tailing surface.

Remnants of mine waste rock/alluvial gravel embankments are present at two locations on the site, dividing the tailing pile into two distinct segments. Both embankments have failed, and a vertical bank of tailing up to 15 feet high is immediately available for stream erosion along 500 feet of the pile's south edge.

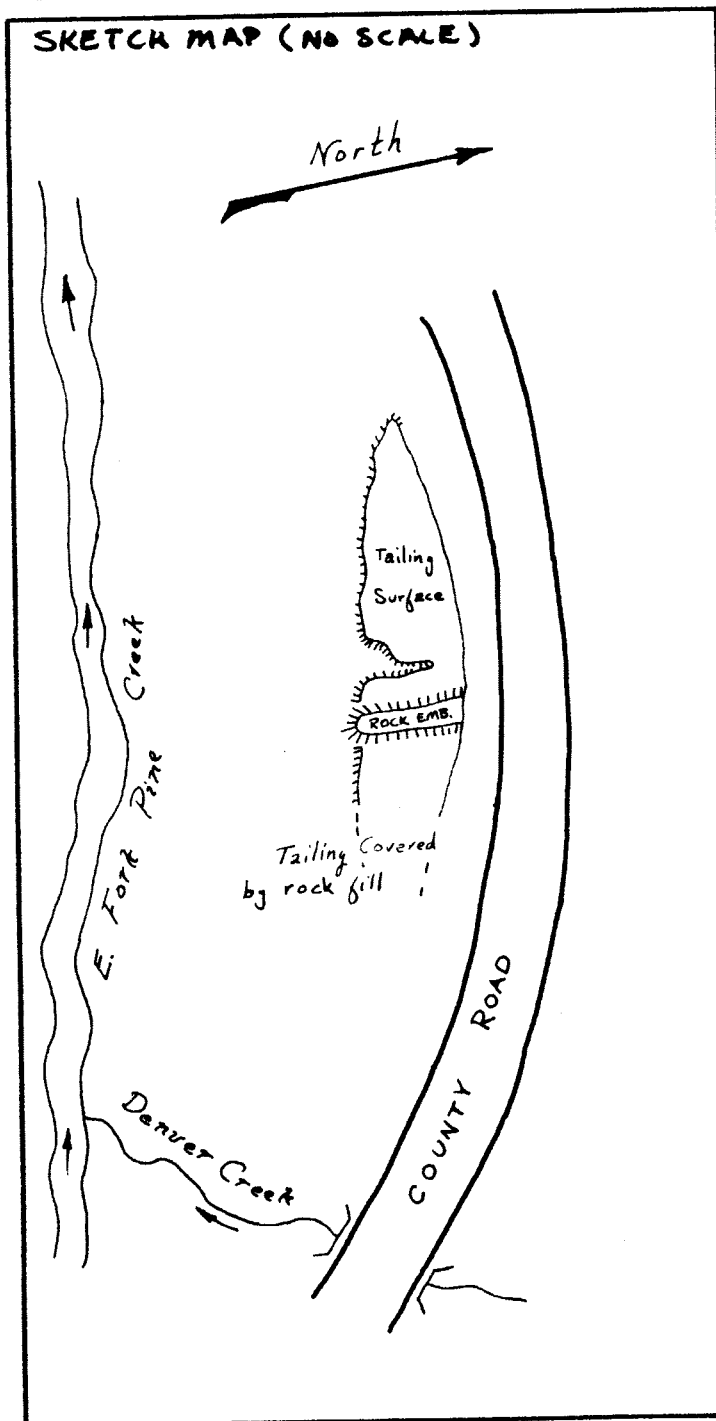
Creek and the county road.

Only a small remnant of an embankment still exists, and the tailing is completely unprotected from wind, sheet wash, and stream erosion.

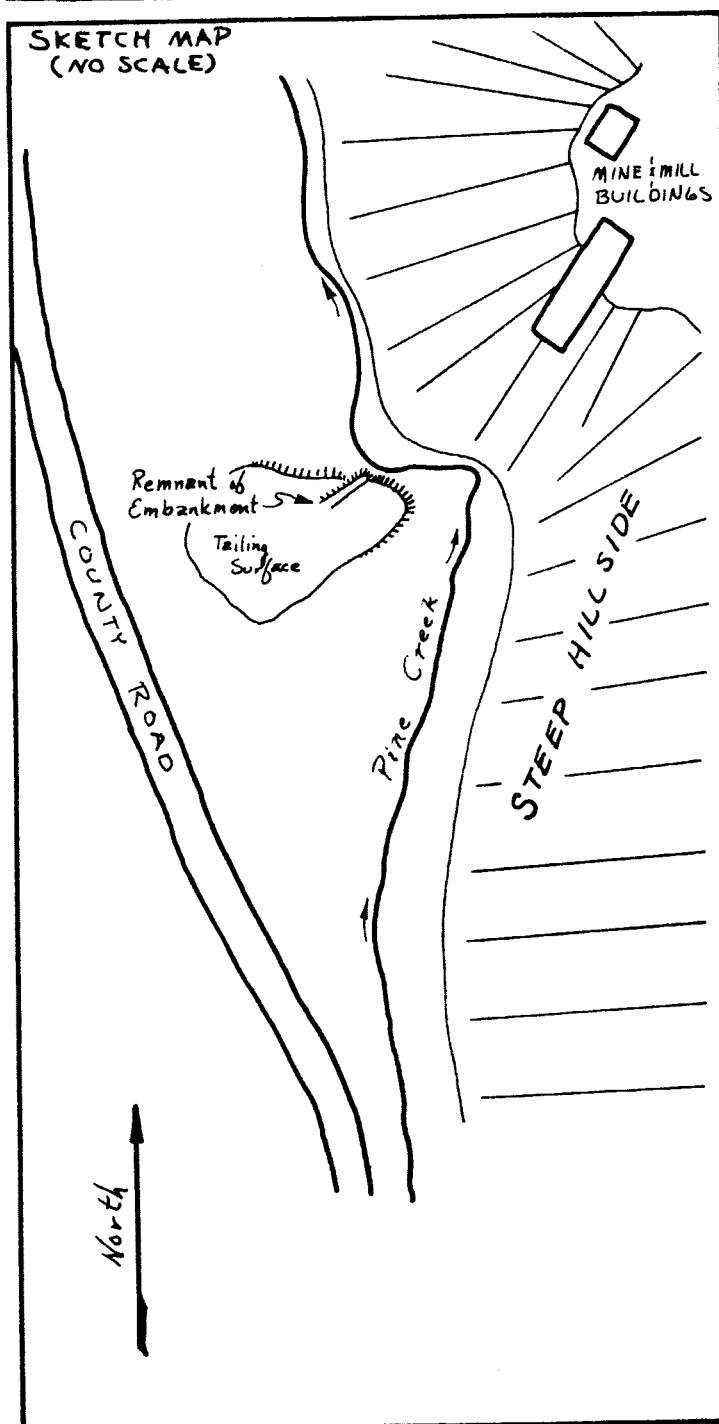
the Pine Creek floodplain behind an auto salvage yard 3 miles south of Pinehurst. Erosion by wind and water (and apparent bulldozer activity) has destroyed all but a small remnant of the controlling embankment. The remaining tailing material is yellow, ranging in size from fine sand to slimes. The deposit is oval, approximately 500 feet in length, with a maximum thickness of about 2.5 feet.

There is no protection from flood waters of Pine Creek, although grasses and small trees are reclaiming the south and east portions of the tailing surface.

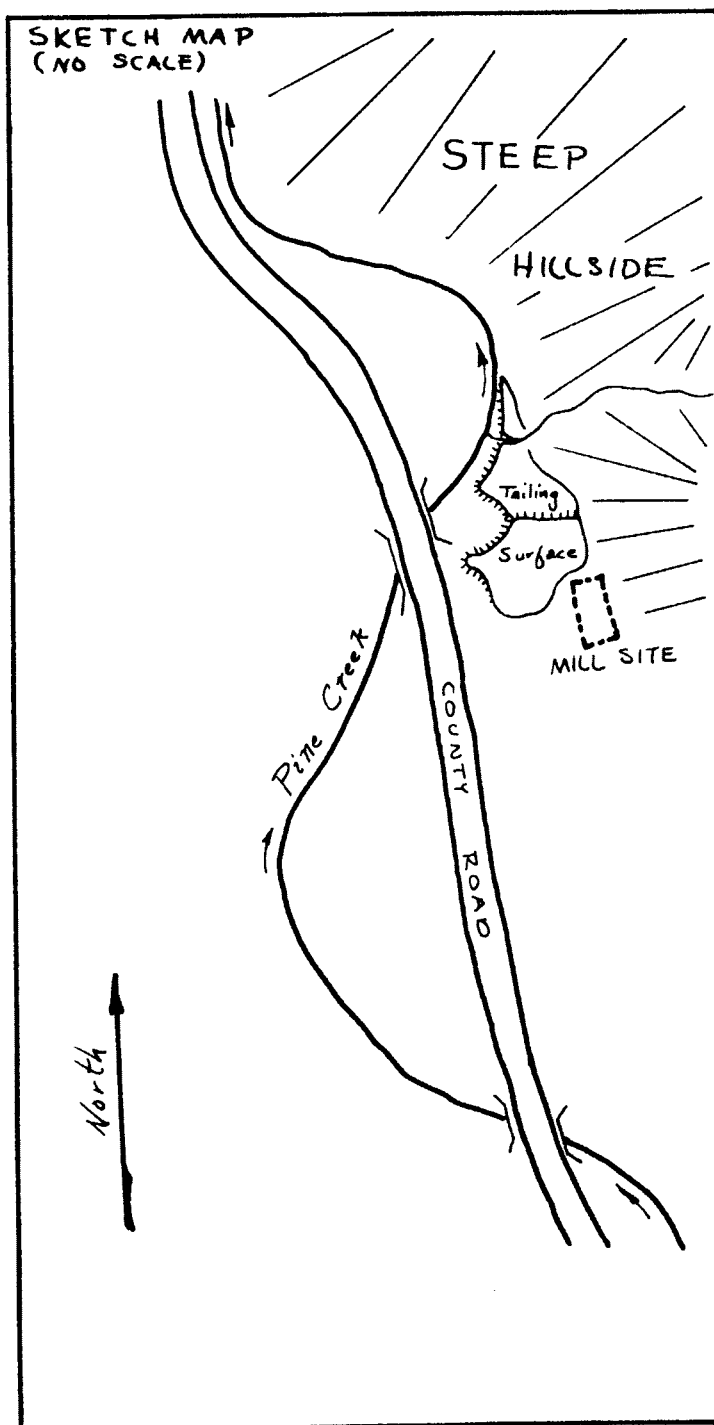
at the second county road bridge south of Pinehurst (approximately 2 miles south of Pinehurst). The recently-constructed bridge abutments and riprap serve to protect most of the site from encroachment by Pine Creek. The northernmost section is vulnerable to erosion both by Pine Creek and the perennial tributary stream which crosses the tailing surface.

Much of the tailing surface now supports vegetation, especially the section nearest the mill site and roadway. Both jig and flotation tailing are found at the site, and pieces of abandoned structures and equipment litter the area.
