RECLAMATION PLANS FOR ABANDONED MILL TAILING IMPOUNDMENTS
IN THE SOUTH FORK COEUR D'ALENE RIVER BASIN

A Thesis

DEGREE OF MASTER OF SCIENCE

MICHAEL ROBERT GROSS

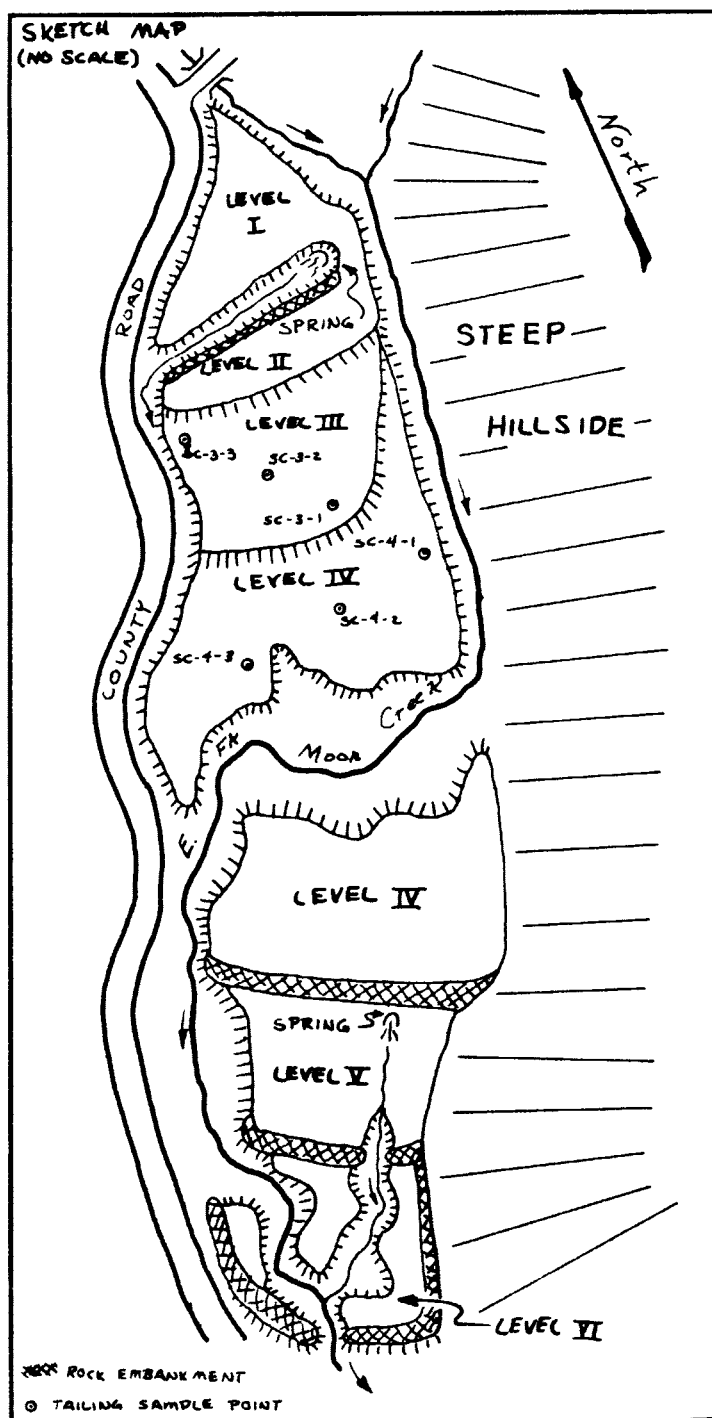
Creek 3 miles above its confluence with the South Fork of the Coeur d'Alene River. The remnants of tailing piles and embankments are deeply eroded by streams and exhibit six distinct levels of tailing, as shown at left. Erosion is active on all levels, and vertical banks 6 feet high are sloughing into the stream with each runoff event. At least three embankments in the series have failed, providing a path for the stream directly across tailing surfaces.

Two major ground-water discharge points exist at the site. One is in an apparent former stream channel now blocked by tailing between levels I and II, and the other is on the surface of level V just below the toe of the level IV embankment.

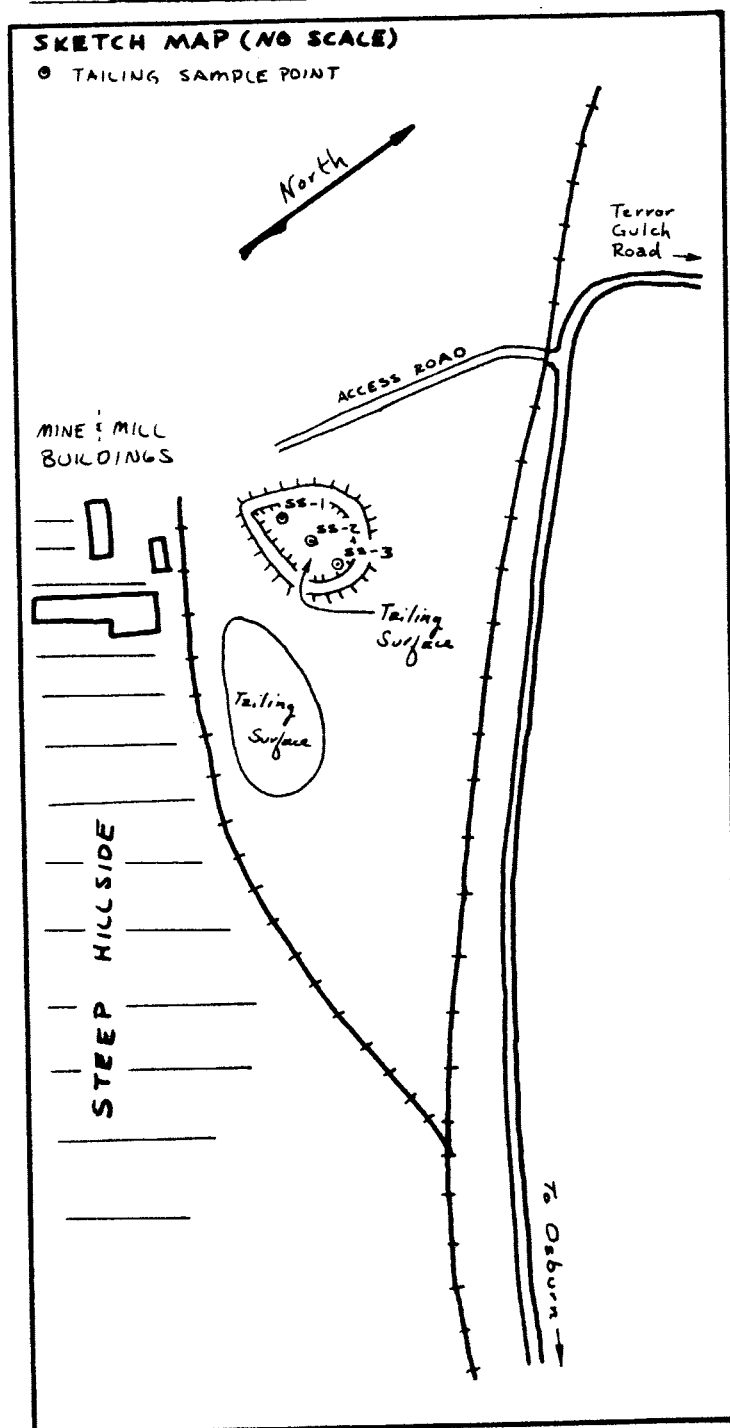
of Interstate Highway 90 at the edge of the community of Osburn. The western pile has obvious embankments and a decant system. Deposition has been by means of a single-pipe discharge near the pile's center. The second site has been graded flat and is used informally as a motorcycle racetrack. The area surrounding the piles has very little relief, and neither site is in any danger from stream erosion or overtopping from storm runoff. Chemical analysis results are given in Appendix C. Tailing samples show high iron and manganese concentrations, but very little lead, zinc, or cadmium.

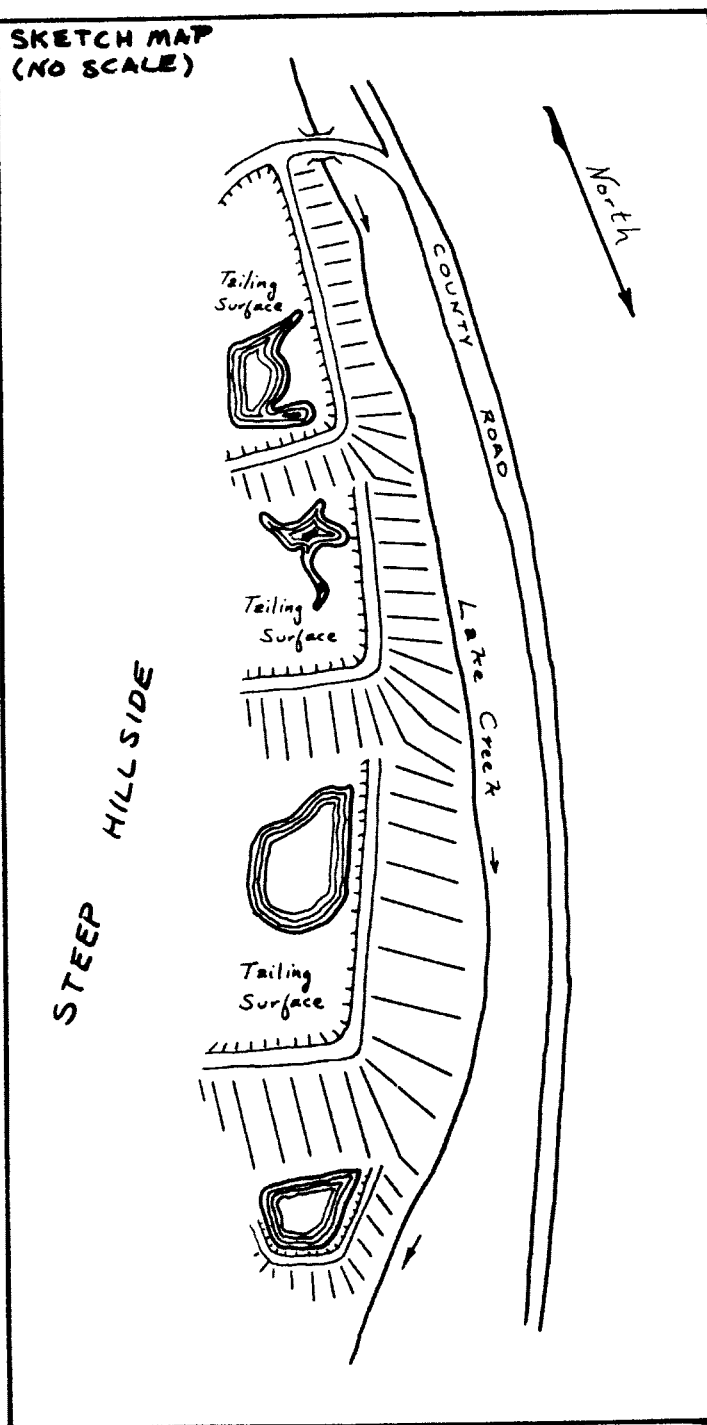
**SKETCH MAP
(NO SCALE)**

detailed examination in this study, and is described on pages 30 - 43 of the text. Only the lowest pile (Galena tailing Impoundment No. 3) has been studied. The other two piles can be expected to have similar chemical composition and hydrologic properties. All three are being kept ready to receive additional tailing. New embankment lifts were constructed prior to 1977, and the decant systems are in constant use as mine drainage water is circulated.

Ground-water quality data are available for the downstream pile, but are not conclusive regarding the site's potential for providing pollutants to the Lake Creek drainage. More frequent monitoring will be necessary to adequately assess the site's need for chemical stabilization or isolation procedures. Vegetation has

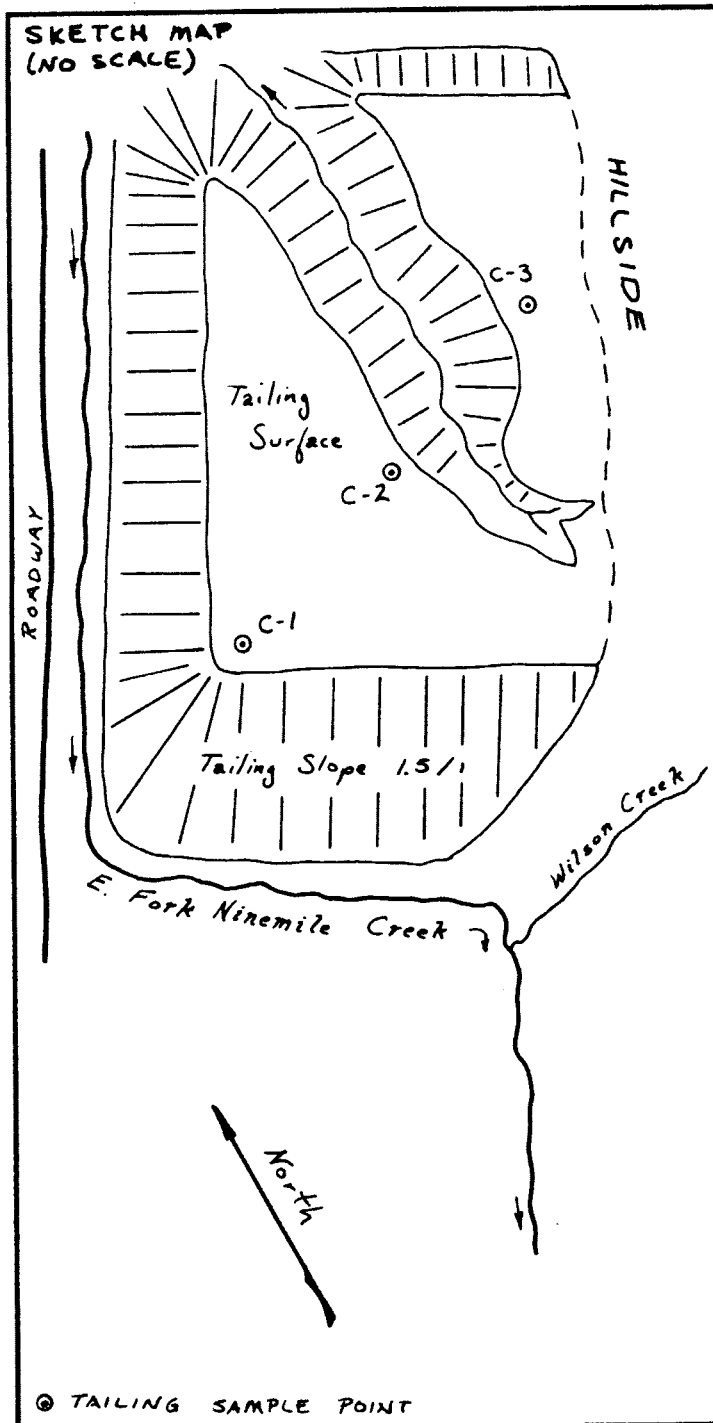
East Fork of Ninemile Creek approximately 6 miles north-east of Wallace. It is the only site in the basin with no rock embankment. Tailing was deposited using the upstream method, with coarser material forming the steep outside surface. The remaining pile has side slopes of 1.5:1 and has failed along a decant line. A major erosion channel is cut into the pile's center, and the toe of the northwest-facing slope is being cut by stream erosion.

Chemical analysis of tailing samples shows moderately high concentrations of lead, zinc, and iron, but very little calcium. No water quality data is available.

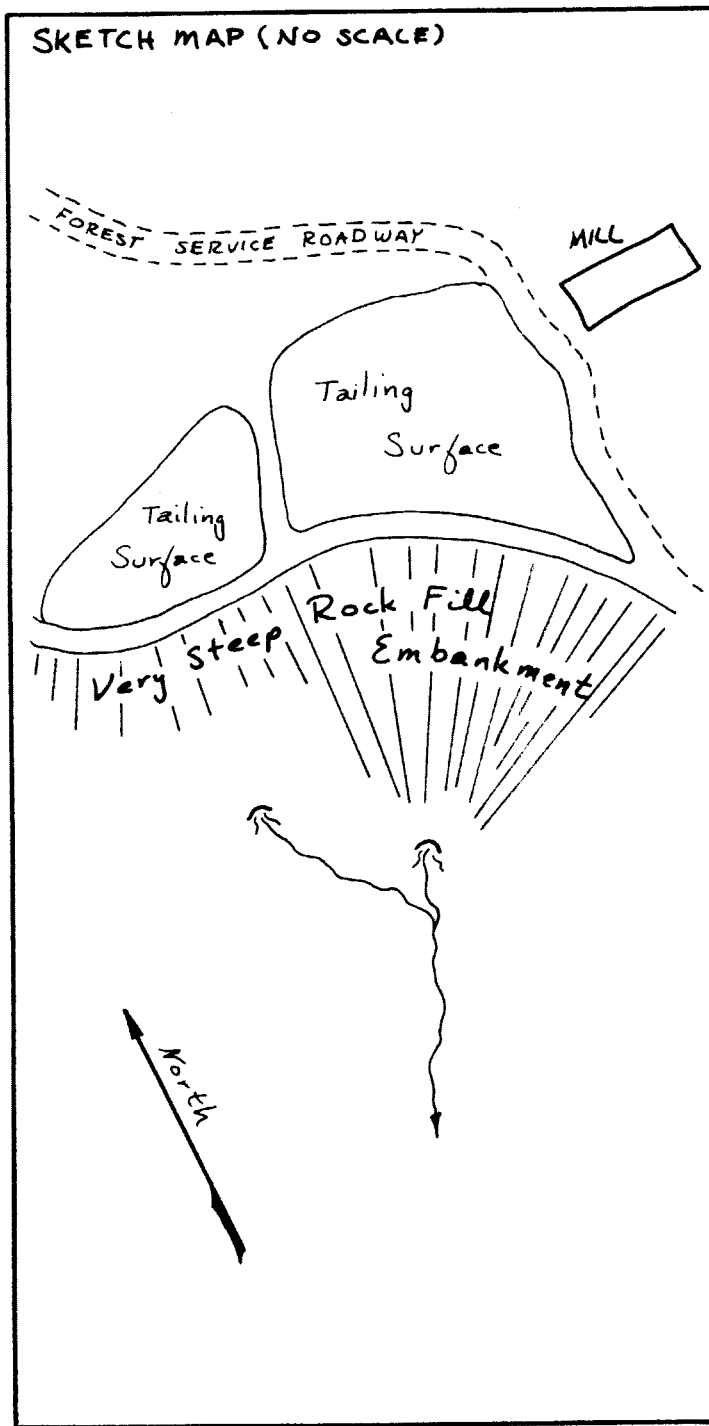
narrow valley high in the Ninemile Creek watershed. A steep rock-fill embankment over 100 feet high (slope distance) has no vegetation cover and appears to be discharging water at the toe. Flotation tailing (sands to slimes) fills the area above the embankment, and a single pipe through the embankment is the only protection from overtopping in a severe precipitation event. Runoff diversions to by-pass the impoundment surface are inadequate.

Chemical analysis was not performed on ground water or tailing at this site.

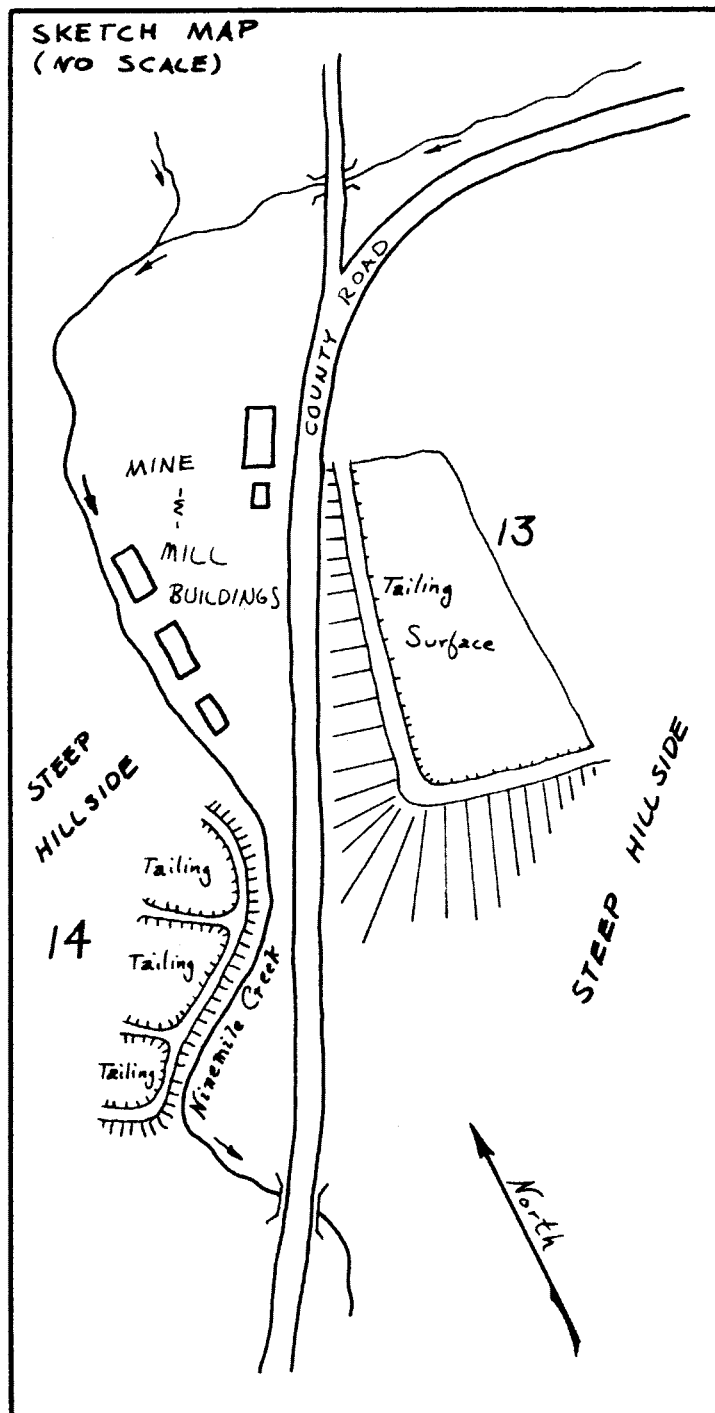
ment built against a steep hillside across the county road from Ninemile Creek approximately 3 miles NE of Wallace. The L-shaped rock-fill embankment has good vegetation growth and appears quite stable, with a small tributary area and low visibility of the tailing surface. No tailing composition data are available.

Site 14 contains three small ponds just west of Ninemile Creek, all of which appear to have adequate embankment protection and good vegetation growth both on the embankments and tailing surface. Some standing water is present, but flow conditions have not been investigated. No chemical data is available.

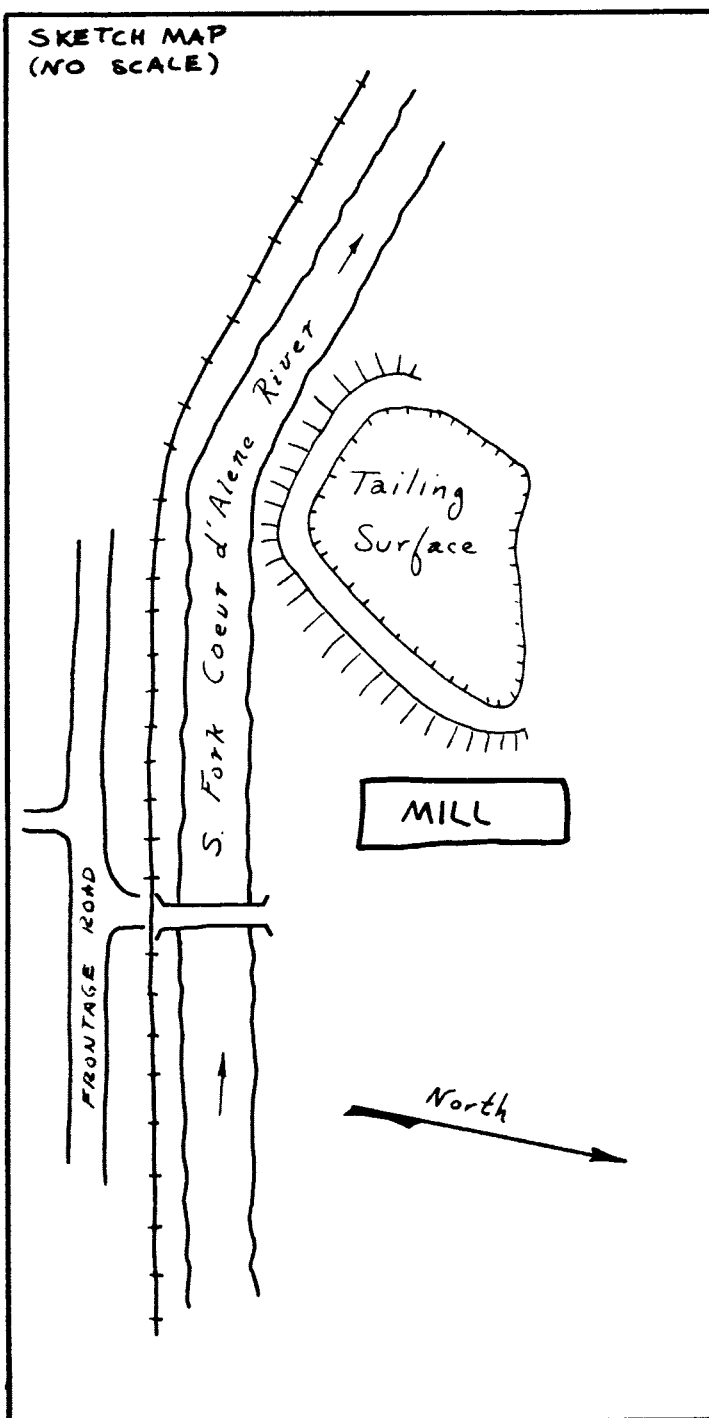
Site No. 15 consists of a small impoundment with adequate embankments and small tributary drainage area. It is located just north of the South Fork of the Coeur d'Alene River approximately 3 miles east of Wallace. The embankments and tailing surface are visible from Interstate Highway 90. An abandoned mill stands near the impoundment. Material within the impoundment includes sandy brown tailing at the surface with gray sands and slimes below. No samples of ground water or tailing material were collected at this site.

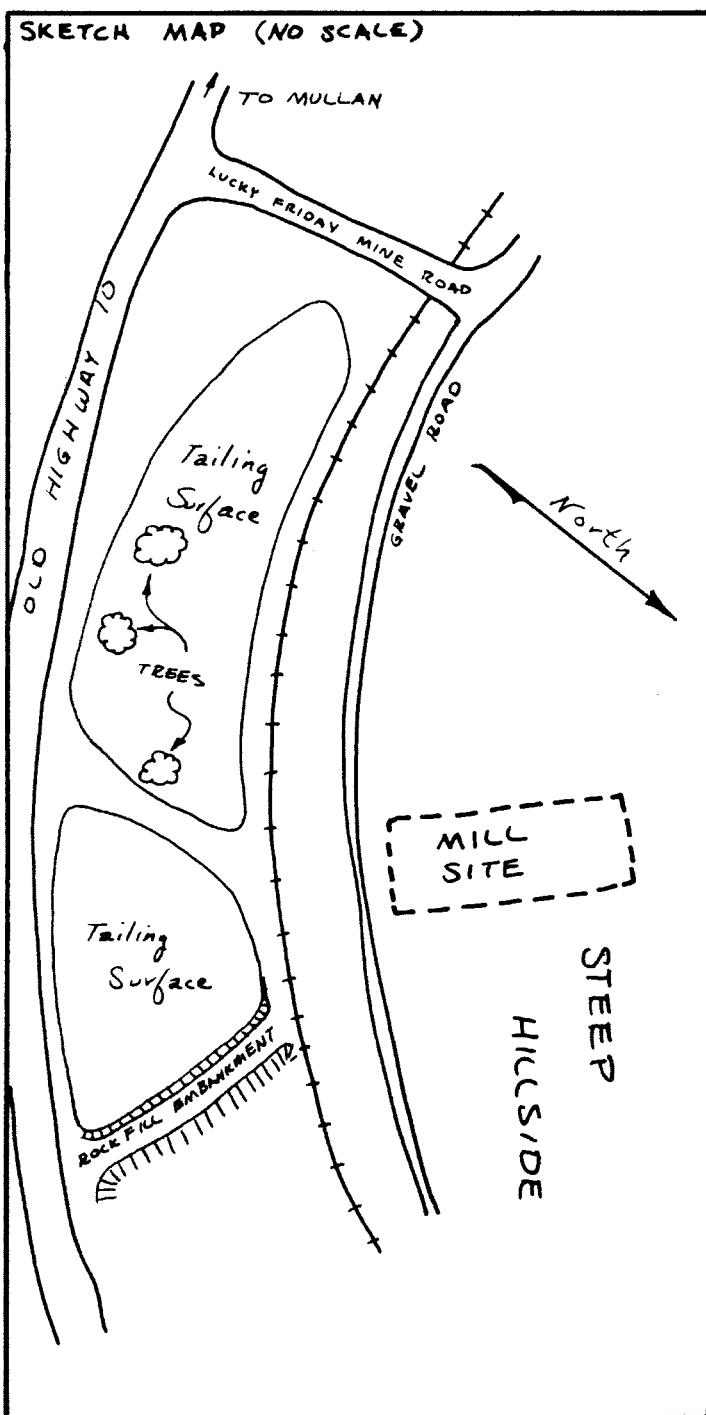
railroad tracks and the Shoshone Park Road just east of Mullan. An obvious embankment exists at the east end of the site, but all that remains of the mill is a foundation on the steep hillside to the north. The tailing surface is composed of black and brown sandy material which has been subject to wind erosion. Natural reclamation by trees, shrubs, and grasses is taking place on the tailing, and the site is not subject to stream erosion.

No chemical analysis was performed for this site. The dark appearance and apparent age of the tailing at this site probably warrant chemical testing. The original mill may have been a copper concentrator, in operation early in the District's history, and may have produced tailing unlike any other examined in this study. The site is
