GEOHYDROLOGIC CONDITIONS  
IN THE  
VICINITY OF BUNKER HILL COMPANY  
WASTE-DISPOSAL FACILITIES

Kellogg, Shoshone County, Idaho - 1976

National Enforcement Investigations Center  
Denver, Colorado

March 1977

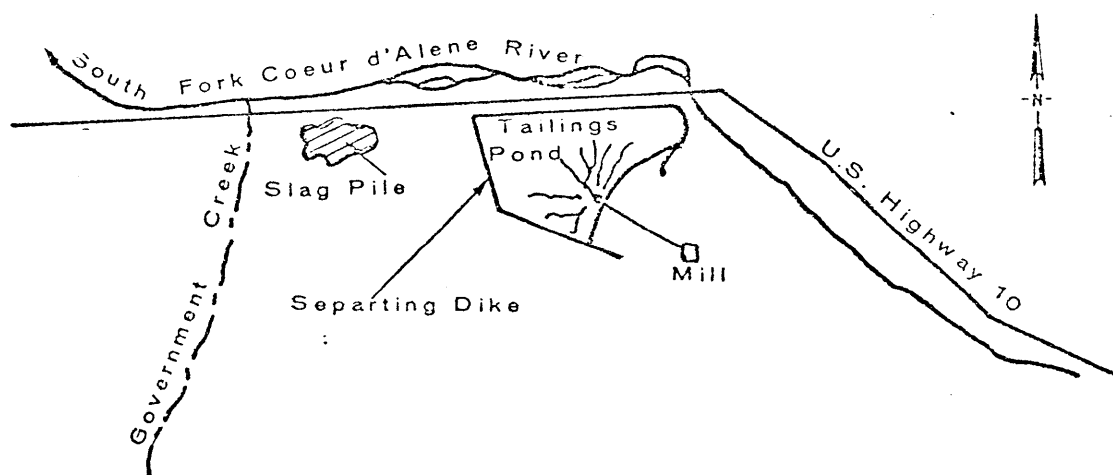
Figure 1. Sketch of Bunker Hill Facilities as shown on U.S.G.S. Airphoto, September 2, 1954

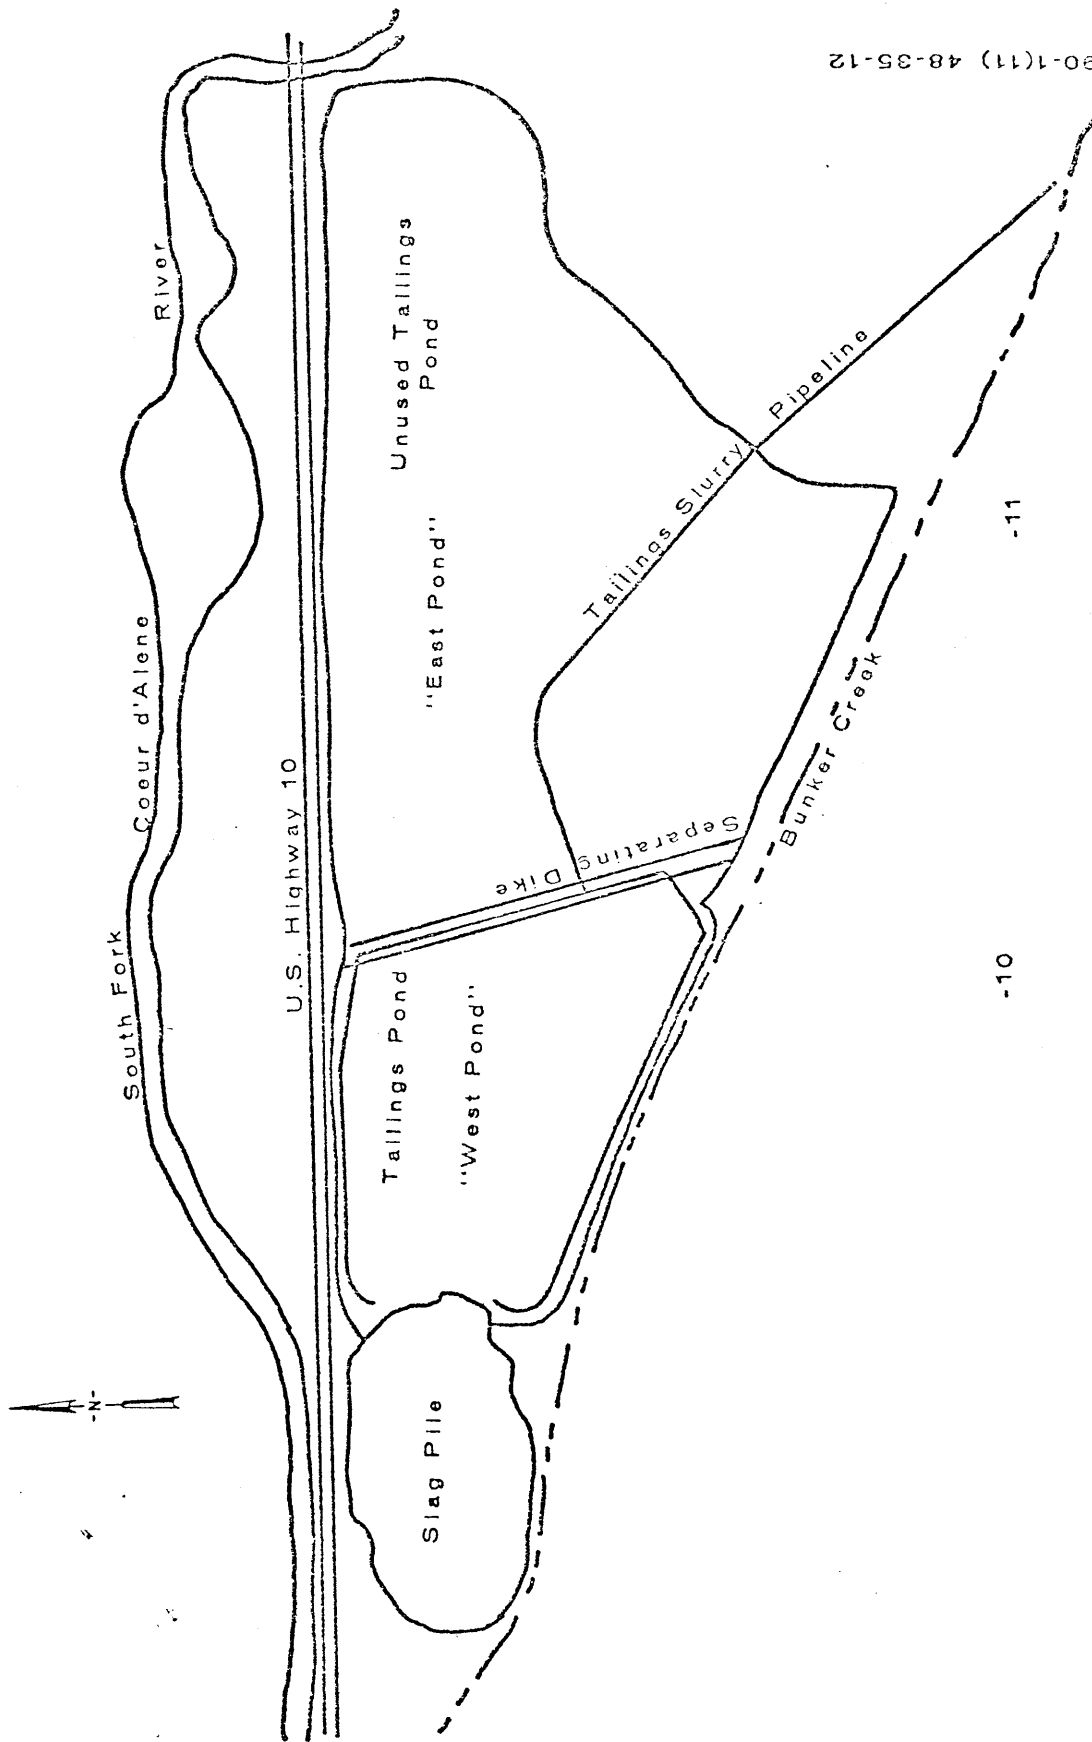
the design and construction of Interstate Highway 90 and clearly showed conditions which obtained in the tailings pond at that time. A sketch map [Figure 2] prepared from the Oct. 25, 1958 photos shows the facilities as they existed on the date of photography. The previously used tailings pond (east pond) was abandoned and was being sprinkled to prevent wind erosion. A new pond (west pond) had been created between the slag pile and the east pond. Dike construction involved the use of peripheral discharge of sand material, with a decant pipe located near the center of this pond, with decant discharge to the South Fork Coeur d'Alene River. The west end of the pond was formed by the slag pile, with tailings lapping onto the slag. The east end was formed by the separating dike. Indications are that the separating dike had been reinforced by coarse sand discharge. Effluent from the zinc plant and lead smelter apparently were discharged directly to Silver King Creek.

Figure 2. Sketch Map showing Bunker Hill Pond Area October 25, 1958

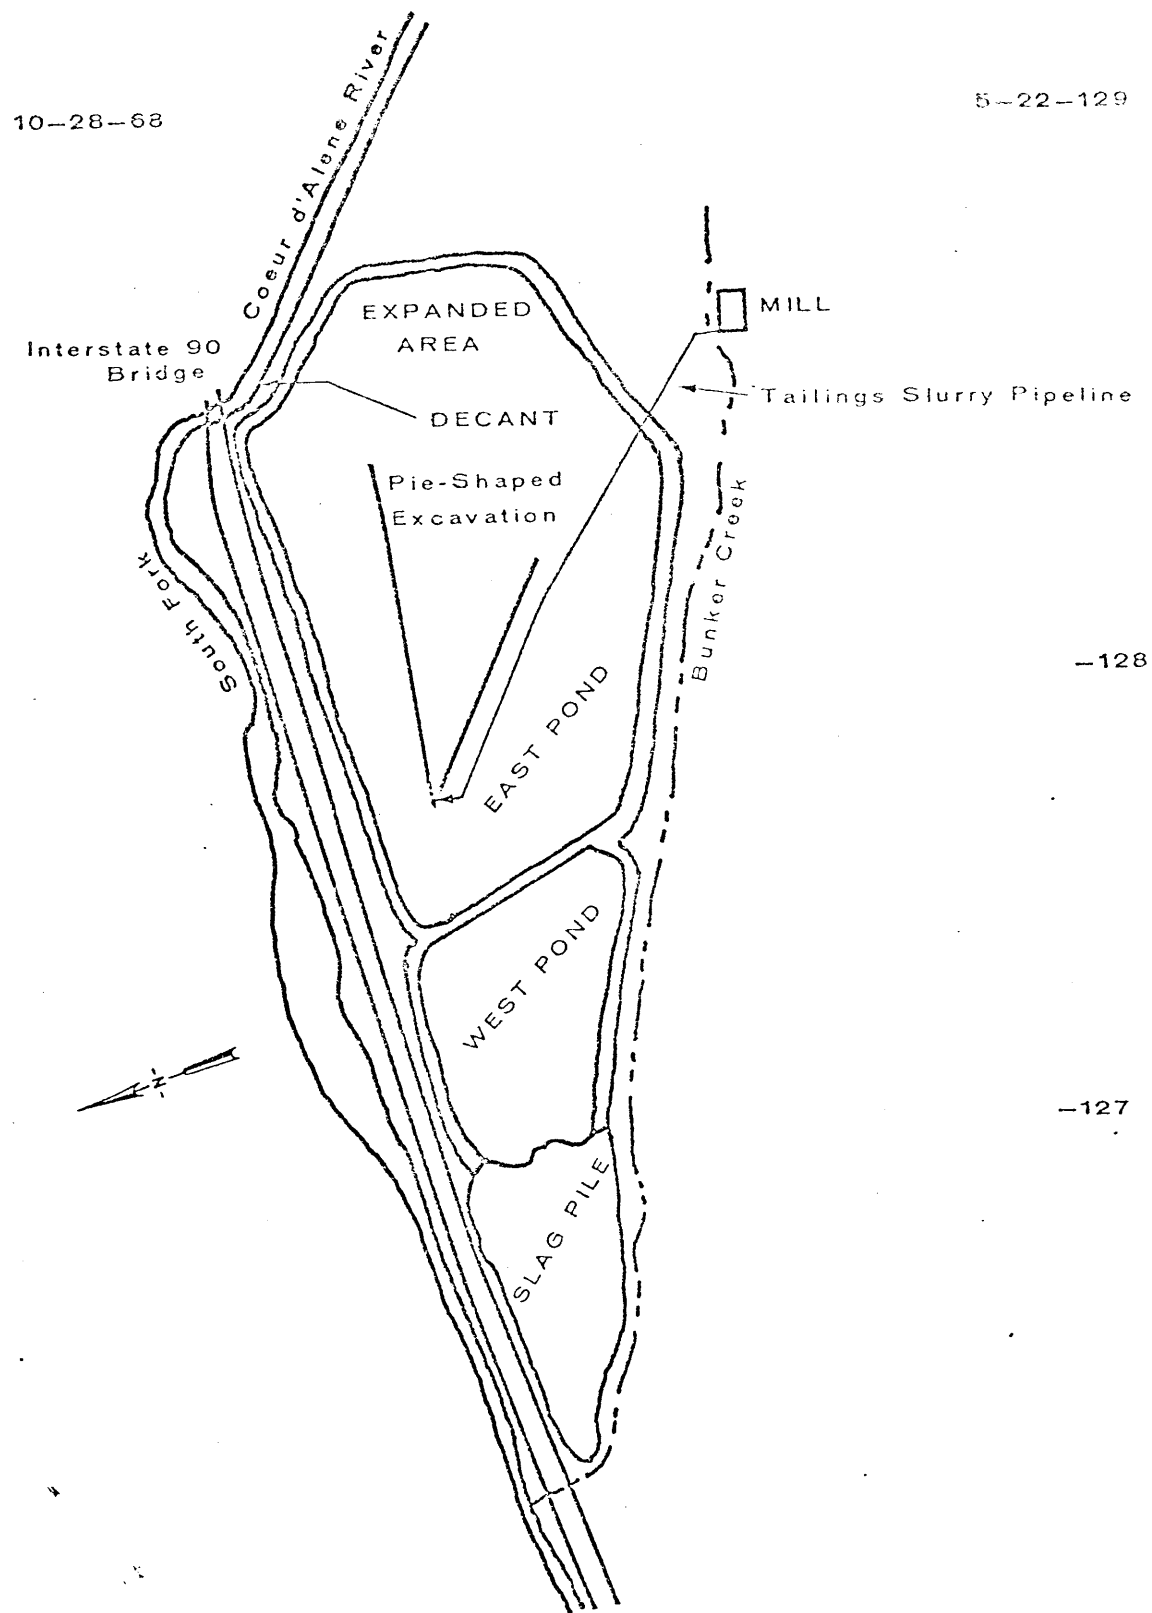
The Idaho Highway Department again photographed the Bunker Hill area on October 28, 1968. Figure 3, prepared from the photos, depicts conditions as they existed on the date of photography. Conditions at that time were similar to the conditions as portrayed on the 1964 and 1966 Bunker Hill drawings. A dike had been completed around the eastern end of the east pond, expanding it eastward to its present site. The pie-shaped wedge, previously excavated, was clearly visible. The upper surface of the east pond was extremely dark in color, indicating either slag spread on the surface to prevent wind erosion or oxidation of material due to exposure. Tailings were discharged from a pipe ending at the apex of the pie-shaped excavated area. The tailings sands flowed and formed a beach in the wedge with water ponded at the easternmost end of the section and adjacent to the eastern dike. The west pond was .

Figure 3. Sketch Map Showing Bunker Hill Pond Area  
October 28, 1968

still intact, with recent evidence of raising of the dike by pushing sand up with a crawler tractor. A decant pipe drained the western pond directly into the South Fork Coeur d'Alene River while another decant pipe drained the eastern pond into the River just upstream of the Interstate 90 bridge. The new eastern dike of the eastern pond had been raised and reinforced by peripheral discharge of tailings material.

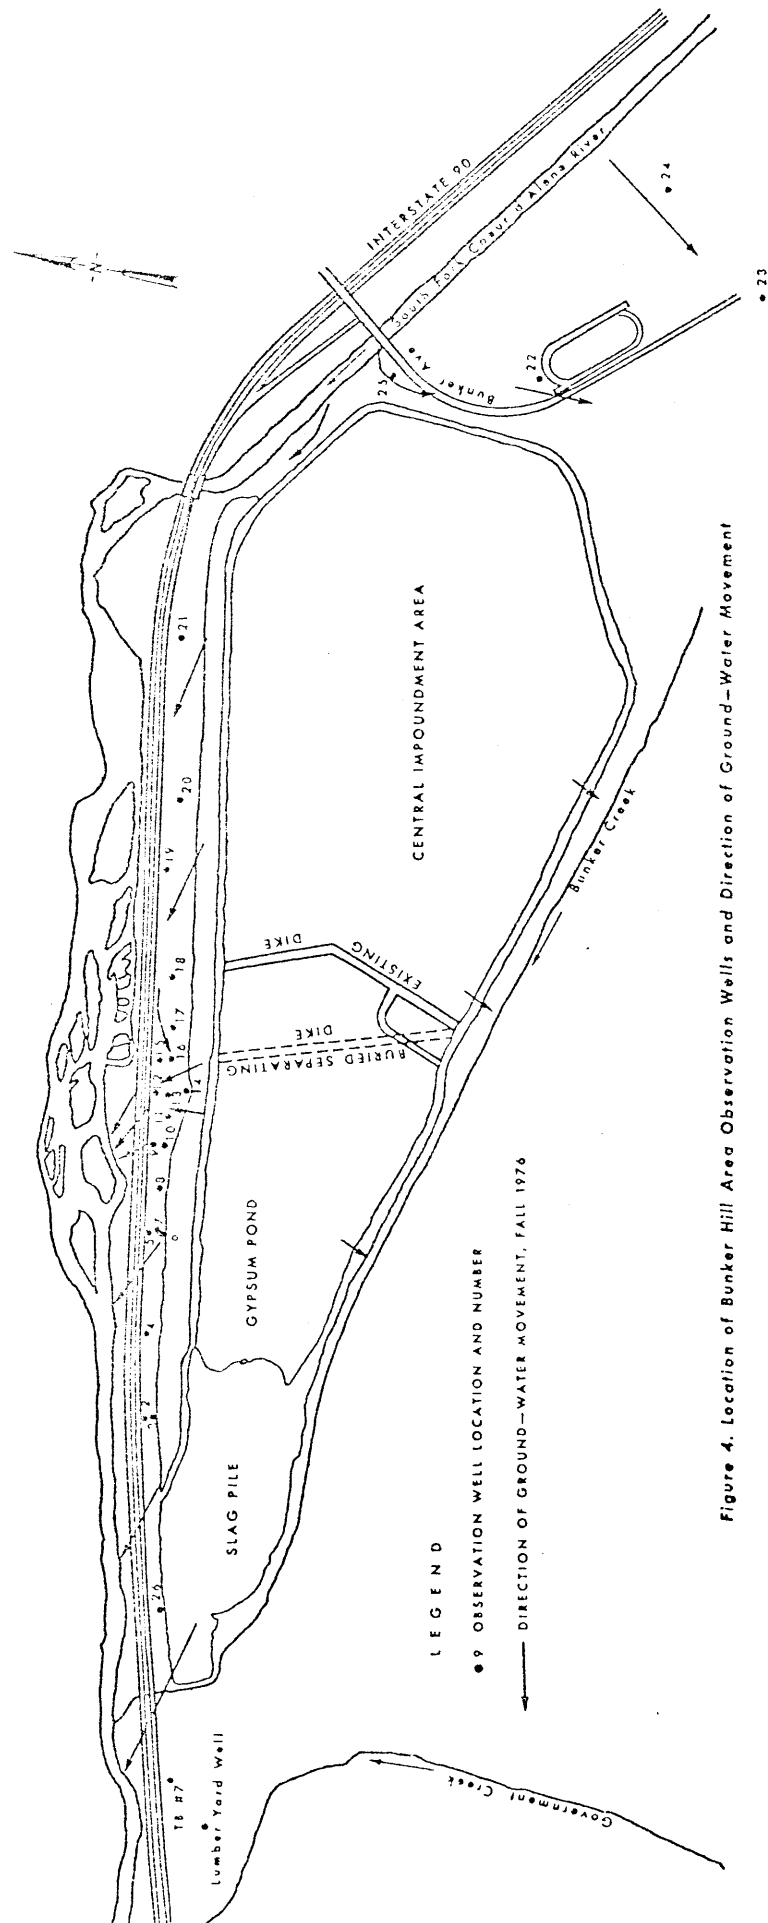
Figure 4. Location of Bunker Hill Area Observation Wells and Direction of Ground—Water Movement

The direction of ground-water movement is locally affected by differences in alluvium permeability. This is most pronounced in the area of an old buried gravel bar, observed near observation well 9.

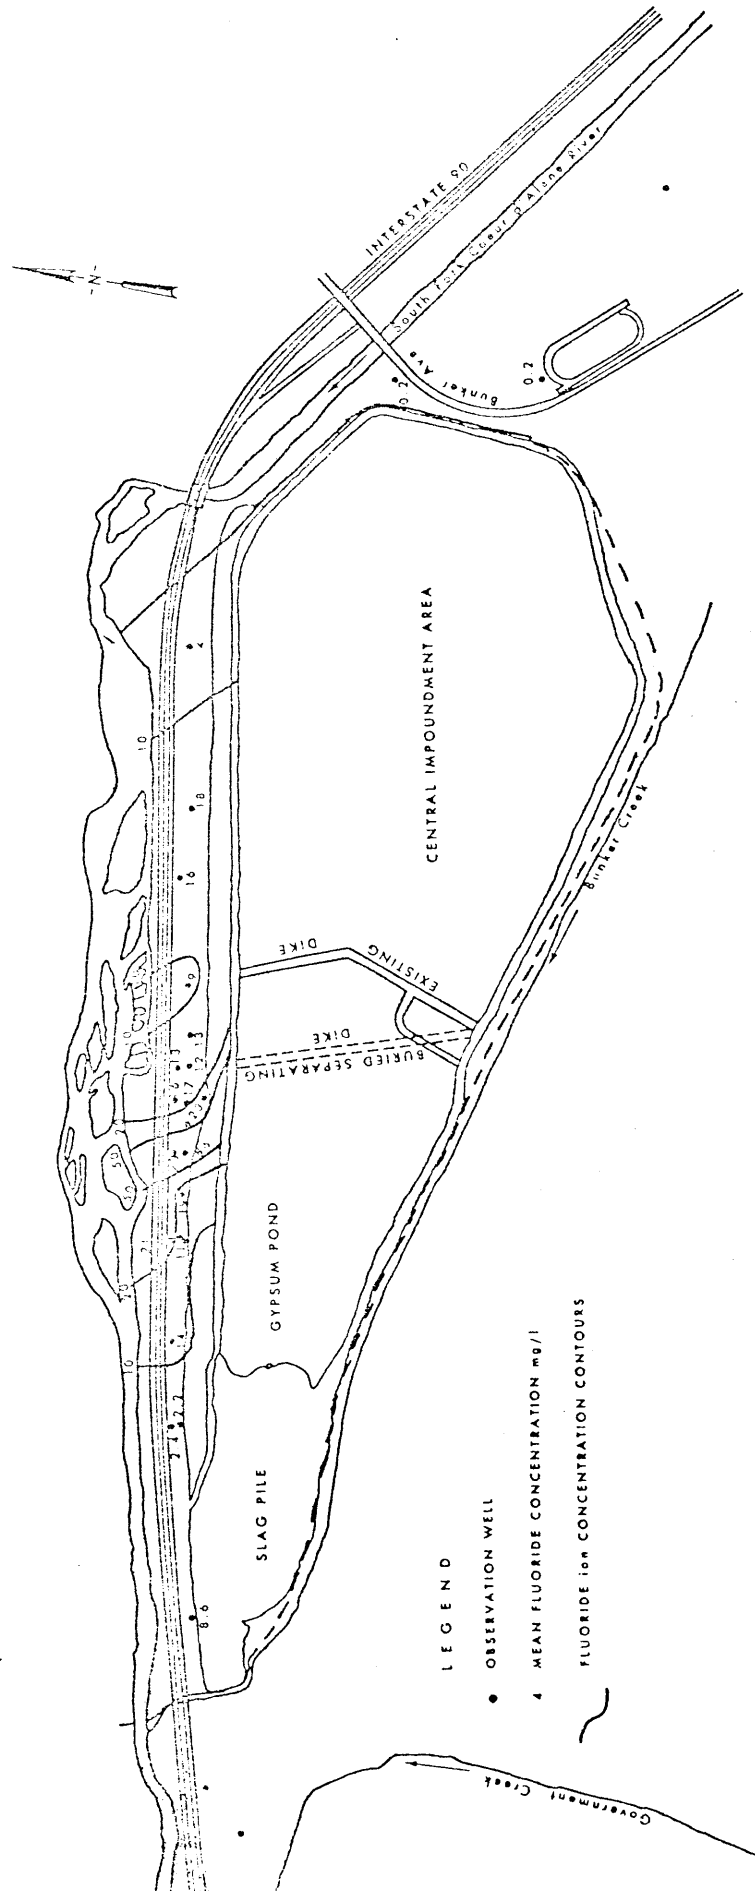
Figure 5. Mean Fluoride Concentrations in Bunker Hill Observation Wells, Sept-Dec, 1976

As shown in Figures 5 and 6, the quality of ground water north and northwest of the Bunker Hill tailings pond has been appreciably degraded below the quality of natural ground water. The contamination involves a zone of saturated alluvium 4 to 7 meters thick between the underlying clay layer and the water table, along the north portion of the tailings pond and the gypsum pond, a distance of approximately 1.5 km. When viewed on the regional scale of the South Fork Coeur d'Alene River valley alluvium, this is an extremely small portion of the total volume. It comprises a rectangular prism 4 to 7 meters thick by 1.5 km long. This constitutes a discernible, confined, and discrete conveyance of contaminated seepage from the Bunker Hill ponds discharging to the South Fork Coeur d'Alene River. Techniques are available to capture and control such seepage.

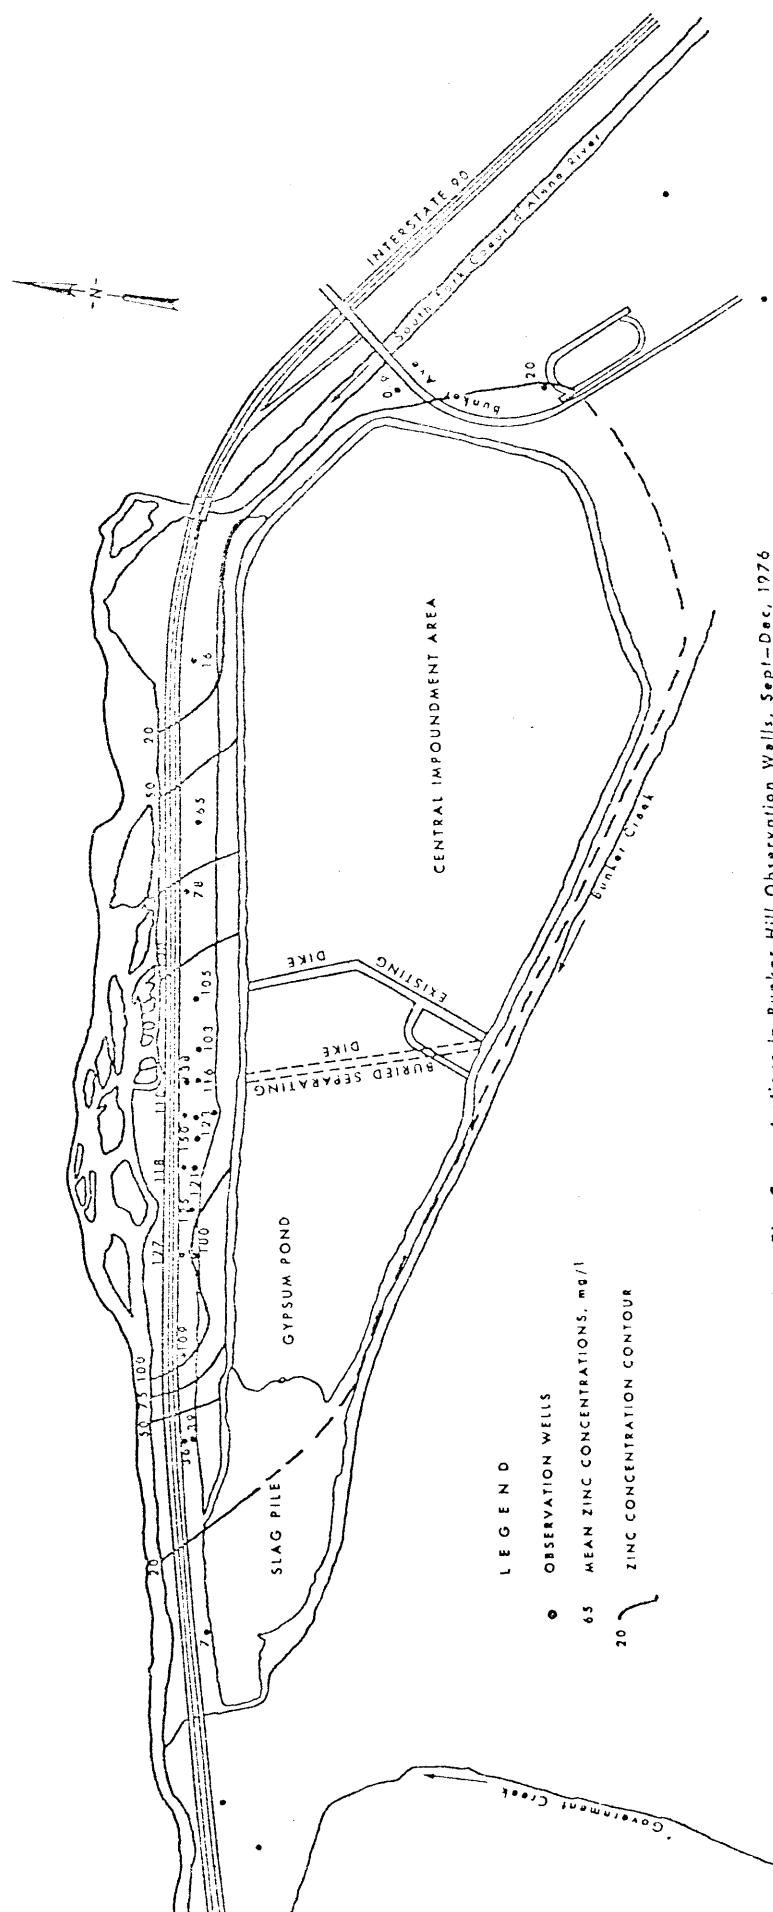
Analyses of samples collected from the various observation wells [Table 3] indicate that zinc is present in relatively high concentrations in the ground water in the shallow alluvium of the South Fork Coeur d'Alene Valley due to leaching from jig tailings which cover the floor of the South Fork Valley. Despite the relatively high values (approximately 1 mg/l) which comprise background levels, the effect of the Bunker Hill tailings pond leakage was clearly demonstrated in the abnormally high concentrations of zinc in the observation wells. As shown in Table 3, values of zinc as high as 180 mg/l were observed in observation wells along the north side of the dike. By way of comparison, a sample collected December 9 from the clear water in the western end of the Bunker Hill CIA was found to contain 220 mg/l zinc. The highest average values of zinc in the observation wells were present in wells 11, 13, and 15, along the eastern side of the old gravel bar [Figure 6]. This probably reflects a conduit effect from the separating dike and from within the Central Impoundment Area moving into this channel. Zinc is probably also present in seepage from the gypsum pond as a result of leaching of zinc from old tailings which underlie the gypsum pond.

Figure 6. Mean Zinc Concentrations in Bunker Hill Observation Wells, Sept-Dec, 1976
