Developing and Implementing a UAS-Based Reach-Scale Protocol to  
Understand and Test Indicators for Monitoring Beaver Dam Analog  
Effectiveness

A Thesis

University of Idaho

August 2021

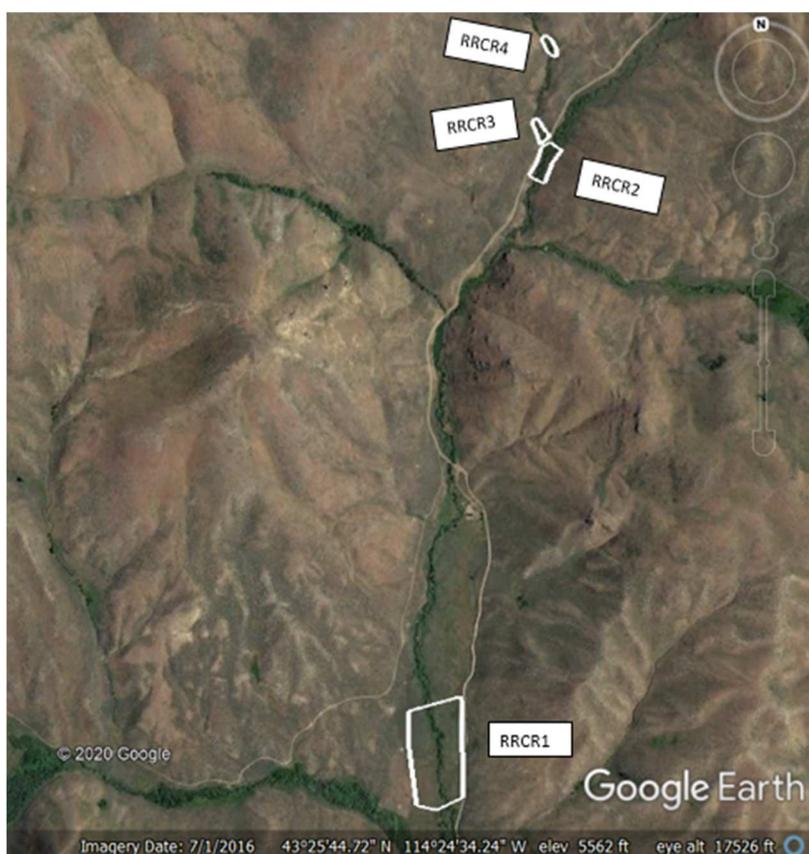
Figure 5. A map of the Rinker Rock Creek Ranch Post-Line Weaves project area located west of Bellevue, ID on the University of Idaho's Rinker Rock Creek Ranch showing the 4 complexes sampled.

West of Bellevue, ID on the University of Idaho's Rinker Rock Creek Ranch, a 2018 BDA project consisted of sections of the main channel of Rock Creek (1.0 mile of stream) and sections of a tributary, West Fork Rock Creek (0.2 miles of stream) (Figure 5). Upstream drainage areas total roughly 14 square miles and restoration efforts have the potential to directly impact roughly 41 acres. Rock Creek and West Fork Rock Creek are perennial streams (Streamstats 2021). Old small mine operations present potential upstream influences based on a review of satellite imagery. Current land uses include recreation, ranching, and wildlife conservation. This project area is in the Foothill Shrublands Ecosystem (Omernik et al., 2018).

Each complex was relatively small, so I sampled all four complexes and the entire project area. Rock Creek provided 2 sites and West Fork Rock Creek provided 2 more sites. From downstream up, RRCR1 has an objective to increase riparian extent and move beaver upstream. RRCR2 has an objective to aid in the recovery of current beaver dams. On West Fork Rock Creek, both RRCR3 and RRCR4 aim to slow flows, promote deposition of sediment.

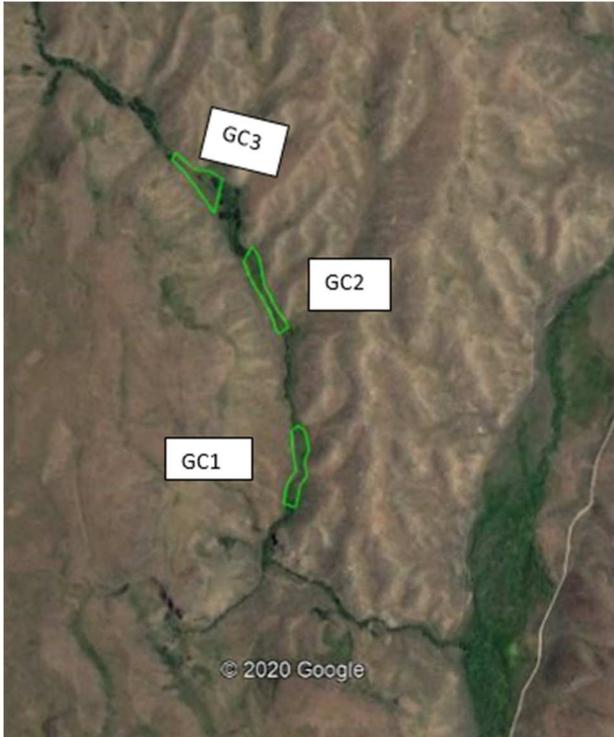
Figure 6. The Guy Canyon Project area located west of Bellevue, ID on the University of Idaho's Rinker Rock Creek Ranch.

At the university's Rinker Rock Creek Ranch, roughly 800 m of a tributary to the main Rock Creek, Guy Canyon, will have BDAs installed from 2021-2023 (Figure 6). Specific reaches were selected because they did not meet potential hydrologic function, desired plant community composition and vigor, or had incised channels. The total project area was roughly 10 acres over 3 different sites and an upstream drainage area of roughly 2.7 square miles. Streamstats categorized Guy Canyon as an intermittent stream. Recreation, ranching, and wildlife are the main operations on the landscape currently. Old small mine operations present potential upstream influences from the satellite perspective. According to the EPA ecoregion level IV classification, the project area is in the Foothill Shrublands Ecosystem (Omernik et al., 2018).

Project goals include stopping active head-cuts, reducing sections of incised stream banks, increasing riparian vegetation, and increasing the length of time when upper reaches of the stream are flowing. Three separate complexes make up the 800 m of project area where BDAs, PALS, and Zeedyk structures will be installed over the three-year period. All three complexes have the same general complex goals which included increasing water retention, increasing lateral movement of wetted areas, increasing sedimentation, increasing greenline riparian areas, slowing water increasing duration of time water passes, and increasing riparian area across valley bottom.

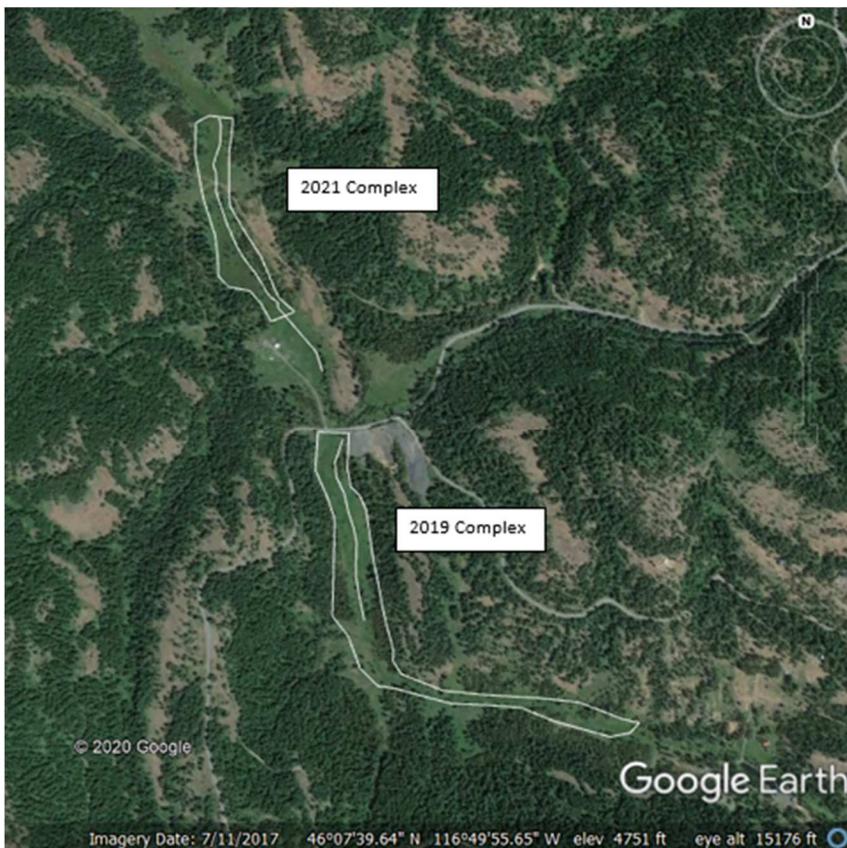
Figure 7. Idaho Department of Fish & Game (IDFG) Craig Mountain BDA Projects (2019 & 2021) located south of Lewiston, ID on the Craig Mountain Wildlife Management Area. The lines indicated where BDAs are and will be installed. The upper area is the 2021 project, and the lower area is the project that was implemented in 2019.

Along with roughly 57 BDAs in one complex installed in 2019 (lower 0.4 miles of stream), other techniques implemented included: plant manipulation (thinning), burning the meadow boundary, plantings, and installing large woody debris. This group of techniques is also planned to be used on the upper 0.6 miles of stream as well in 2021. Both complexes have the same general complex goal which includes increasing water retention and increasing lateral movement of wetted areas. With a smaller project area, I included the full project area, but separated both the 2019 and 2021 complex due to their large sizes totaling 4 sites for the study.
