Creep and Microstructural Characterization of Advanced Austenitic Stainless Steel Alloy 709

A Thesis
Presented in Partial Fulfillment of the Requirement for the
Degree of Master of Science
with a
Major in Material Science and Engineering
in the
College of Graduate Studies
University of Idaho
by
Martin Taylor

August 2018

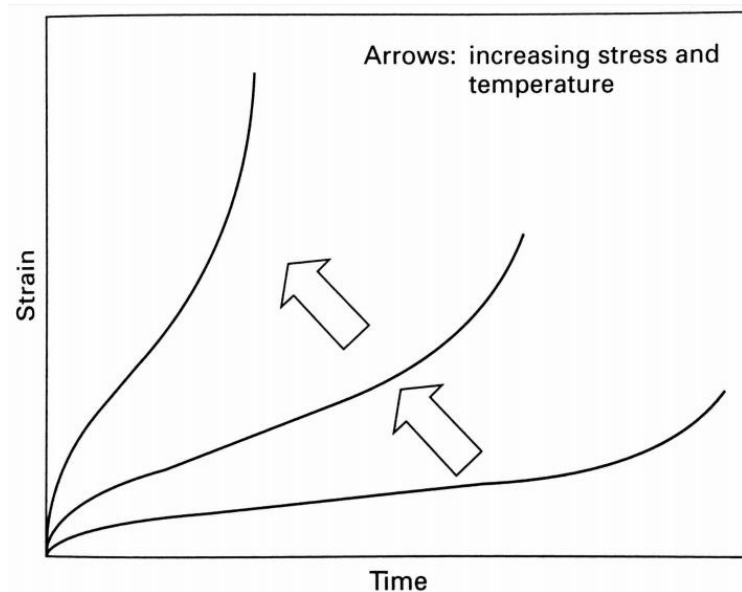
Figure 1.5. Schematic creep curves with increasing stress and temperature [3].

Microstructure evolution is usually dynamic recovery, dynamic recrystallization, coarsening of precipitates, or other phenomena. Damage evolution generally is caused by the formation of cracks and voids or cavities often on grain boundaries [3]. The testing conditions can cause a wide variety of creep curves with varying length of the primary, secondary and tertiary creep stages. Increasing the temperature and stress will result in more plastic strain over a period of time resulting in faster failure (Figure 1.5). Failure is typically the end of the creep curve.

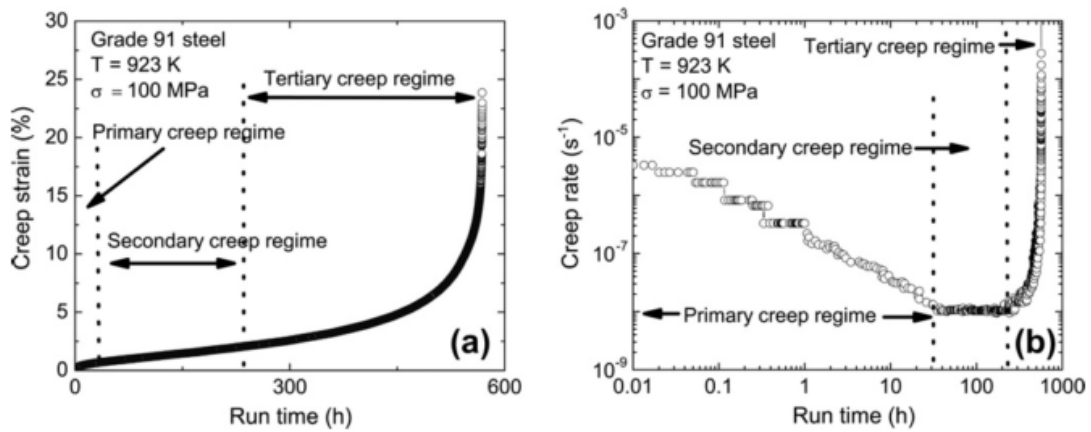
Figure 1.6. (a) A standard creep curve for Grade 91 steel, and (b) a creep rate vs. time showing the minimum creep rate being the same as the steady state creep rate [19]

Some creep resistant steels and alloys under certain conditions do not have a clear steady state creep stage. In these instances the creep curve will start with primary creep and move directly into tertiary creep. When this occurs the minimum creep rate can be defined as the moment the hardening in the primary is equivalent to the softening of the tertiary [3]. Research has shown that the microstructure during creep is constantly evolving for many creep resistant steels and alloys. This has led to many engineers and researchers preferring the term minimum creep rate over steady state creep rate because there is no true dynamic microstructural equilibrium for many materials [3]. Figure 1.6(a) and (b) show the creep curve and creep rate vs. time curve for a modified 9Cr – 1Mo (Grade 91) steel [18].

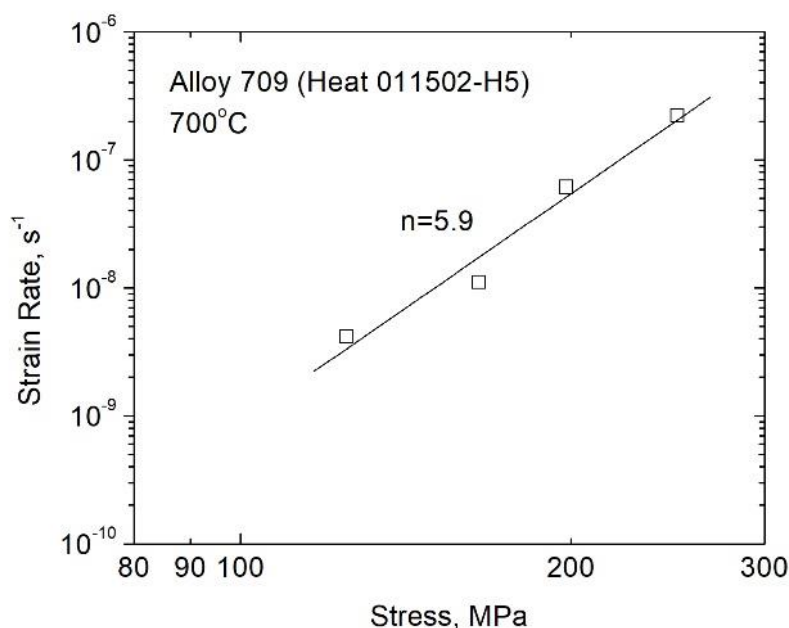
Figure 2.6. The variation of minimum creep rate as a function of stress for the as-received Alloy 709 at 700°C

where $\dot{\epsilon}_m$ is the minimum creep rate, A is a material and temperature-dependent constant, σ is the applied stress, and n is the stress exponent). For this stress range and temperature, there was a single slope with an exponent of $n = 5.9$ from the double logarithmic plot of stress versus minimum creep rate as shown in Figure 2.6. This follows the experimental data obtained for NF709 steel from the datasheet. The stress exponent of 5.9 suggests that the creep mechanism at this temperature and stress range is most likely dislocation climb related. It is well known that a stress exponent between 4 and 7 indicates high temperature dislocation climb as the rate-controlling creep mechanism. However, because of the lack of additional data, it is not possible to unambiguously determine the creep mechanism at this point.

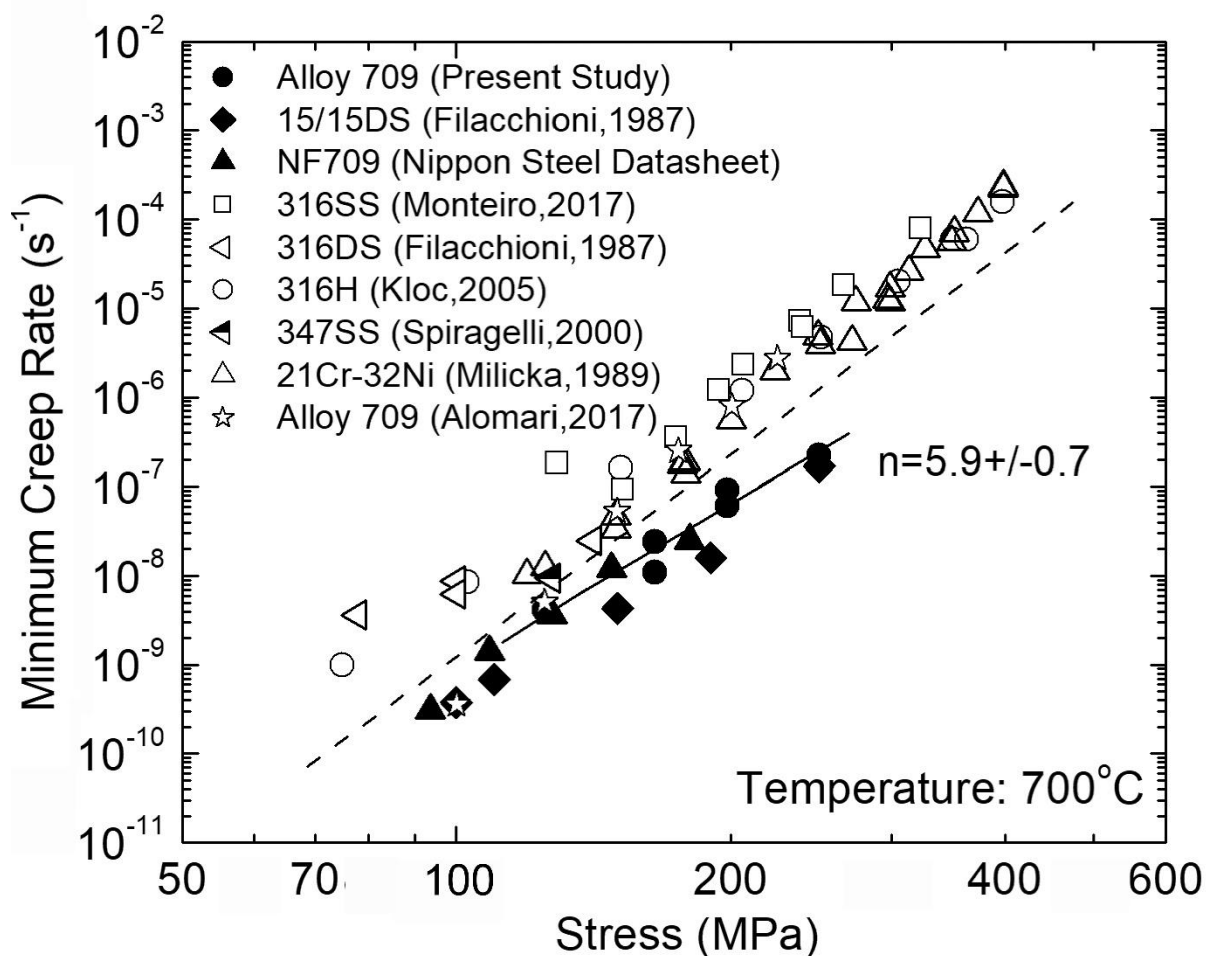
Figure 2.7. Comparison of minimum strain rates rate with applied stress at 700 °C for the as-received Alloy 709 at 700 °C [7] - [13]

single stress creep tests. They also commented that threshold stress imparted by the particles led to the higher stress exponent values.

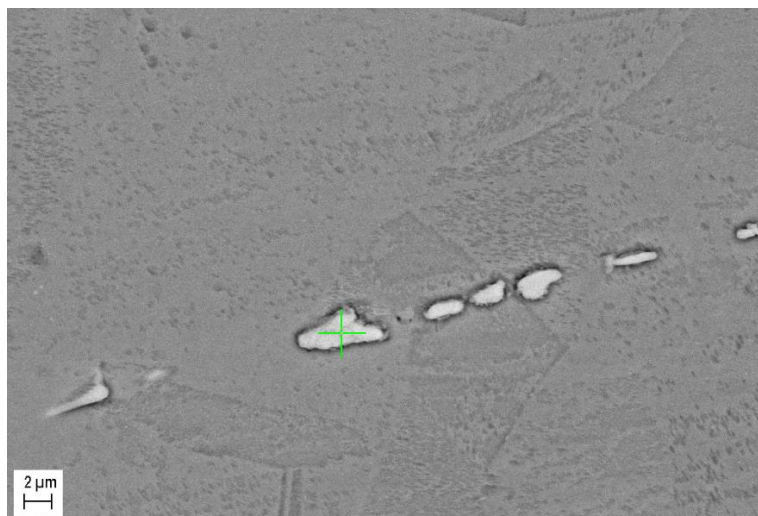
Figure 3.3. SEM SE image showing Nb rich MX precipitates found in the as-received Alloy 709

For Alloy 709, one of the primary strengthening mechanisms comes from precipitation hardening. The as-received material for the first two plates has shown significant amounts of MX precipitates rich in Nb, as shown in Figure 3.3. These MX precipitates are beneficial for hardening the material and preventing dislocations from gliding under creep. M is typically Nb or Ti for Alloy 709 and X is N or C or (N, C) [6]. The specimens that were crept showed a significant increase of precipitate decorations on the grain boundaries.

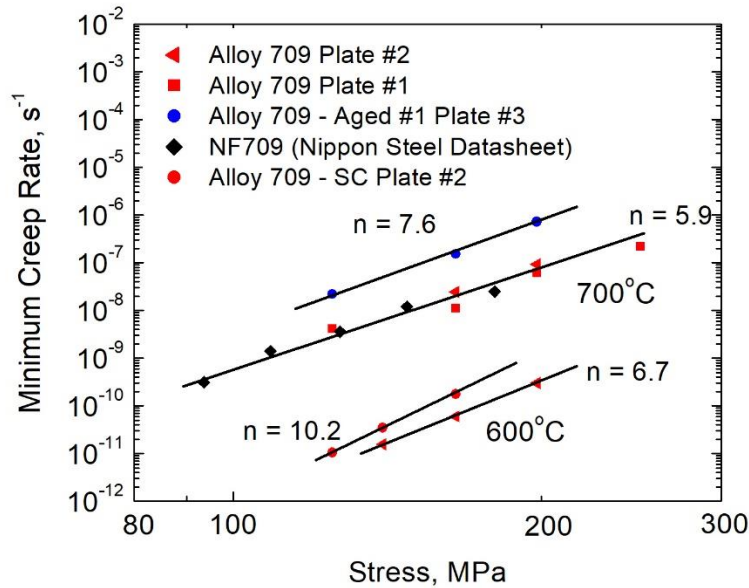
Figure 3.8. Minimum creep rate with the applied stress showing the stress exponents for the various conditions.

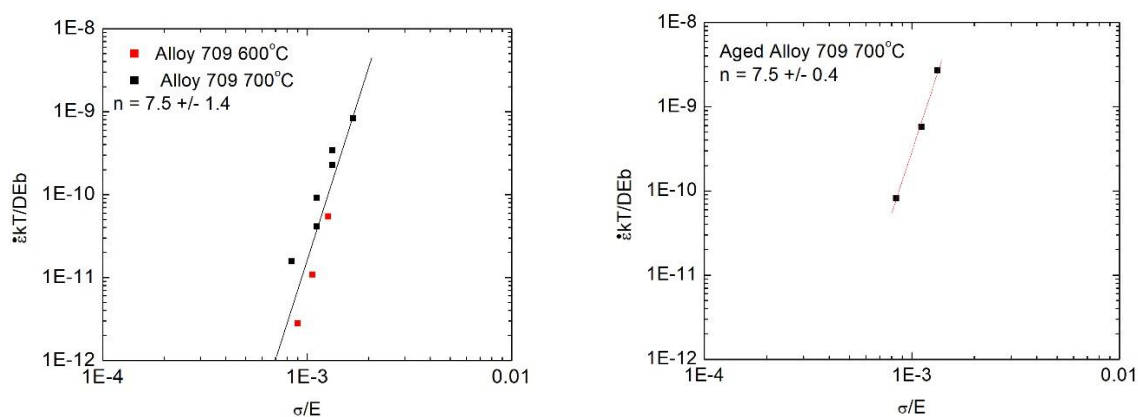
Figure 3.9. BMD plots of the normalized steady state creep rate with the effective stress (a) as-received Alloy 709 crept at 600°C and 700°C and, (b) aged Alloy 709 crept at 700°C.

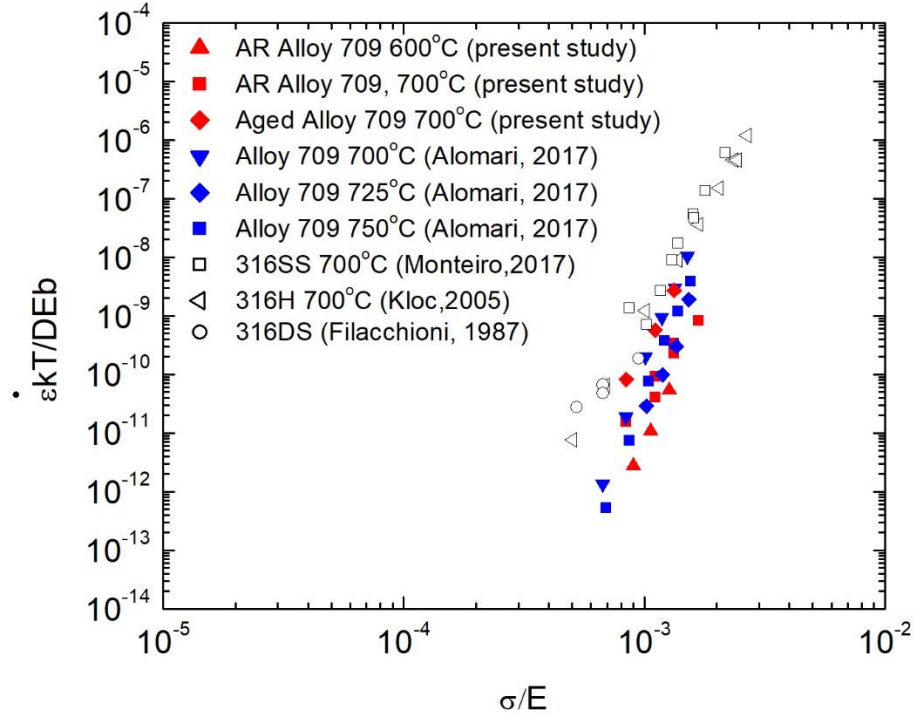
Figure 3.10. Comparison of normalized minimum creep rate with the normalized stress data for different austenitic stainless steels and Alloy 709 [3], [13], [14].

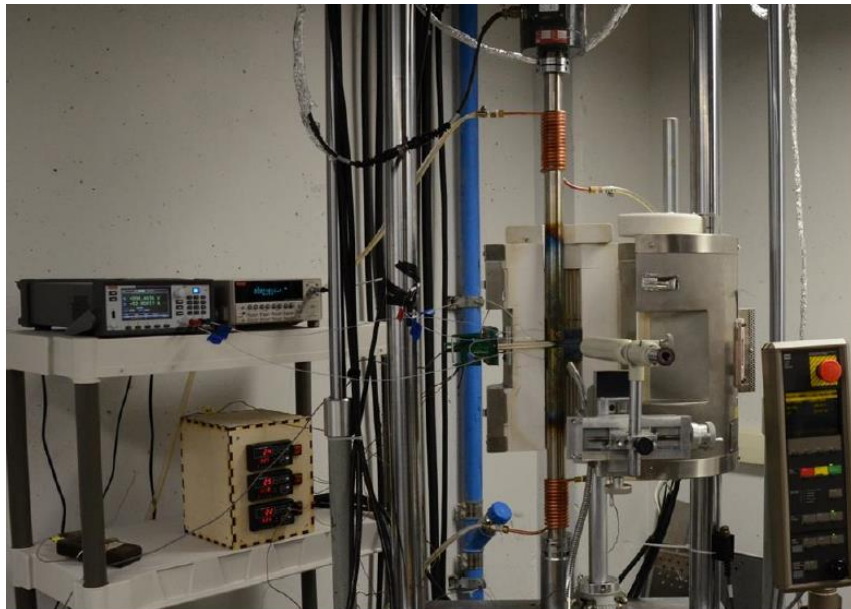
Figure 4.2. The servo-hydraulic MTS test frame used for FCG and CFCG tests.

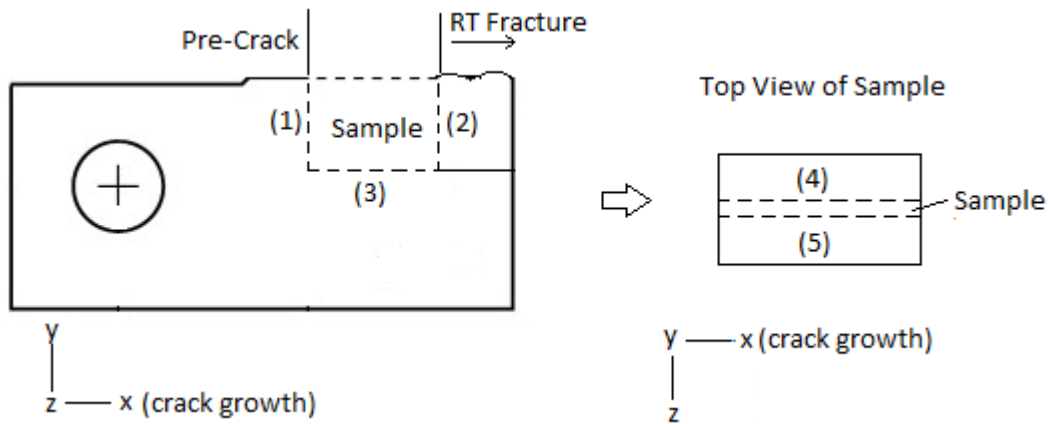
Figure 4.3. Cuts made for FCG and CFCG profile micrographs

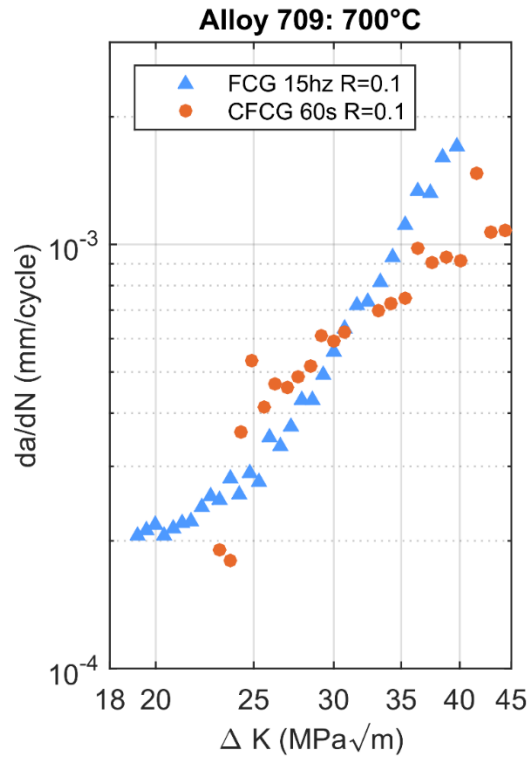
Figure 4.5. Crack growth rate da/dN plotted with ΔK .

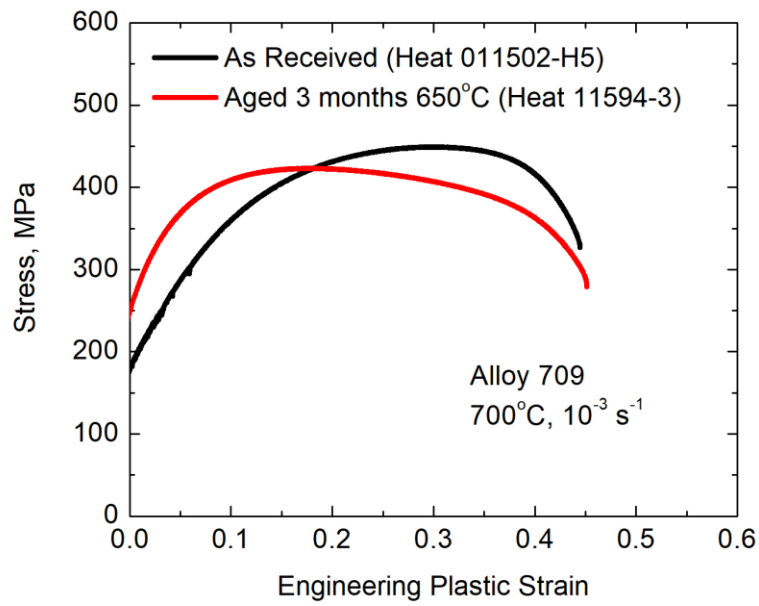
Figure A.4. Engineering stress with the plastic strain at 700°C
