Corrosion Behavior in Friction Stir Processed Austenitic Stainless Steel

A Thesis

Major in Nuclear Engineering

University of Idaho

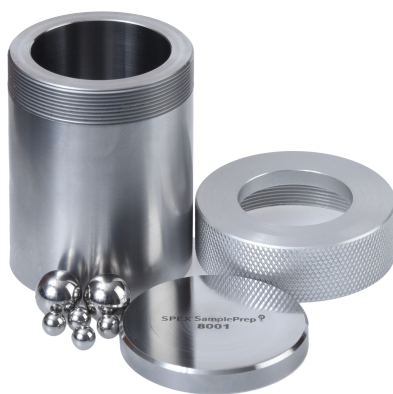
Figure 2.9: Ball mill vial[29]

Ball milling is a process where different elements, often in powder form, are mechanically alloyed to form homogeneous mixtures with custom elemental contents. combined in a vessel called a vial. The vial is filled with a grinding media, balls made from materials like 52100 steel (Figure 2.9), alumina, tungsten carbide, or agate to name a few, and the sample elements that are intended for milling. During the ball

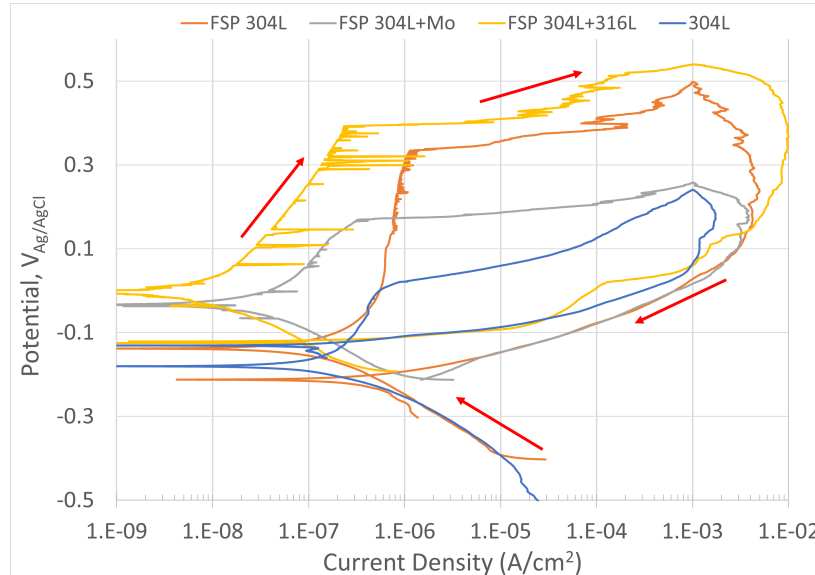
Figure 3.7: Superimposed graph of all samples using cyclic polarization and 3.5%wt sodium chloride solution

FSP 304L+316L With only a 3.7 mV difference in E_p when compared with the FSP 304L sample, and the second best I_{corr} , the FSP 304L+316L sample performed well in the cyclic polarization test using the 3.5%wt sodium chloride. Figure 3.7 shows many oscillations in the current density throughout most of the cyclic polarization test. This provides additional evidence of surface defects which detract from corrosion resistance

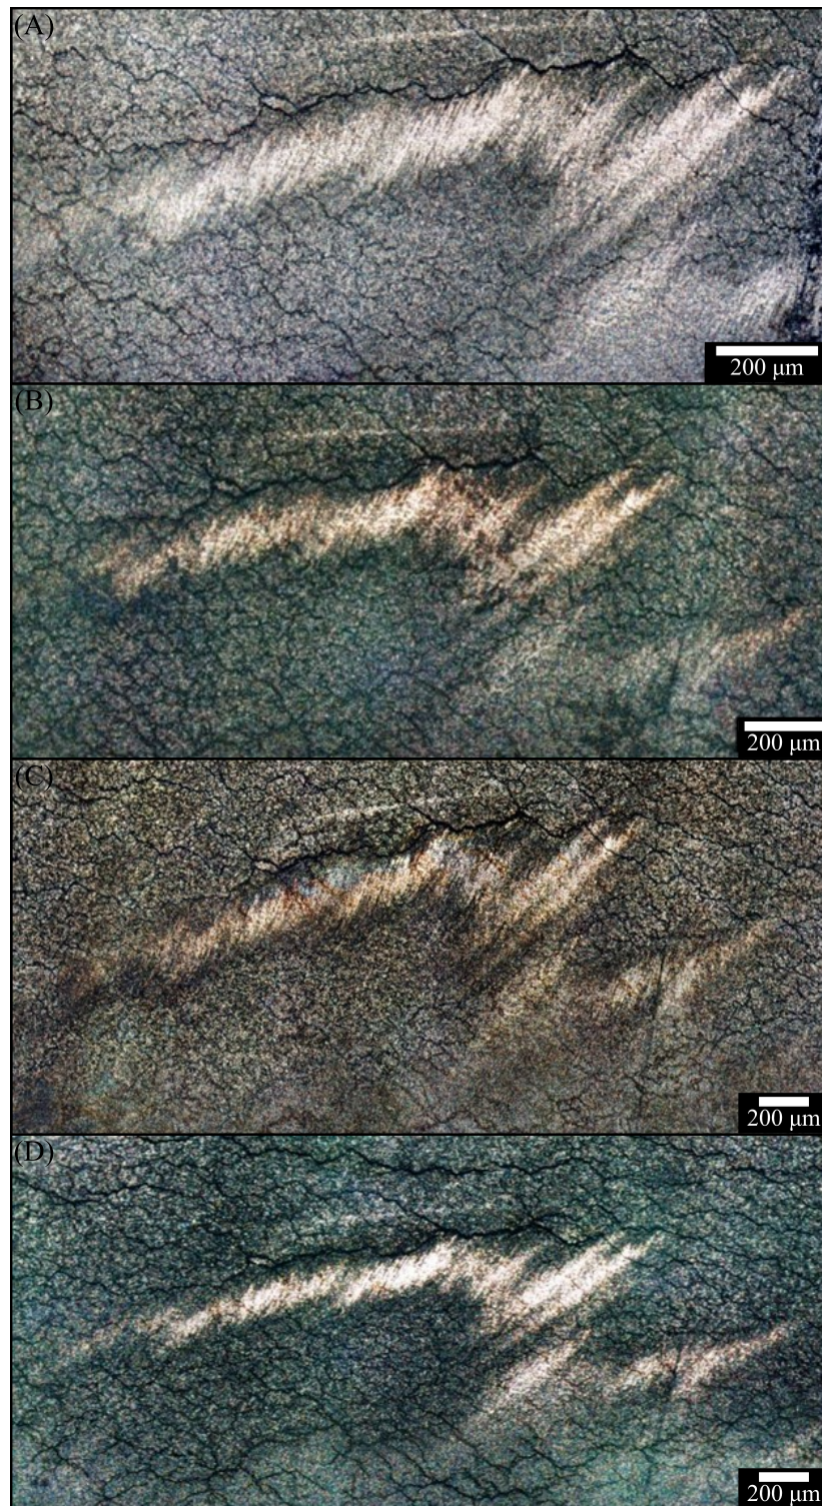
Figure 4.11: Micrograph of FSP 304L+316L sample after (A): 102.75 hours (B): 127 hours (C): 152.75 hours (D): 174 hours

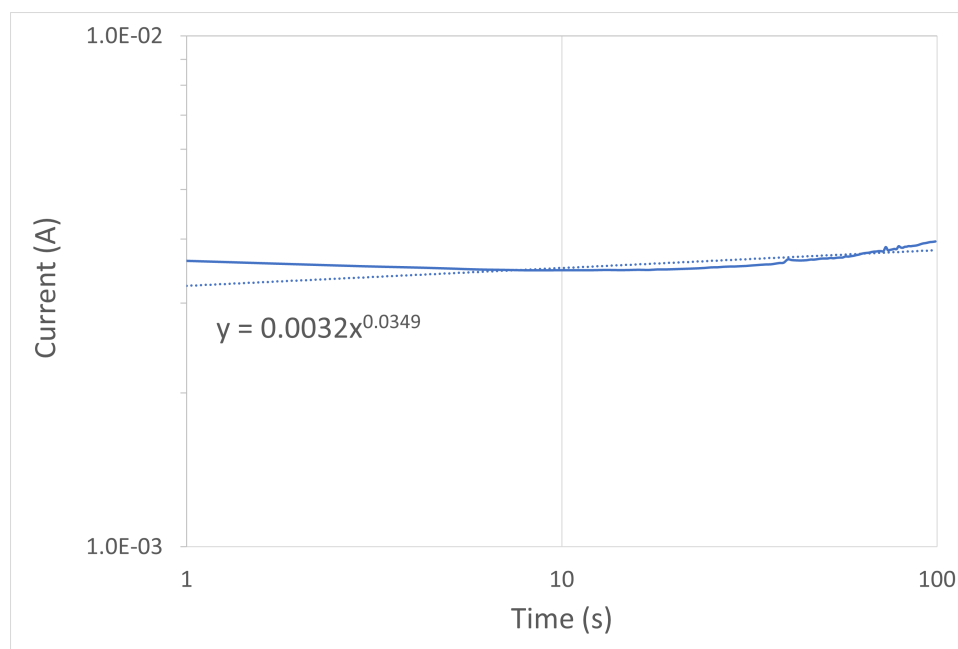
Figure 4.12: First 100 seconds of day one of potentiostatic test of 304L U-bend sample.

Figure 4.13: Day one of potentiostatic test of 304L U-bend sample.

Figure 4.14: First 100 seconds of day two of potentiostatic test of 304L U-bend sample.

Figure 4.15: Day two of potentiostatic test of 304L U-bend sample.

Figure 4.16: First 100 seconds of day three of potentiostatic test of 304L U-bend sample.

Figure 4.17: Day three of potentiostatic test of 304L U-bend sample.
