Bulletin Number 31

AN ANALYSIS OF LANDSLIDE DAMAGE AND SLOPE STABILIZATION

NEAR SEOUL, KOREA

George H. Belt
Bo-Myeong Woo

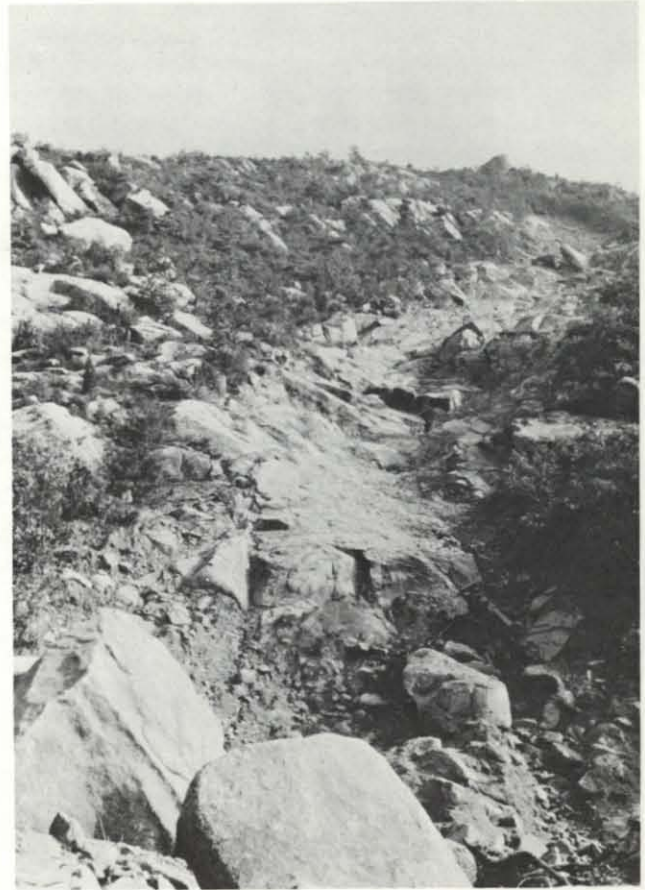
Figure 2. Landslide damage in the upper portion of the Samseong-Cheon drainage. More than 40 similar landslides occurred in this drainage.

earlier erosion. Slopes range from 50 to more than 100 percent. Stream channels are well incised, and evidence of earlier and continued mass wasting is evident. One of the more than 40 landslides observed in the drainage is shown in Figure 2. Terraces, buttressed by dry masonry walls, are being built to stabilize these slide areas.

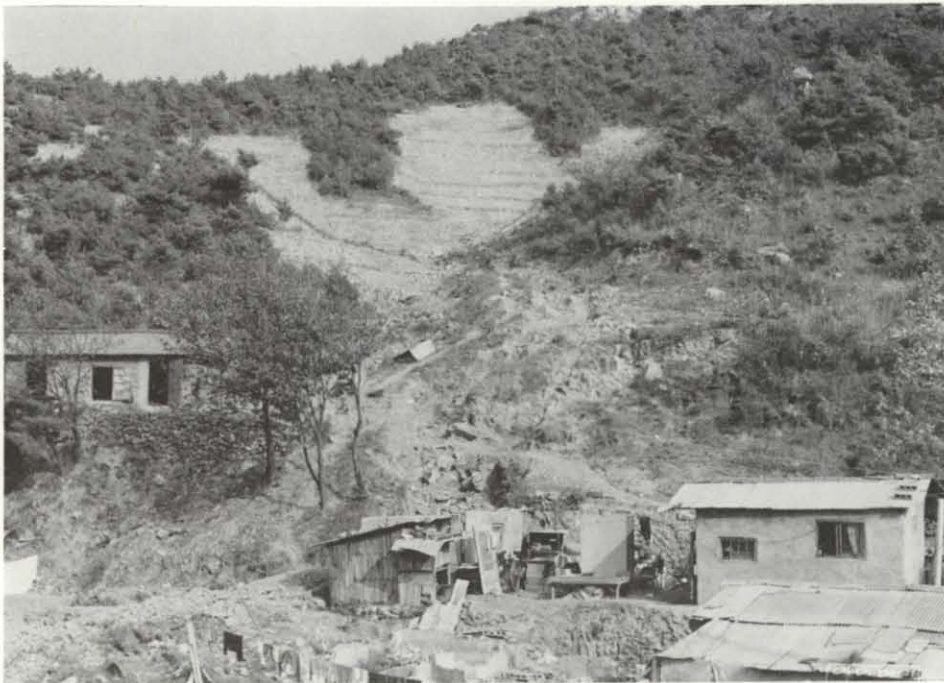
Figure 3. Debris from this slide in the Suam-Cheon drainage killed three people living in a home which was located between the two shown.

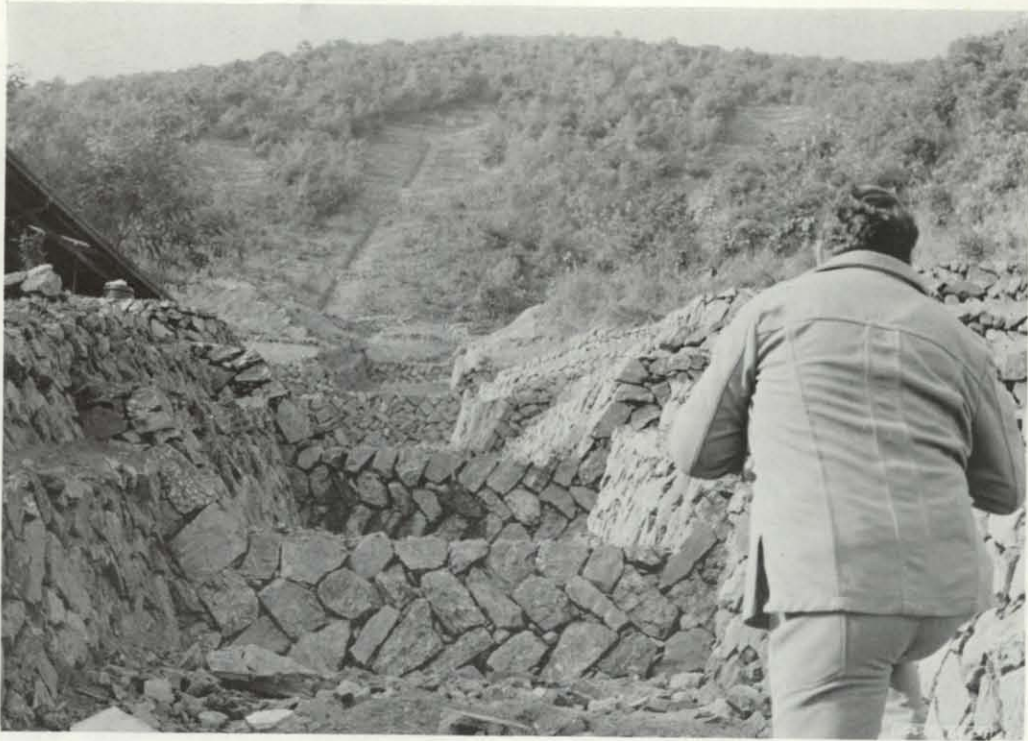
Figure 4. A stone-lined drainage channel has been installed in this slide area. Note walled steps, which reduce the effective channel gradient.

Land use in the 930-ha Suam-Cheon drainage is dominantly agricultural; however, an active quarry and a hardboard plant are found at the lower end. The dominant geological formations are augen gneiss and muscovite schist. These highly fractured formations are overlain by 20 to 100 cm of gravelly-sandy loam. Steep slopes range from 40 to 90 percent. Vegetative cover is well below natural levels due to heavy use during and after the Korean war. Evidence of past slope instability is plentiful. A debris avalanche responsible for the deaths of several people during the July 1977 storm is shown in Figure 3. Stabilization efforts such as the rock-lined channels and grade reduction structures shown in Figure 4 and terraces shown in Figure 5 have been constructed in the Suam-Cheon watershed.
