Final Report

# Lower Coeur d'Alene River Water Quality Monitoring

United States Department of the Interior  
Bureau of Land Management

**Grant, Schreiber & Associates**  
Harbor Center, Suite 220  
1000 W. Hubbard Avenue  
Coeur d'Alene, Idaho 83814

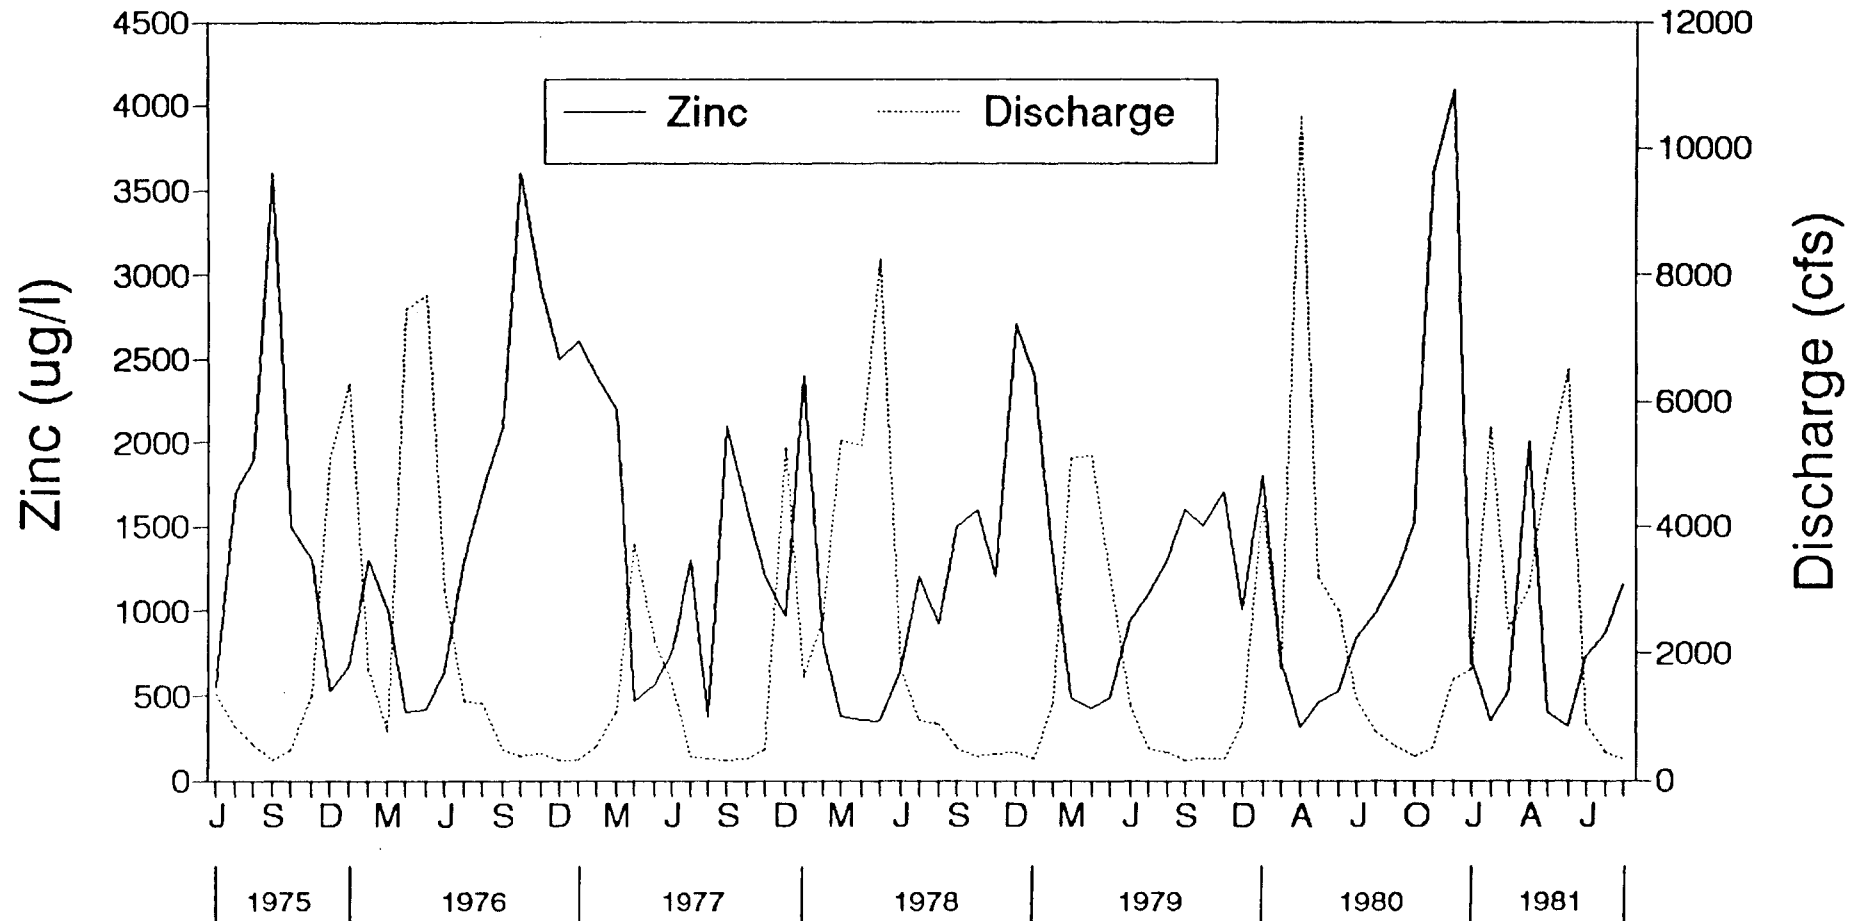
Figure 2-5. Zinc and discharge in the Coeur d'Alene River at Rose Lake.

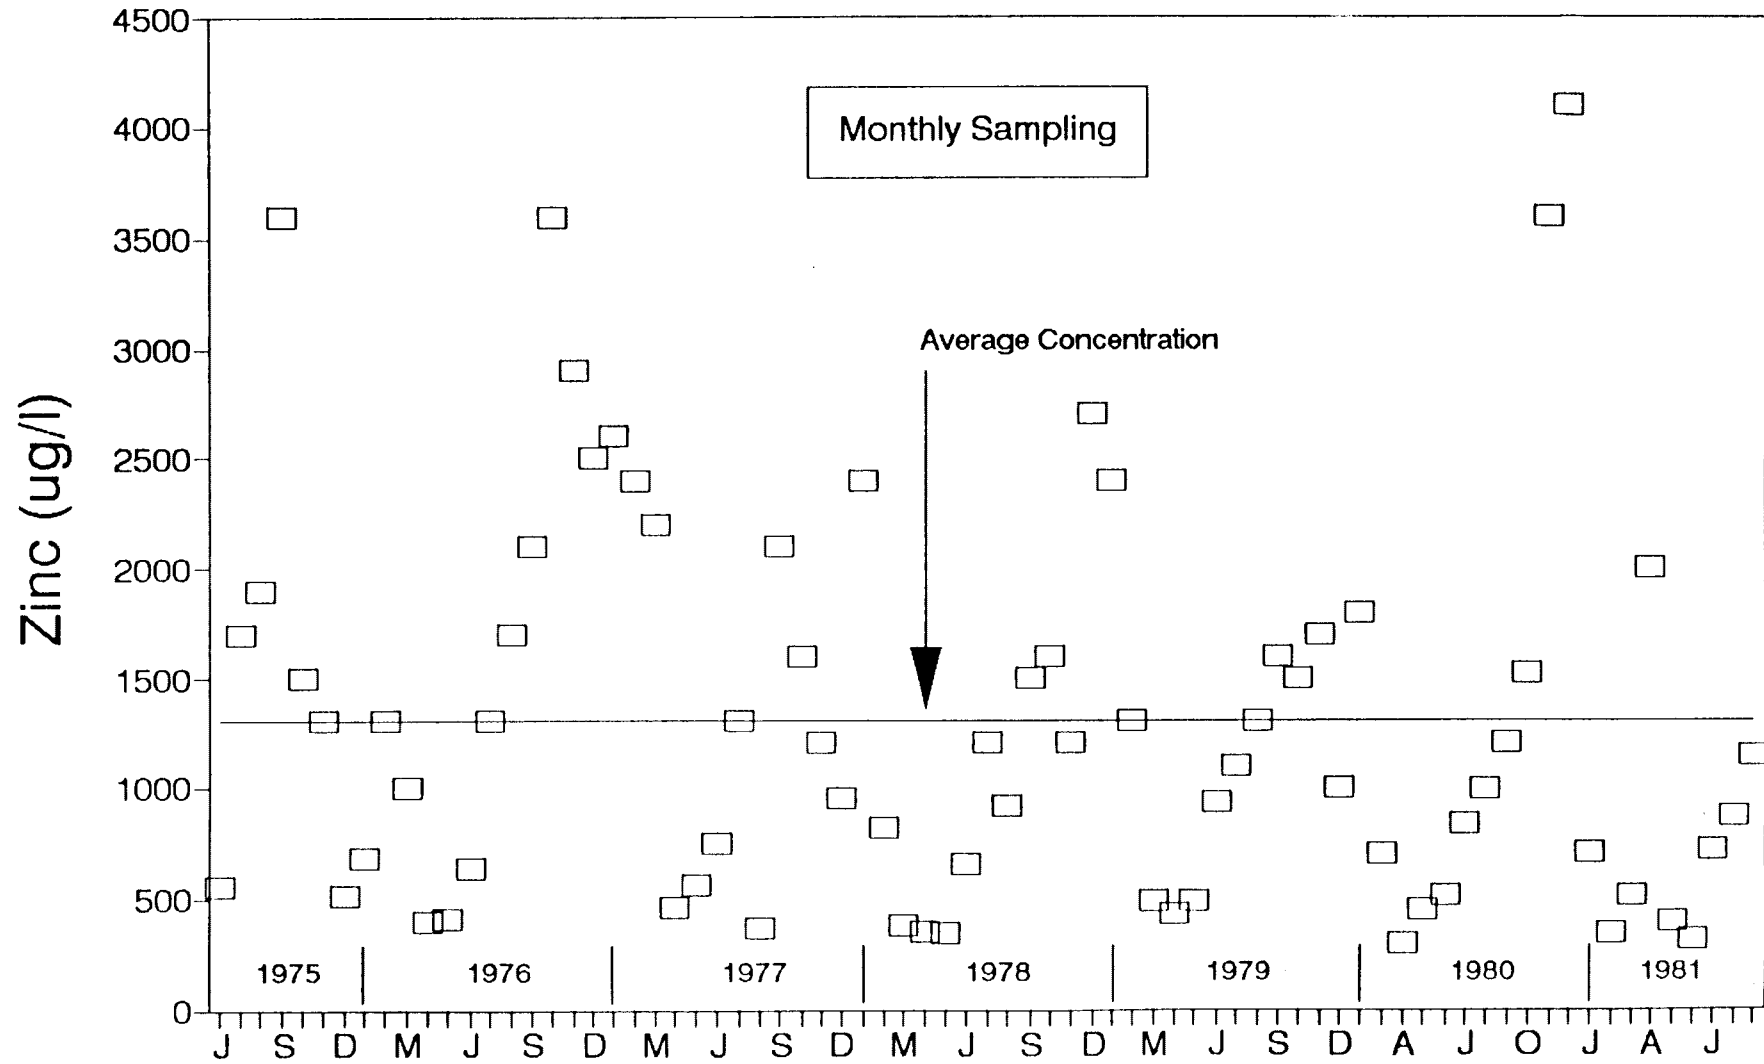
Figure 4-8. Monthly zinc concentration in the Coeur d'Alene River at Rose Lake.

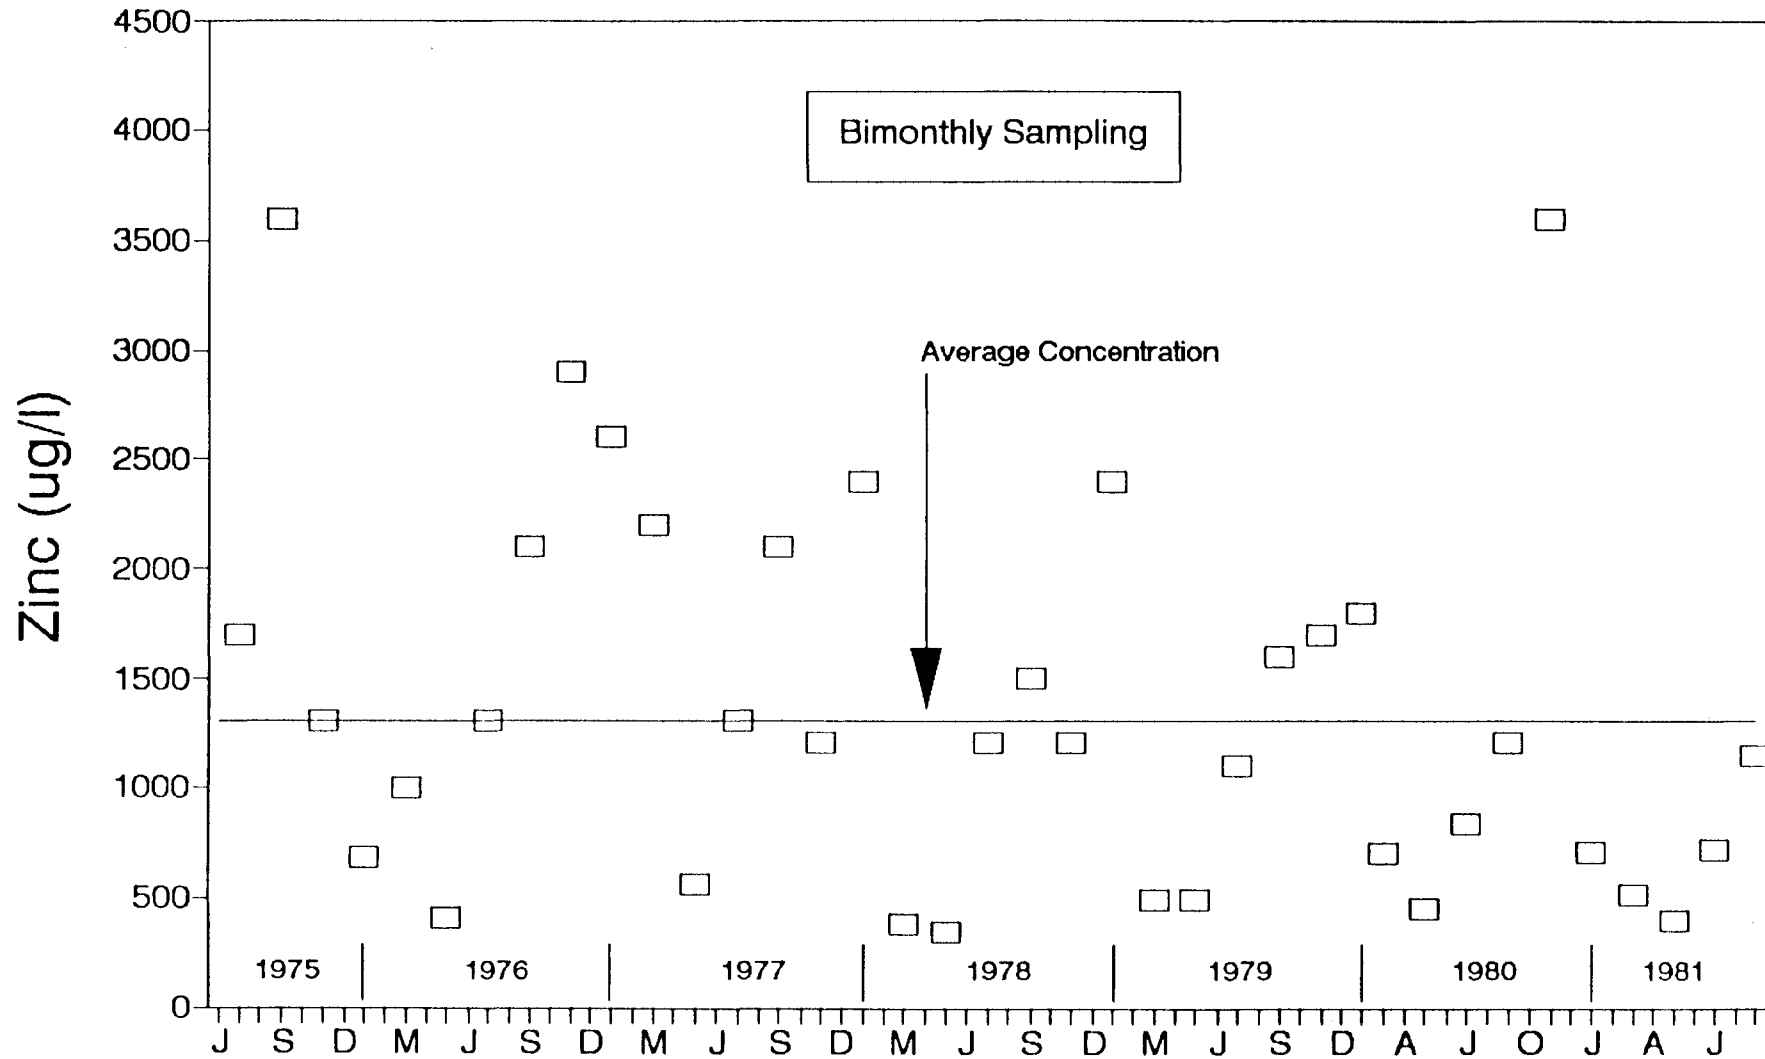
Figure 4-9. Bimonthly zinc concentration in the Coeur d'Alene River at Rose Lake.

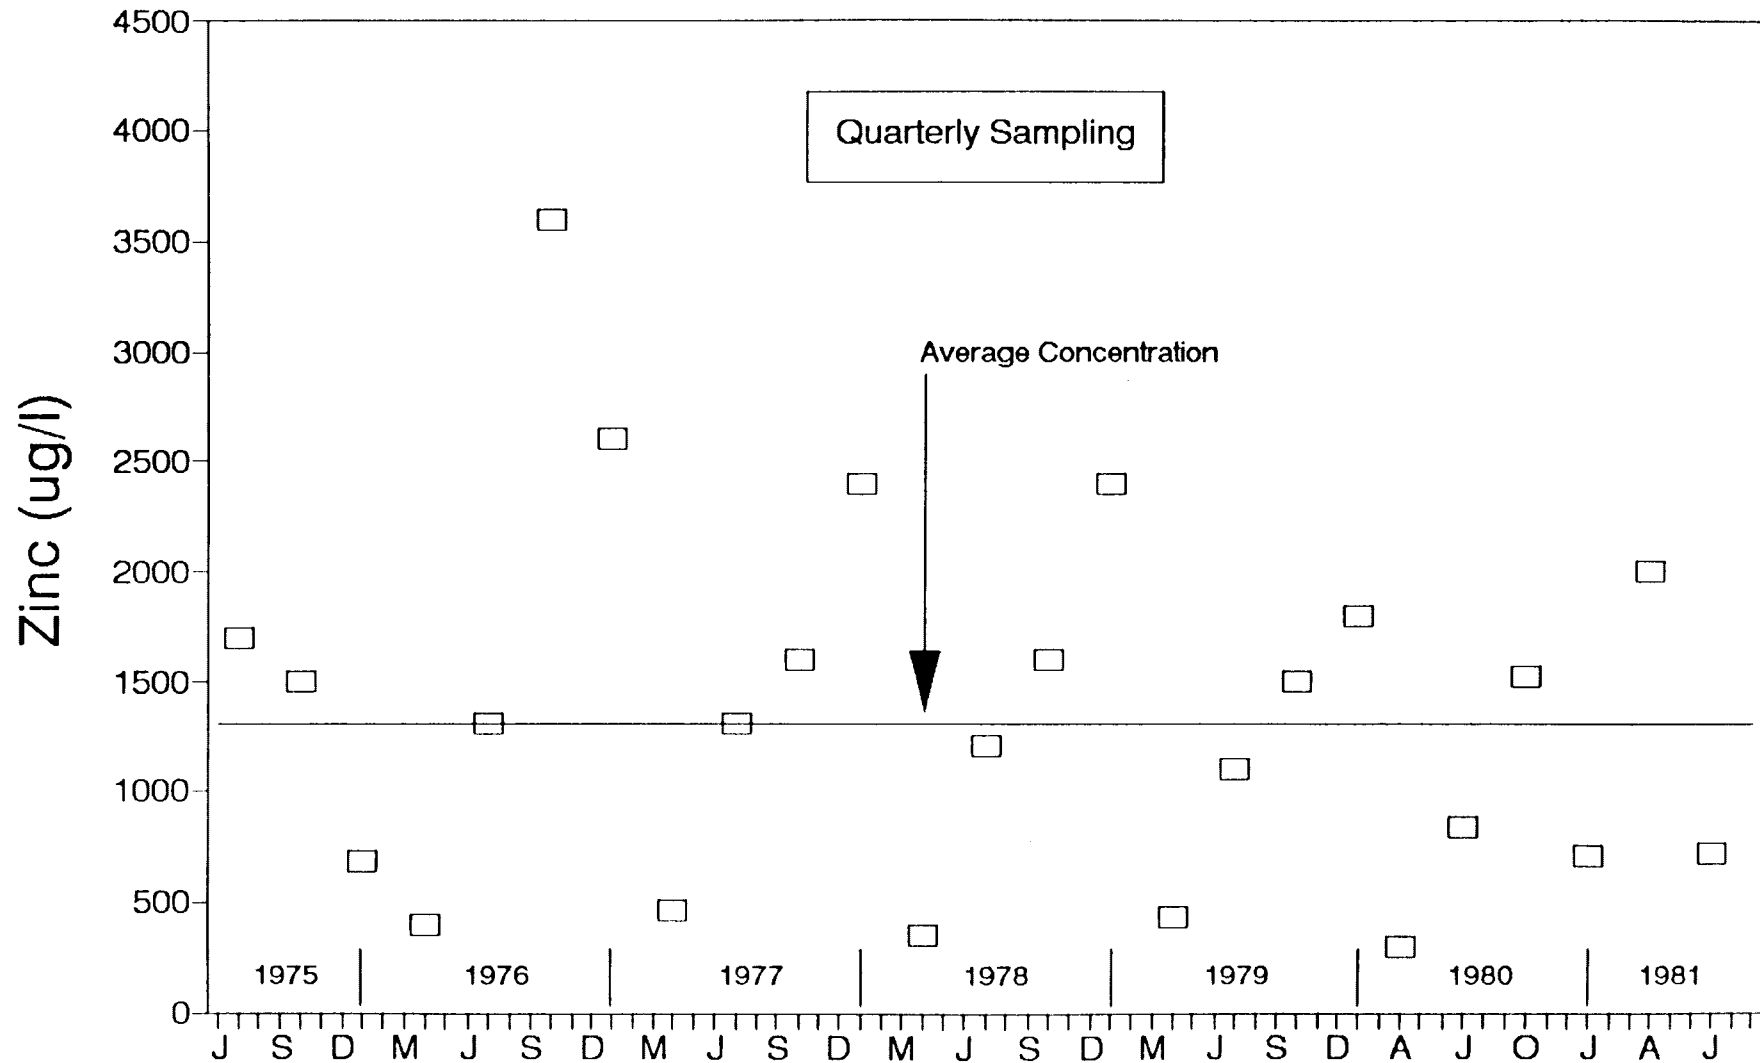
Figure 4-10. Quarterly zinc concentration in the Coeur d'Alene River at Rose Lake.
