TECHNICAL TERMINATION REPORT
Project A-034-IDA
Open File Series No. 203

TECHNIQUES FOR DETERMINING AMOUNT AND DISTRIBUTION
OF
PRECIPITATION IN MOUNTAIN VALLEYS OF IDAHO

E. Woody Trihey
Idaho Water Resources Research Institute

June 1974

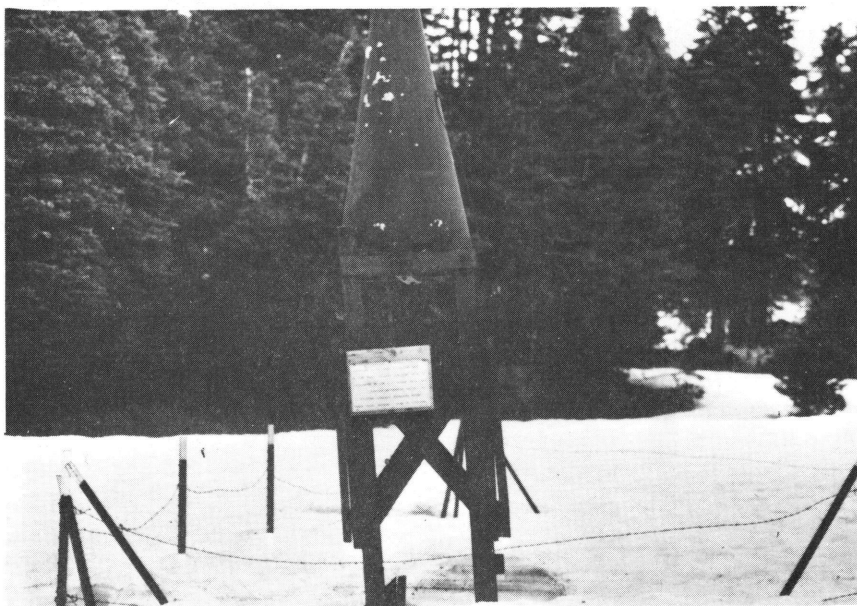
Figure 4. Sacramento Gage installed at the Mount Harrison site.

The third type of gage used was mounted in a tower. Two are Sacramento type gages with the diameter of their storage area being larger than the diameter of their orifice. These were mounted atop wood frame structures such that the gage orifices were approximately ten feet above the ground surface and parrallel to it. Neither of the Sacramento gages were shielded (Figure 4).

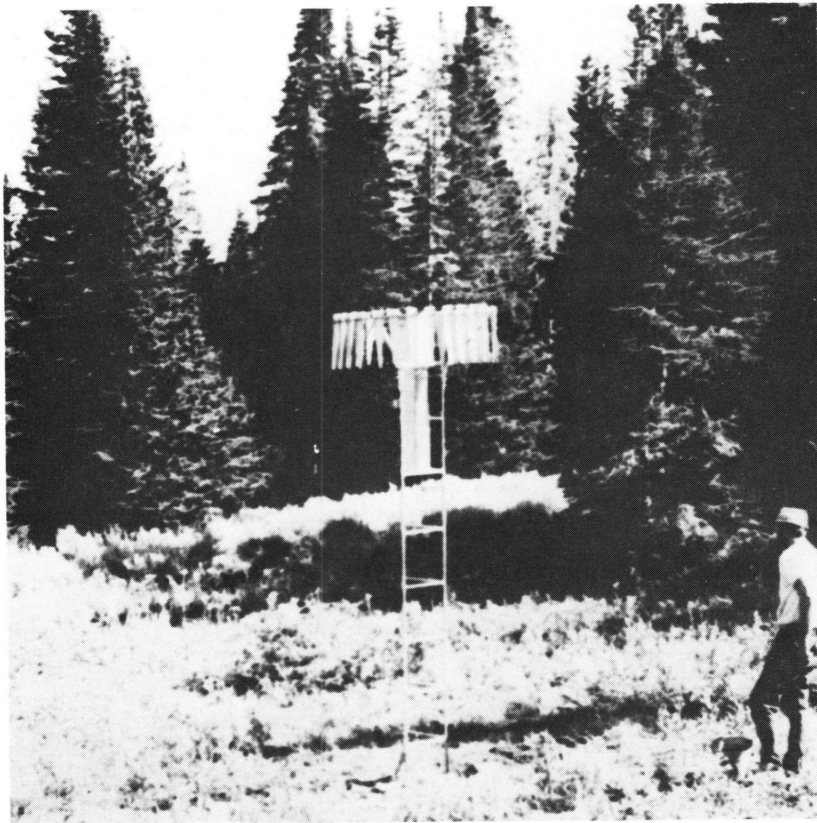
Figure 5. Eight by forty-one inch storage gage mounted in a steel tower

In addition to the Sacramento gages, three standard light inch diameter by forty-one inch straight-tube storage gages were installed atop steel towers. All are installed such that the gage orifice is parallel with the ground surface and approximately 10 feet above it. Unlike the Sacramento gages, the straight tube storage gages are protected by a modified Alter shield (Figure 5).

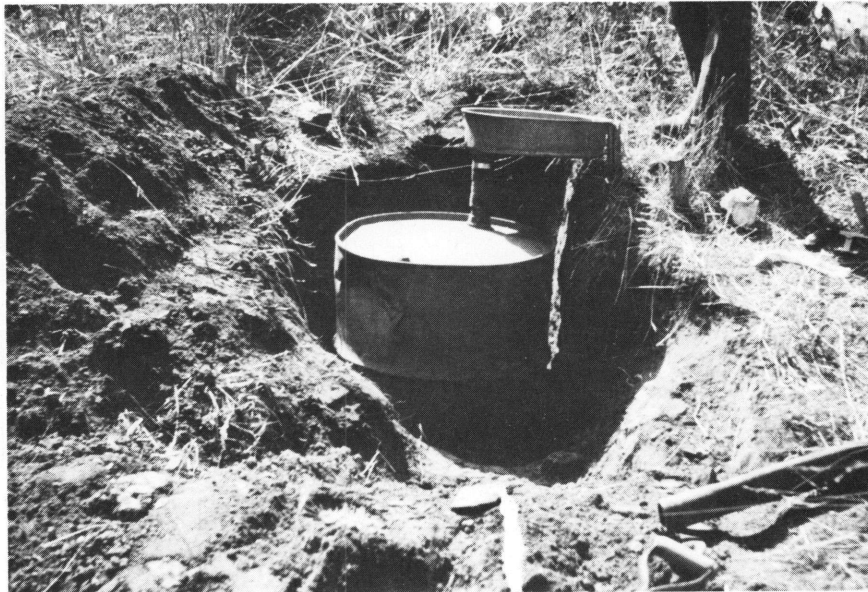
Figure 10. Modified drum installation gage.

The second experimental gage installed is called a "drum gage" and was intended to function as a large volume pit gage. Installation of this gage consisted of burying a 55-gallon oil drum to a depth of approximately three-fourths its diameter, digging a trench for the collector hose and seating the catchment pan parallel with the ground surface on the uphill side of the installed drum (Figure 9). Drum gages were installed at four high elevation sites during August 1971. A later inspection of these installations in September of 1972 indicated that the technique used for installing these gages could also be improved upon. As a result, the four drum gages in service were exhumed in September of 1973 and repositioned as indicated in Figure 10.

In addition to repositioning the gage to eliminate such problems as air lock and collapsed collector hoses, the inside of the collector was also modified. As originally installed,

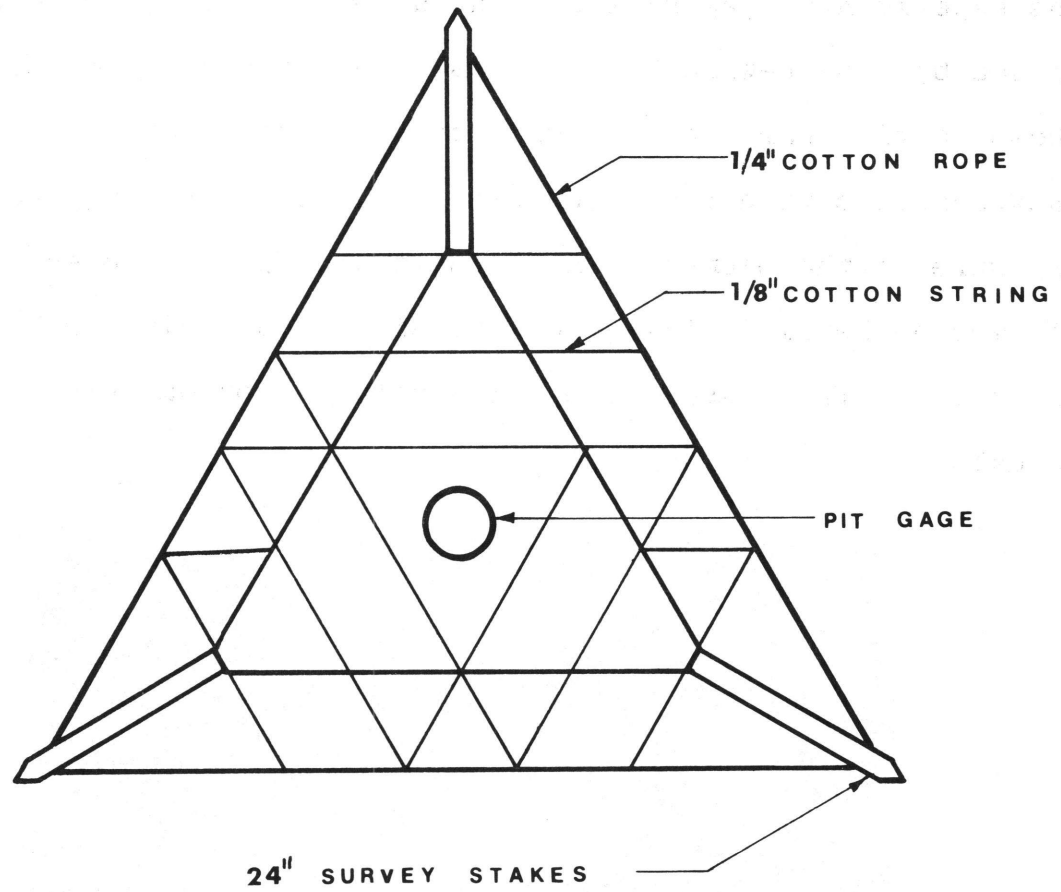
Figure 12. Cattle Guard

An improvised cattle guard (Figure 12) was placed around the experimental gages at all but a few sites. These were enclosed by a barb-wire fence. Based on three years of service, these cattle guards are considered to function adequately. The inexpensive cotton rope and twine did not deteriorate with exposure to the elements, nor was it attacked by rodents. Only one ground level installation was disturbed during the study period. In this case the entire installation was destroyed by vandals.

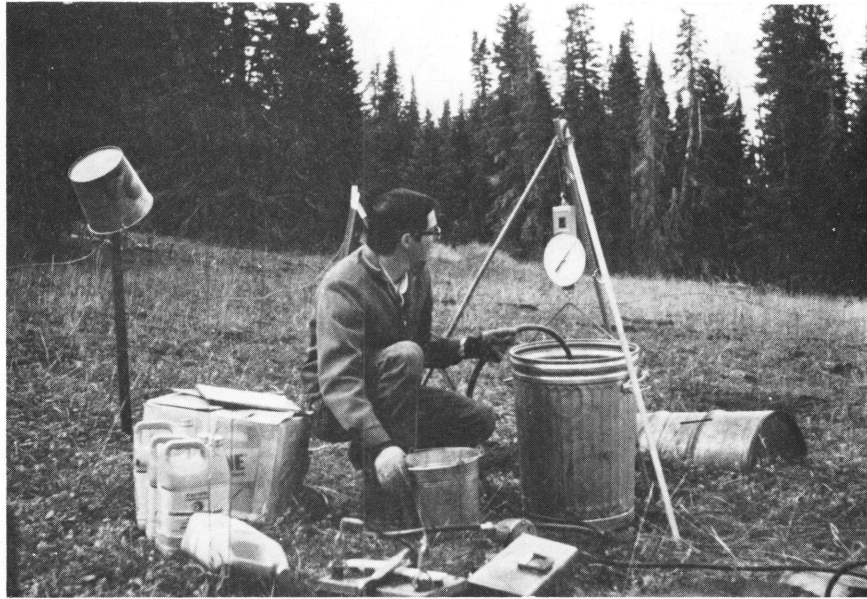
The contents of the gage were pumped out with a portable marine pump operated by a 12-volt auto battery. A length of 5/8 inch garden hose was connected to the suction side of the pump and inserted into the gage. Similarly a second length of hose was connected to the discharge side of the pump and used to direct the contents of the gage into appropriate containers for weighing. A dairy scale equipped with an external adjustment for the contents of the gage to an accuracy of ± 0.1 pounds (Figure 14).

Figure 14. Graduate Student, David Fortier, pumping out the 55-gallon "drum gage" at the Clear Creek Meadows site.
