THE EFFICACY OF AERIAL PHOTOGRAPHY  
ANALYSES FOR DETERMINING DISTURBANCES IN  
AQUATIC ECOSYSTEMS

A Thesis

Degree of Masters of Science

Katherine E. Lanspery

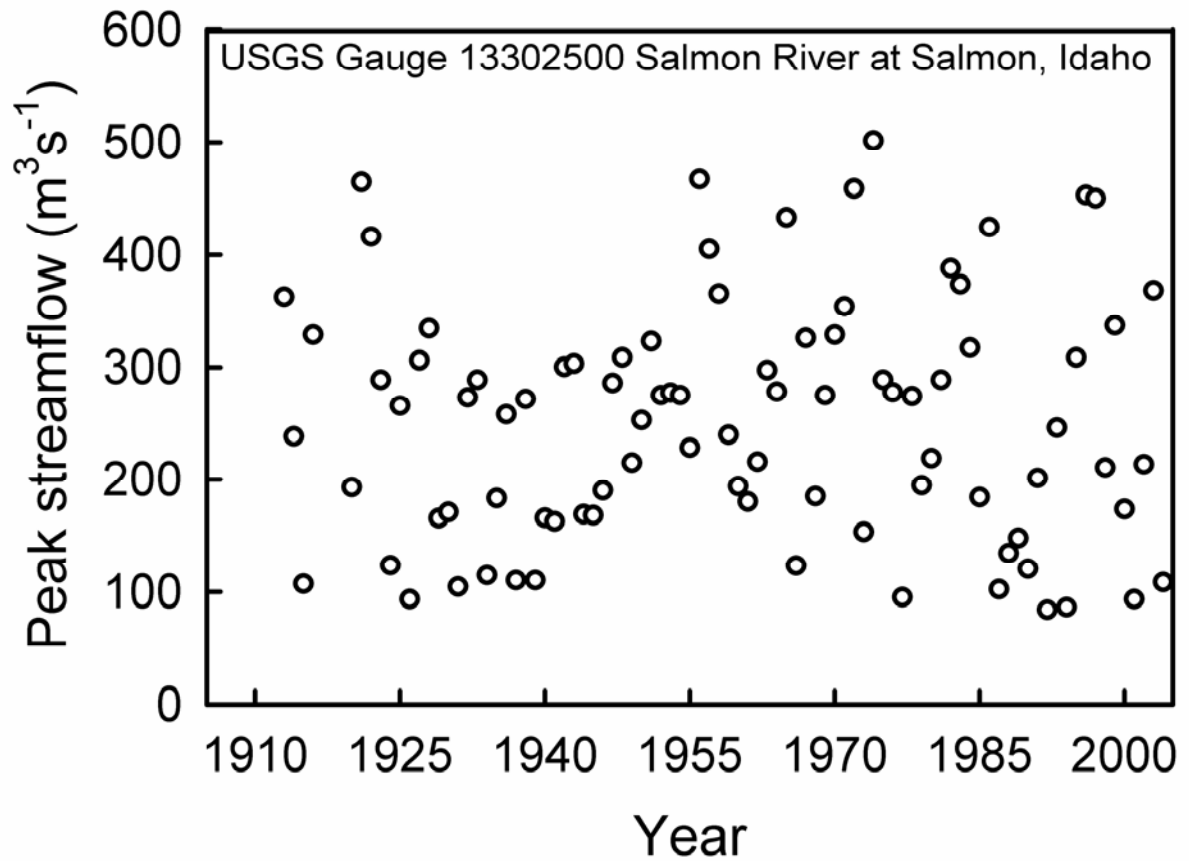
Figure 5. Peak stream flow was variable as shown on the Salmon River over the period 1905 to 2005. Two peak flow events in the 1990s may have played a role in channel migration, altering stream widths and the areas of exposed gravel bars.

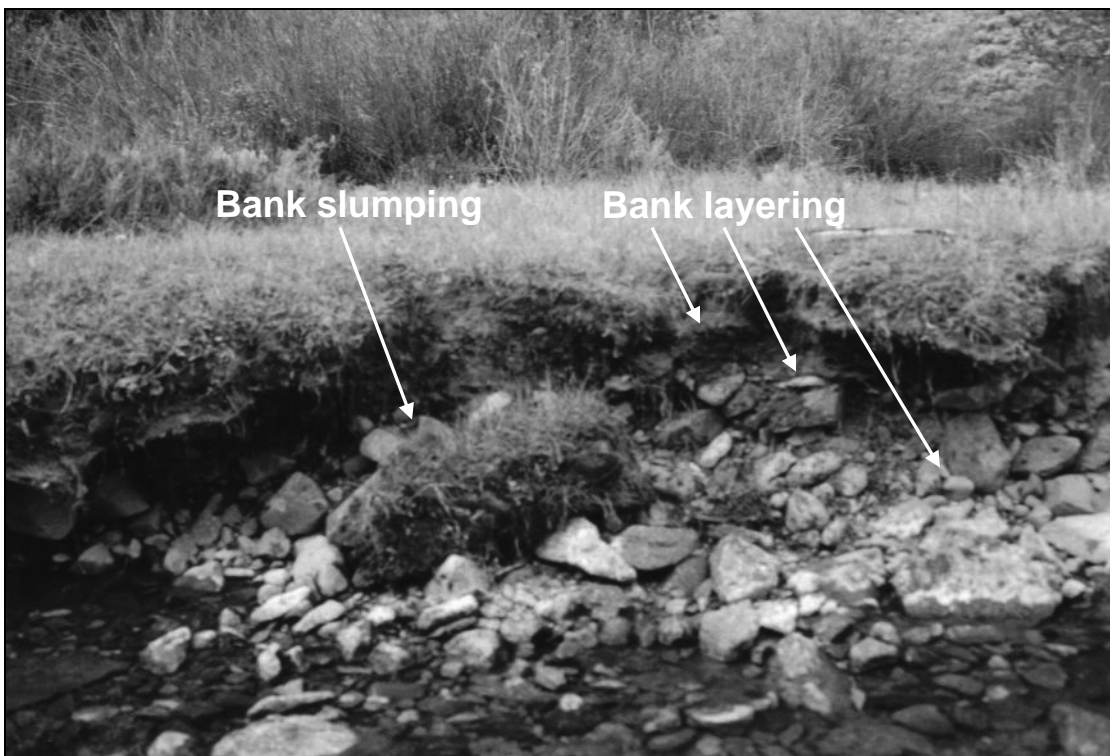
Figure 7. Layers of deposition on this 10-m section of exposed stream bank suggested that natural processes such as flooding were part of the historic range of variability. Streambank alteration may be aggravated by the conversion of the riparian vegetation from woody species such as deeply rooted willow to shallow rooted Kentucky bluegrass.

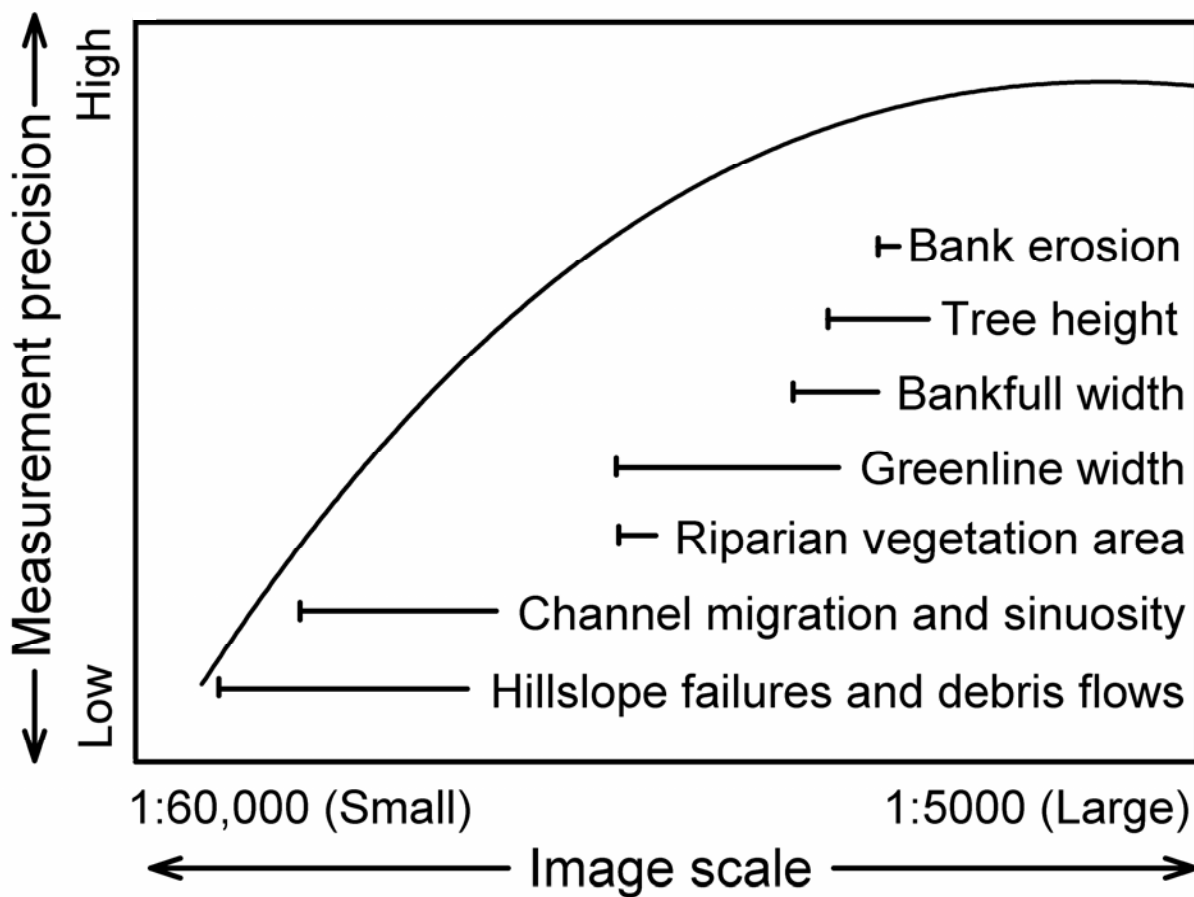
Figure 8. A conceptual model of the relationship between measurement precision and image scale. Different variables can be measured more precisely depending on the scale of the aerial photography.

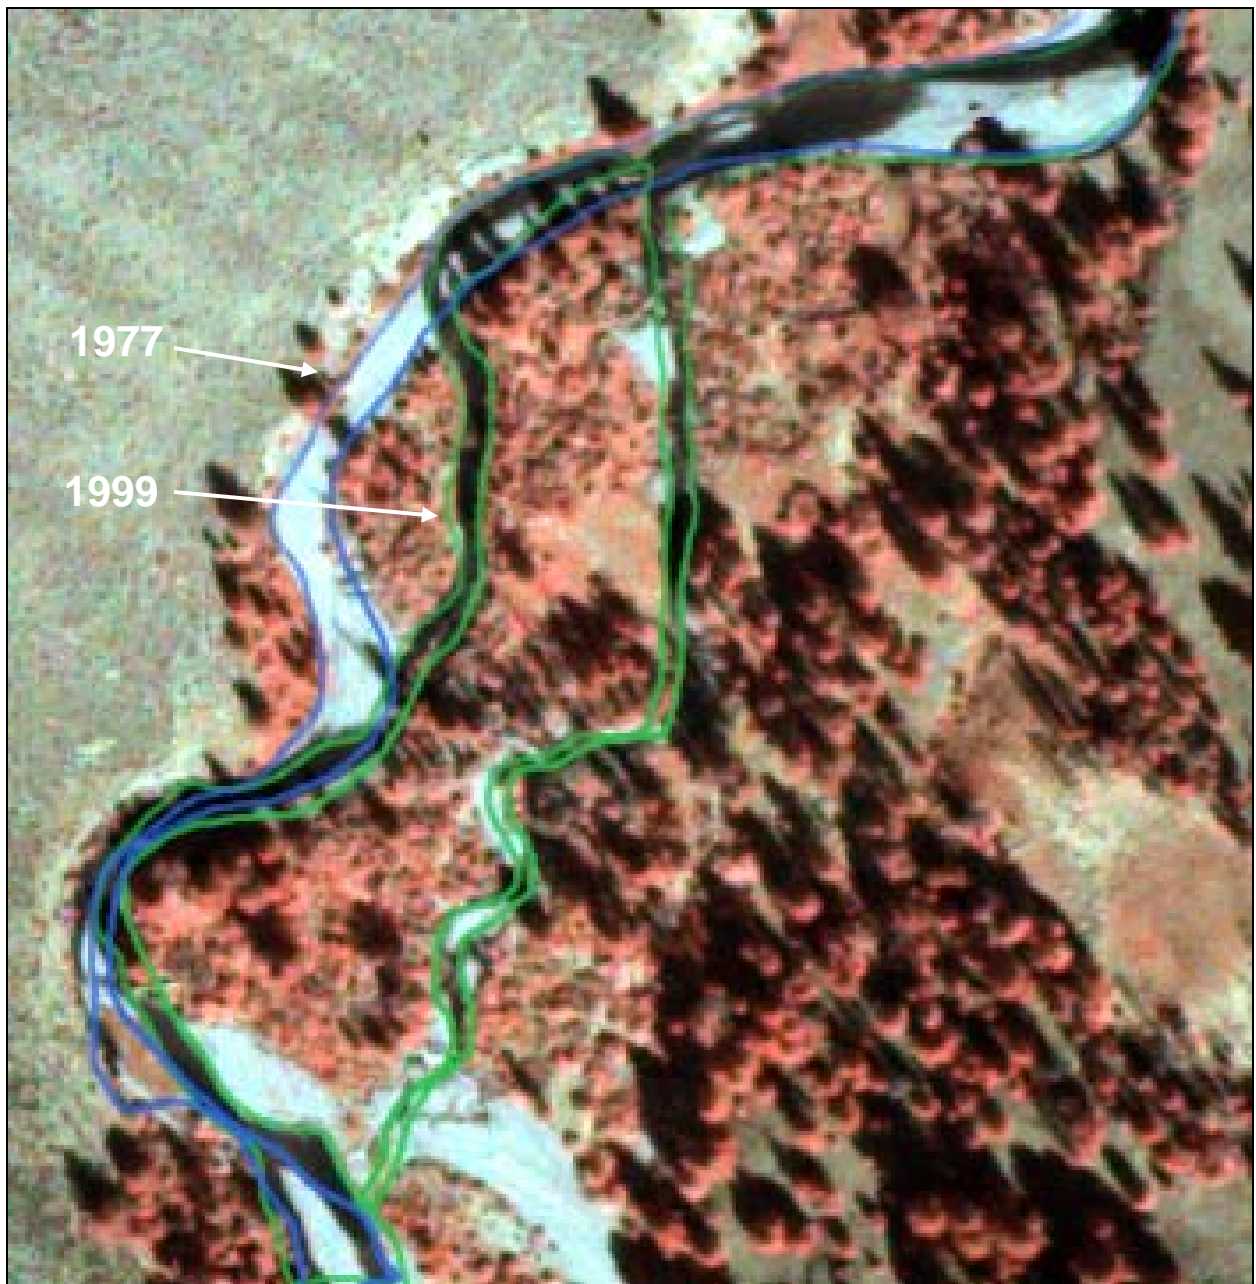
Figure 9. The interaction between frequent high discharge events and riparian vegetation affected by large ungulate herbivory may have caused this channel shift.

This may explain the decrease in stream width as the channel migrated.

The channel moved laterally in the floodplain because of frequent high discharge events and unstable stream banks (see Figure 9). The new channel location had increased canopy cover and decreased stream width. The abandoned channel location was in an exposed location with no canopy cover at the edge of a slope change in the valley floor. In contrast to its prior location, the left bank of the new channel has the potential for large wood recruitment and increased pool availability for fish. Multiple channels throughout the meadow dominated by willow and Kentucky bluegrass were a result of the channel migration.
