# Local and Longitudinal Patterns of Woody Debris Accumulation in Big Creek, Idaho

Susan E Hamilton, Nakul Deshpande, Benjamin T. Crosby; Dept. of Geosciences, Idaho State University

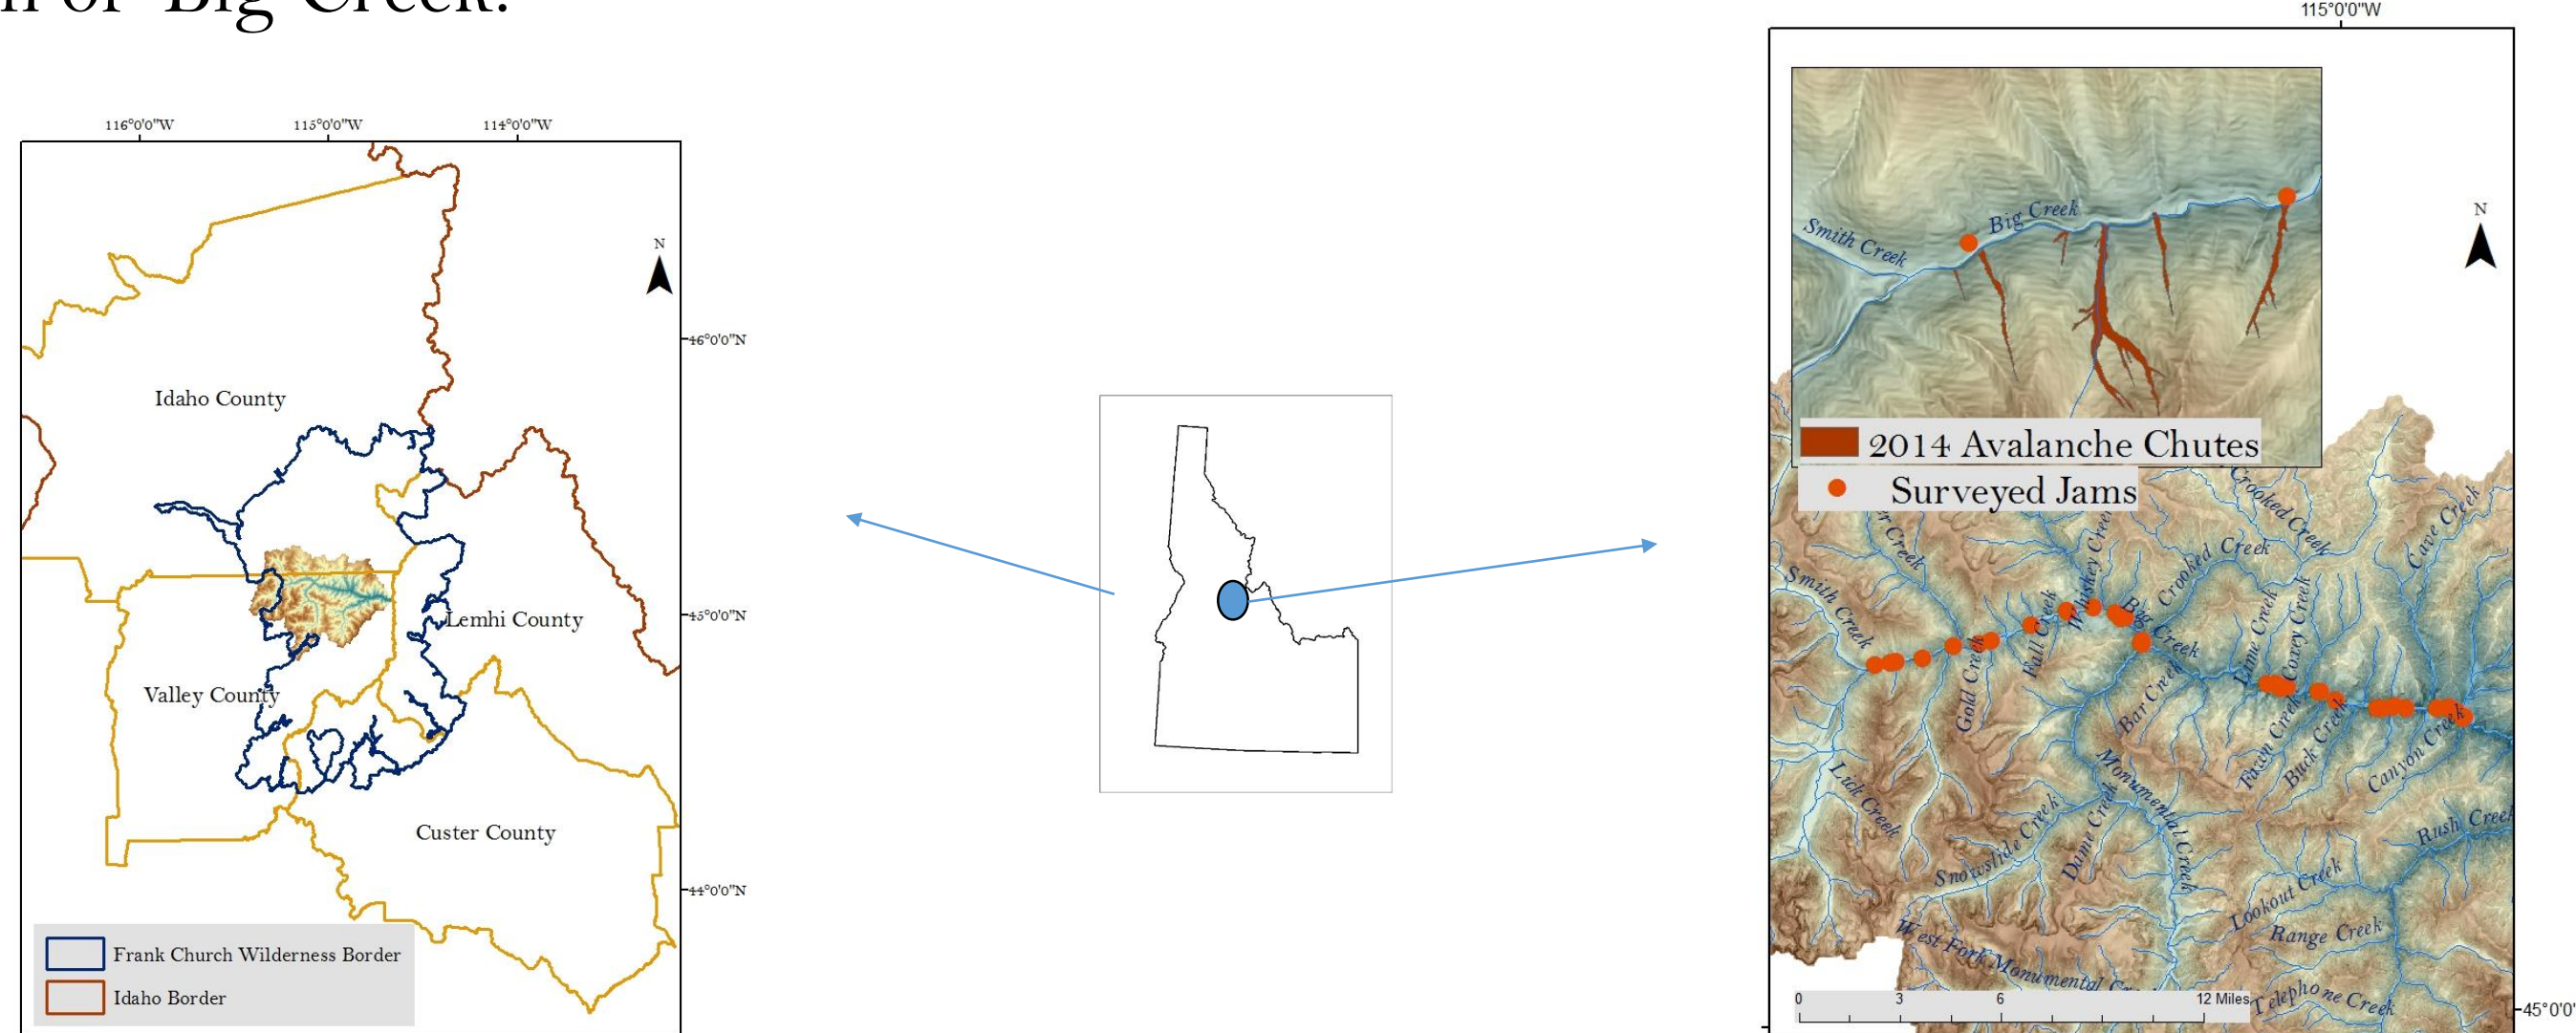
Figure 1. Overview map showing the adjacent counties of Idaho near the field site.

Figure 2. Map showing the locations of the surveyed log jams along Big Creek with an inset map of the avalanche paths of 2014.

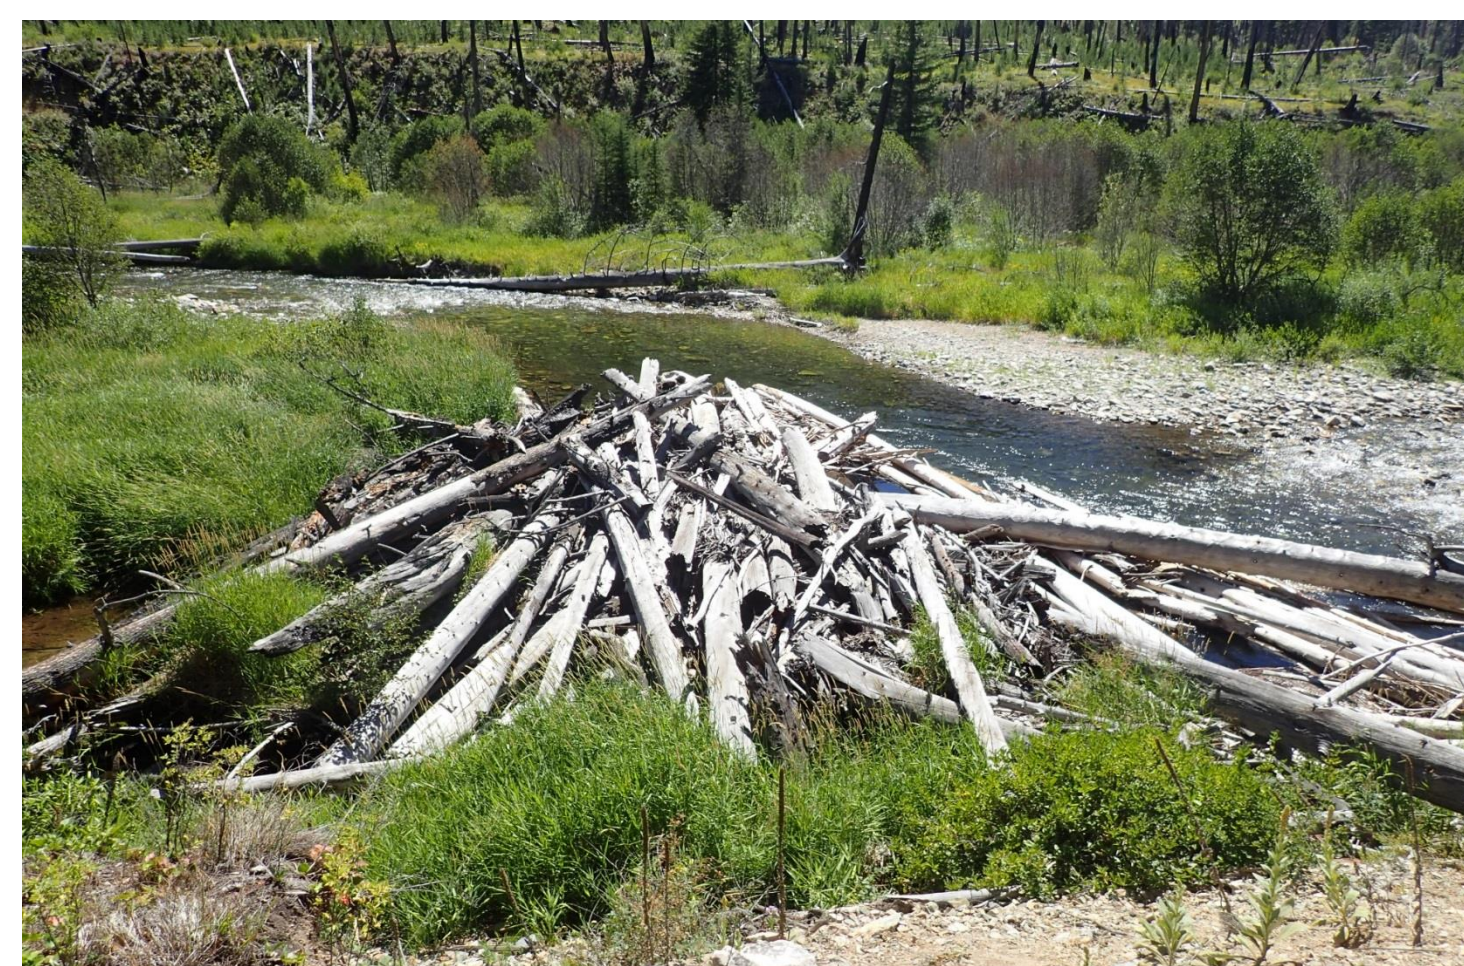
Photo 1. An example of a log jam in Big Creek. This older jam is located on the outside of a meander bend.

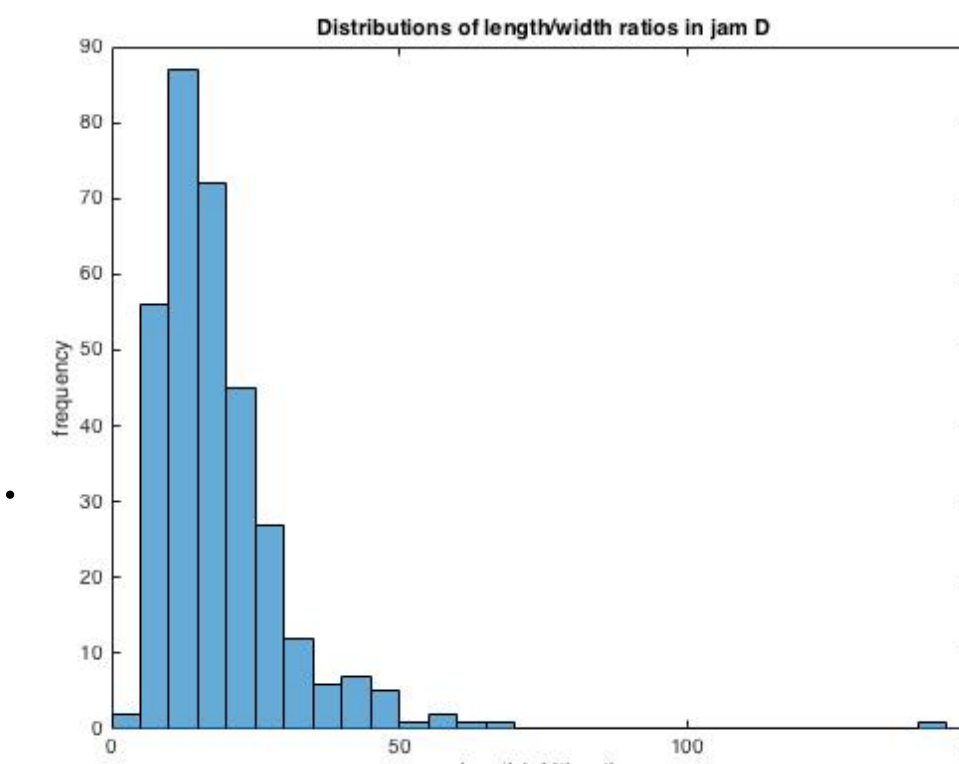
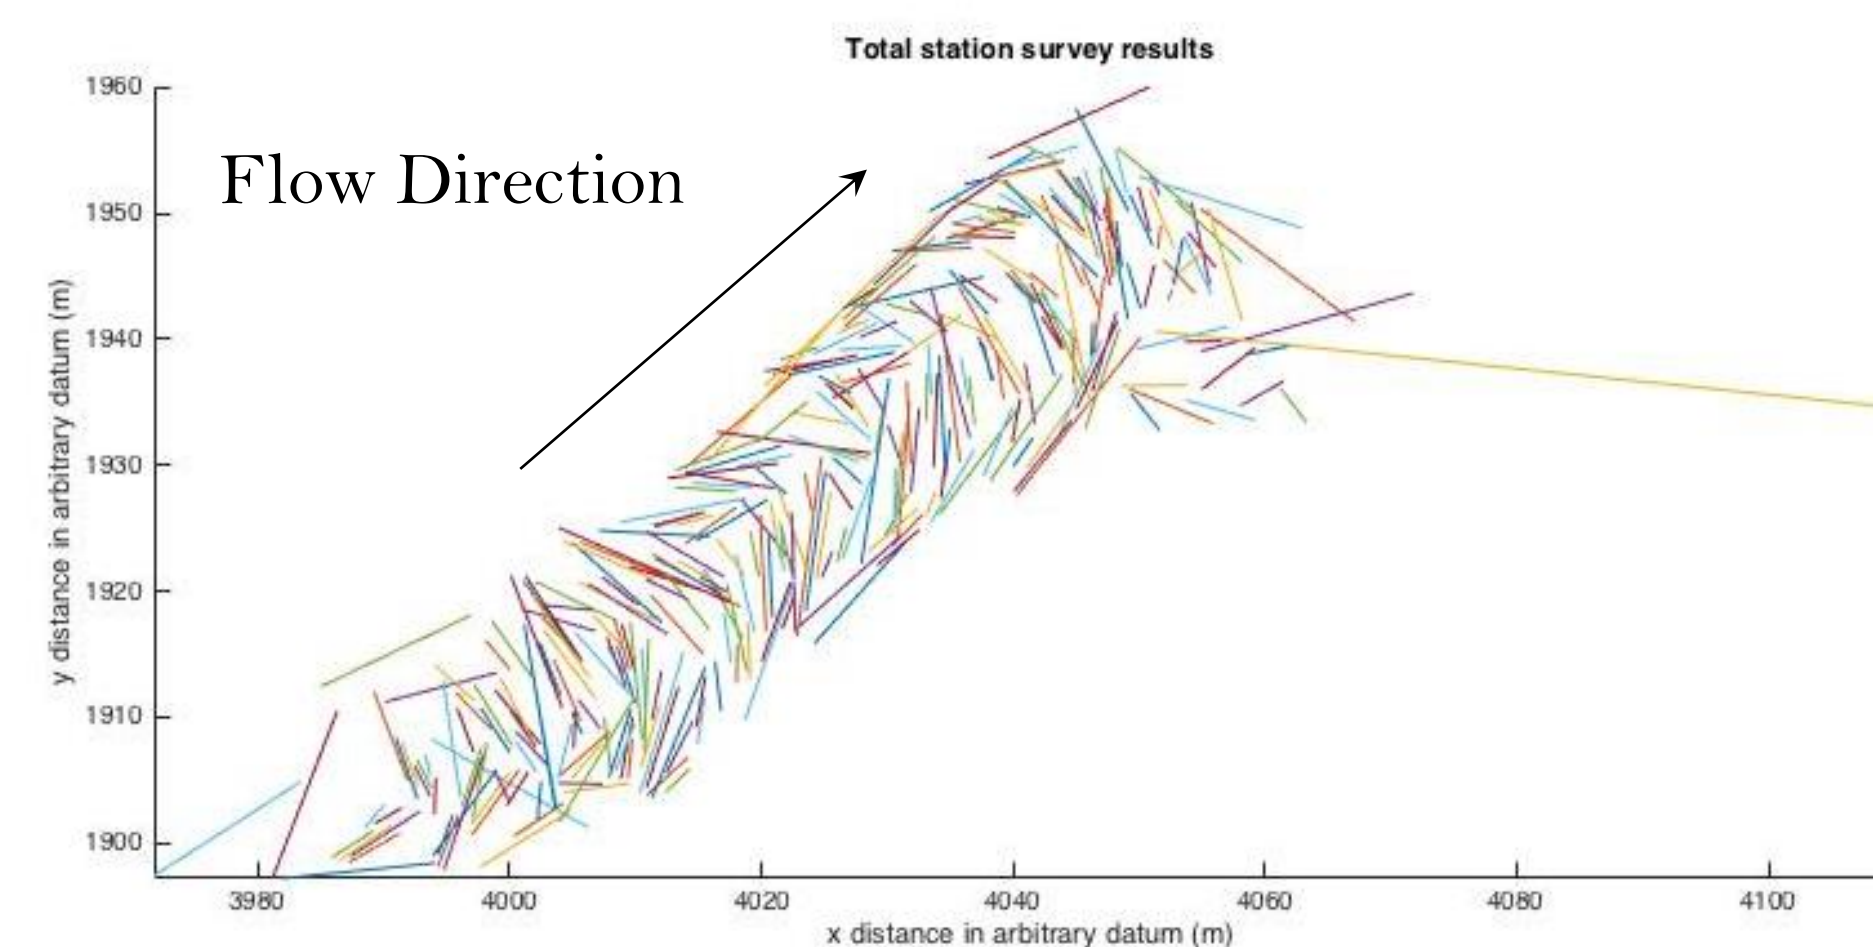
Total station surveys qualitatively show that ‘Jam D’ has an ordered, non-random geometry. The distribution of aspect ratios is also non-random. Connections between log dimensions and jam geometry is the subject of ongoing work.

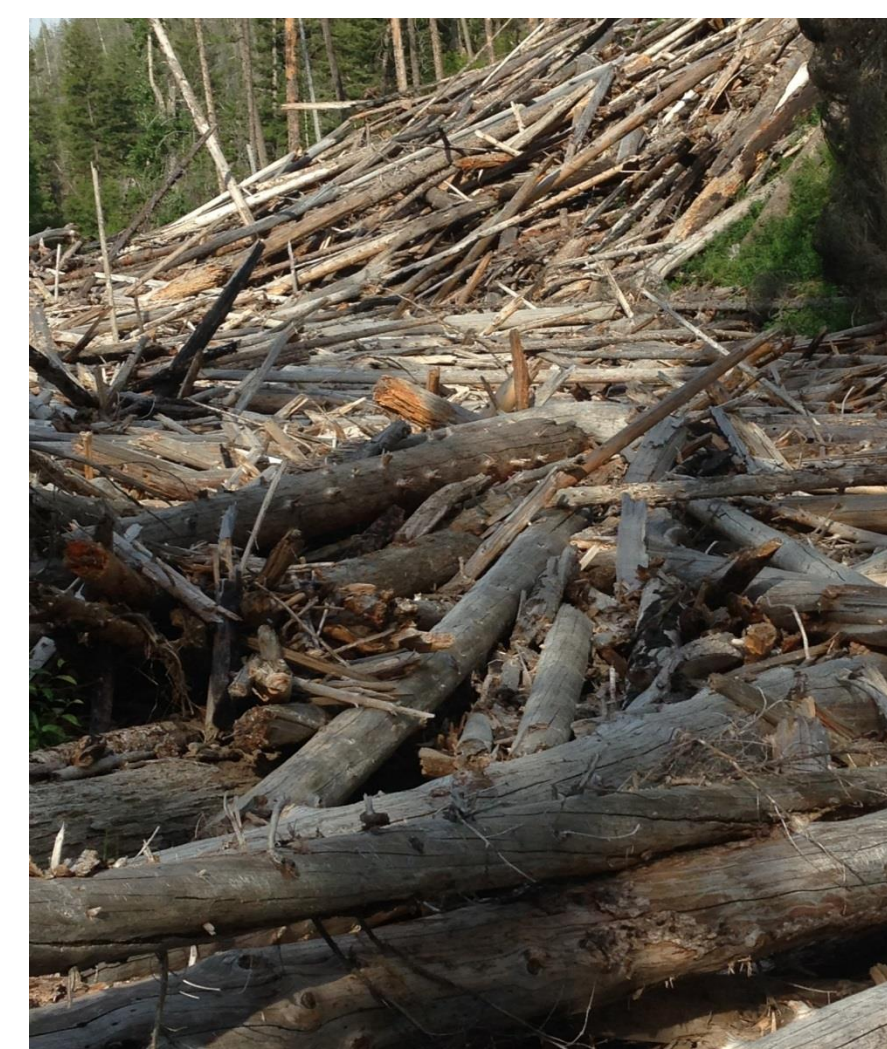
Photo 2. Looking downstream at ‘Jam D’. This is the largest remaining channel spanning jam caused by the 2014 avalanches.

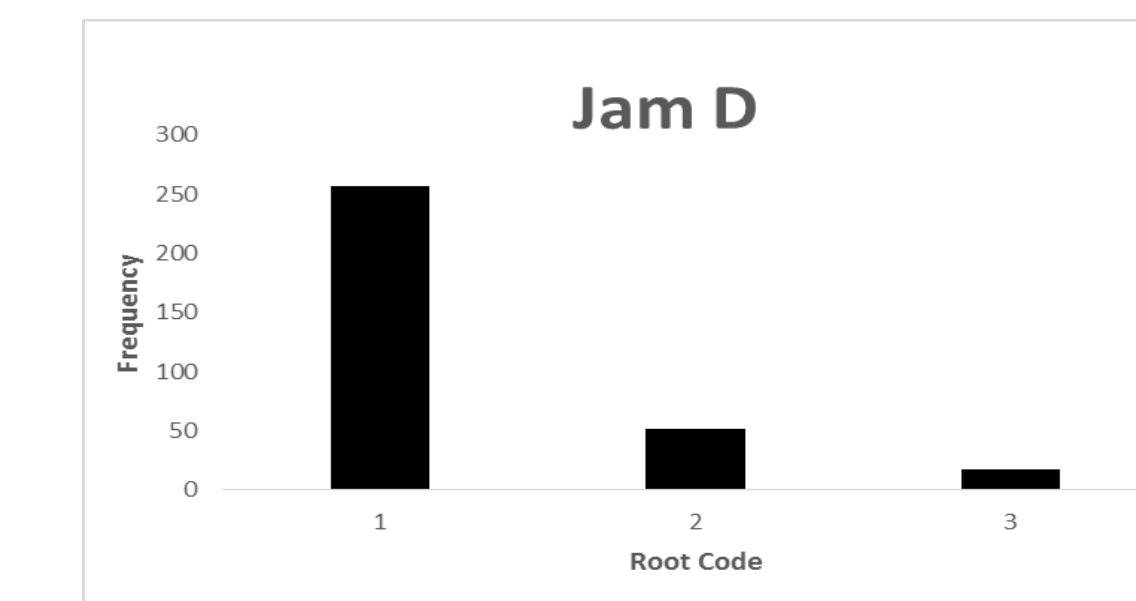
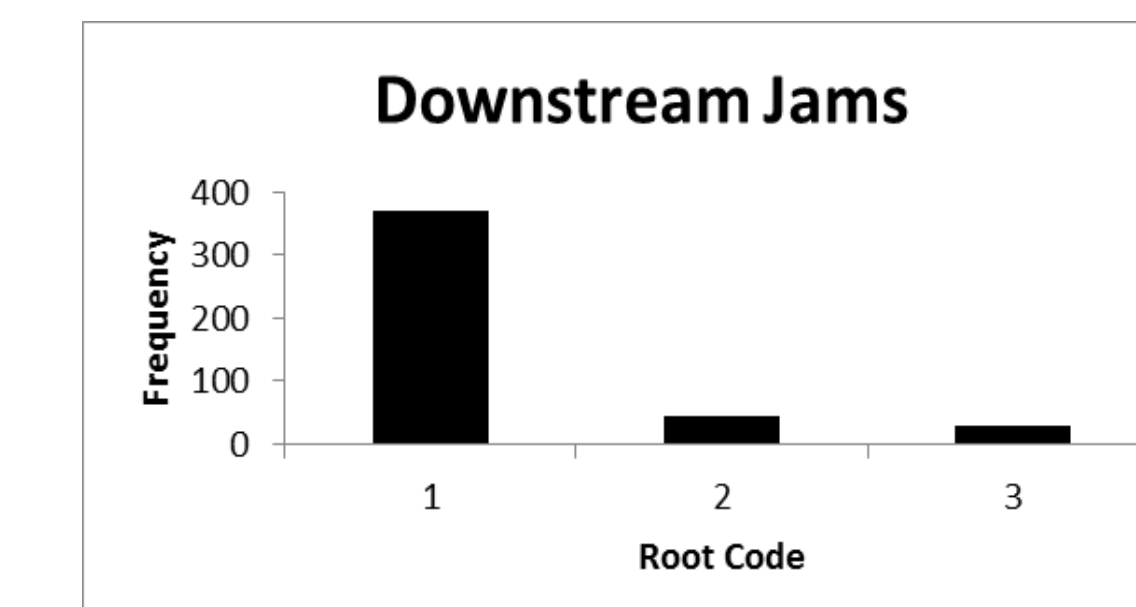
Presence of root wads is not common in Big Creek.

Root Code Key: 1. Snapped Ends 2. Root Bole Present 3. Visible Root Wad

- ‘Jam D’ and the existing downstream jams have similar distributions of root code. Both have a majority of logs with snapped ends.
- Wood in the downstream jams was expected to contain more pieces with root wads, but did not.

In systems unaffected by fire or beetle kill, most riparian inputs to the channel are due to bank erosion undercutting trees, thus delivering live trees into the river, along with their full root wads. This type of bank input is likely not common to Big Creek.

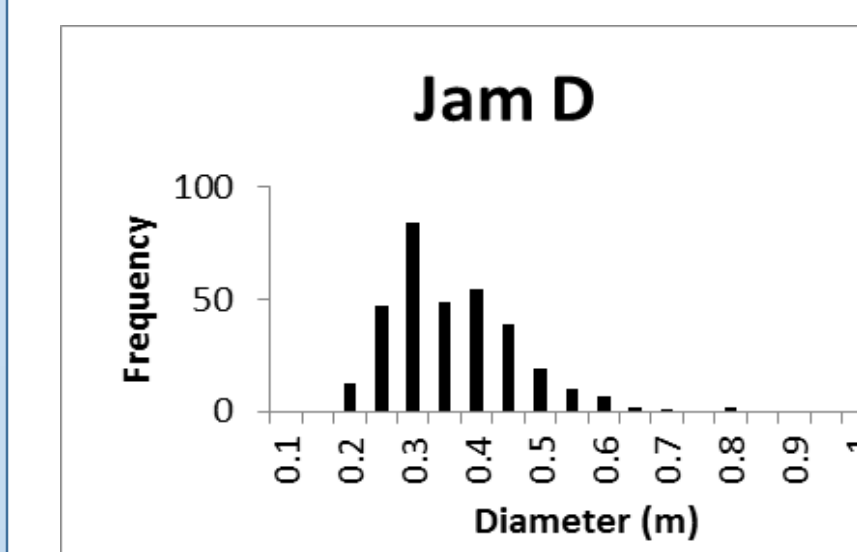
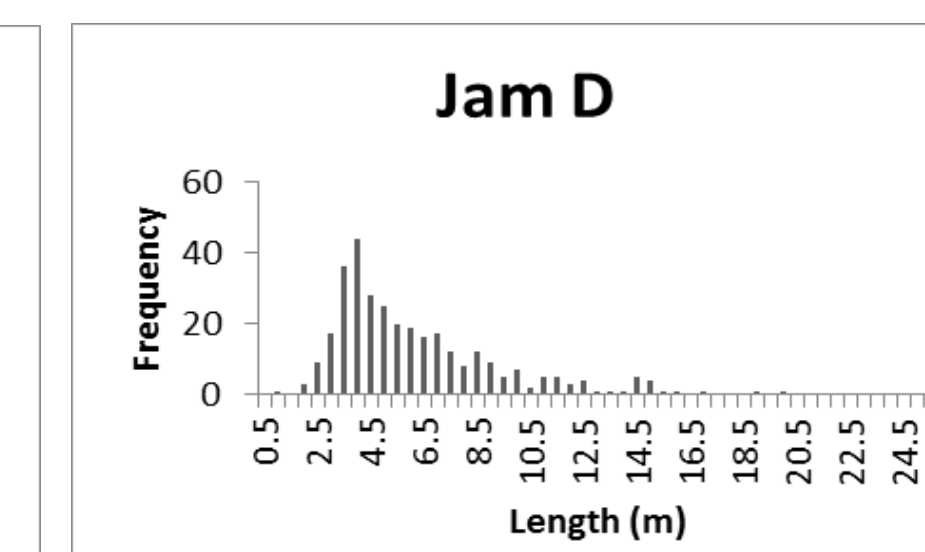
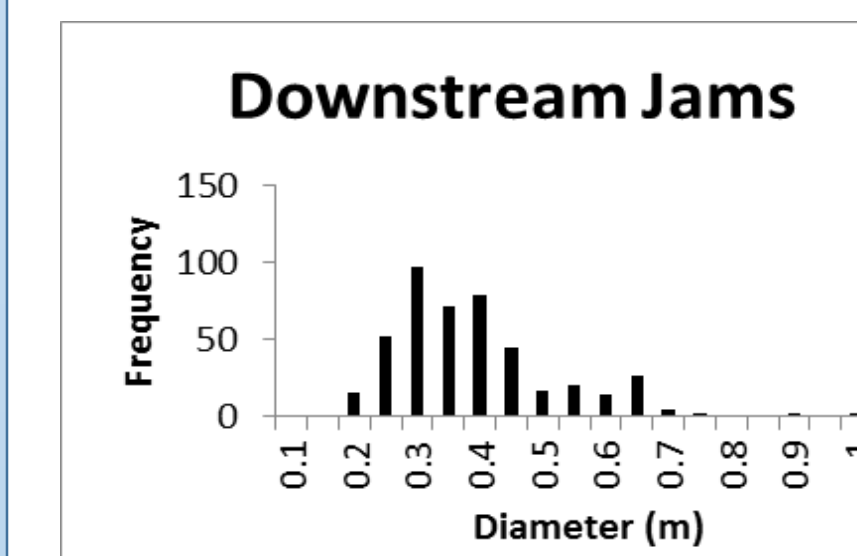
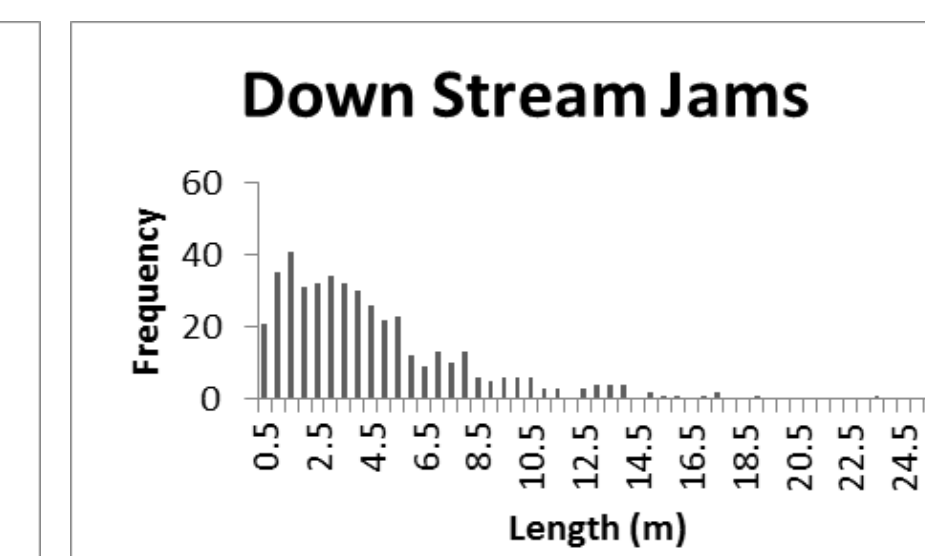
Big Creek logs do not follow a normal size distribution

- Piece length and diameter had greater variance among the downstream jams than ‘Jam D’
- Most logs in both surveys were small: 2m to 4m in length and 30 cm in diameter on average

Less skew and a more normal distribution in size among logs of Jam D reflects a pattern of uniformity in the surrounding forests. The trees were dead standing from previous fire damage and were likely of a similar age.
