**Camp Heyburn (10BW207)
Description and Evaluation**

by
Mitzi Rossillon

Renewable Technologies, Inc.
511 Metals Bank Building
Butte, MT 59701

February 3, 2005

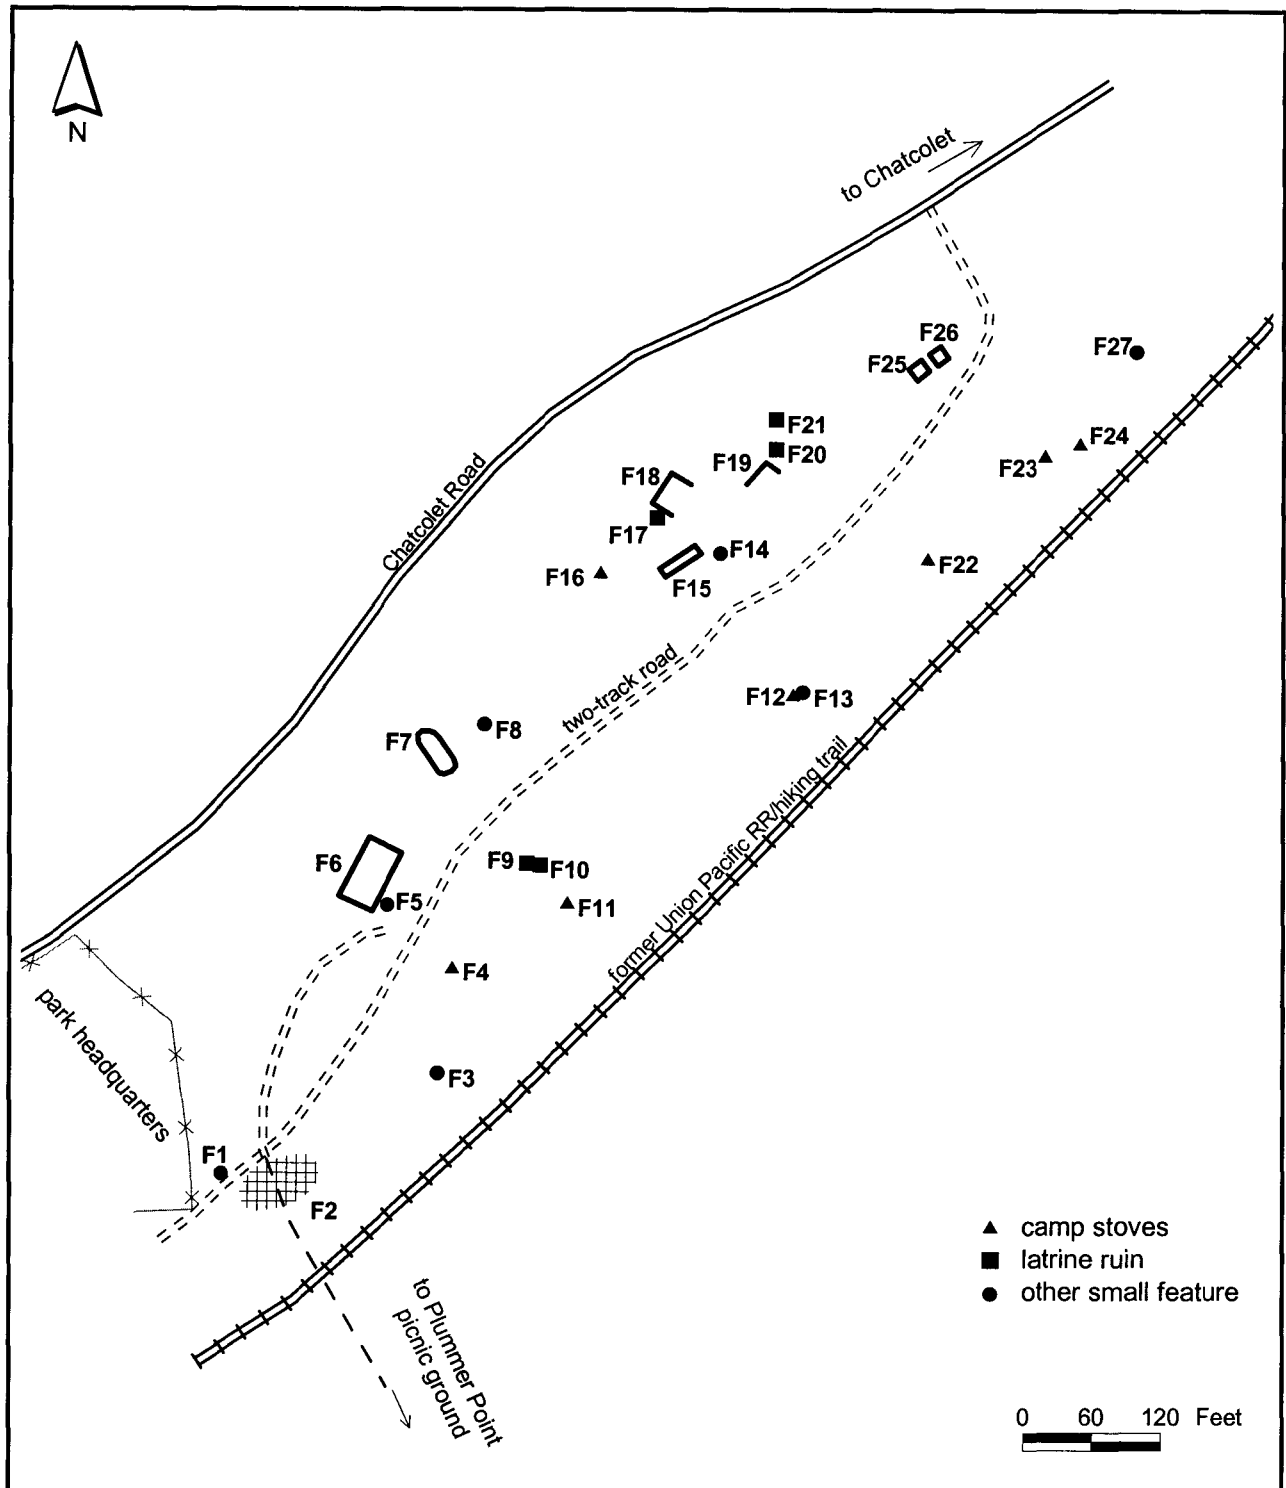
Figure 3. Site map of 10BW207, showing relative positions of 27 recorded features.

Site 10BW207 includes three categories of features, two related to the CCC and the third possibly associated with post-World War II state park operations. As noted above, the CCC features either are remains of Camp Heyburn or are camp and/or picnic improvements built by the CCC but used by the public while visiting the park. Identification of which CCC features are which is based primarily on feature form and position.
