RECLAMATION PLANS FOR ABANDONED MILL TAILING IMPOUNDMENTS
IN THE SOUTH FORK COEUR D'ALENE RIVER BASIN

A Thesis

DEGREE OF MASTER OF SCIENCE

MICHAEL ROBERT GROSS

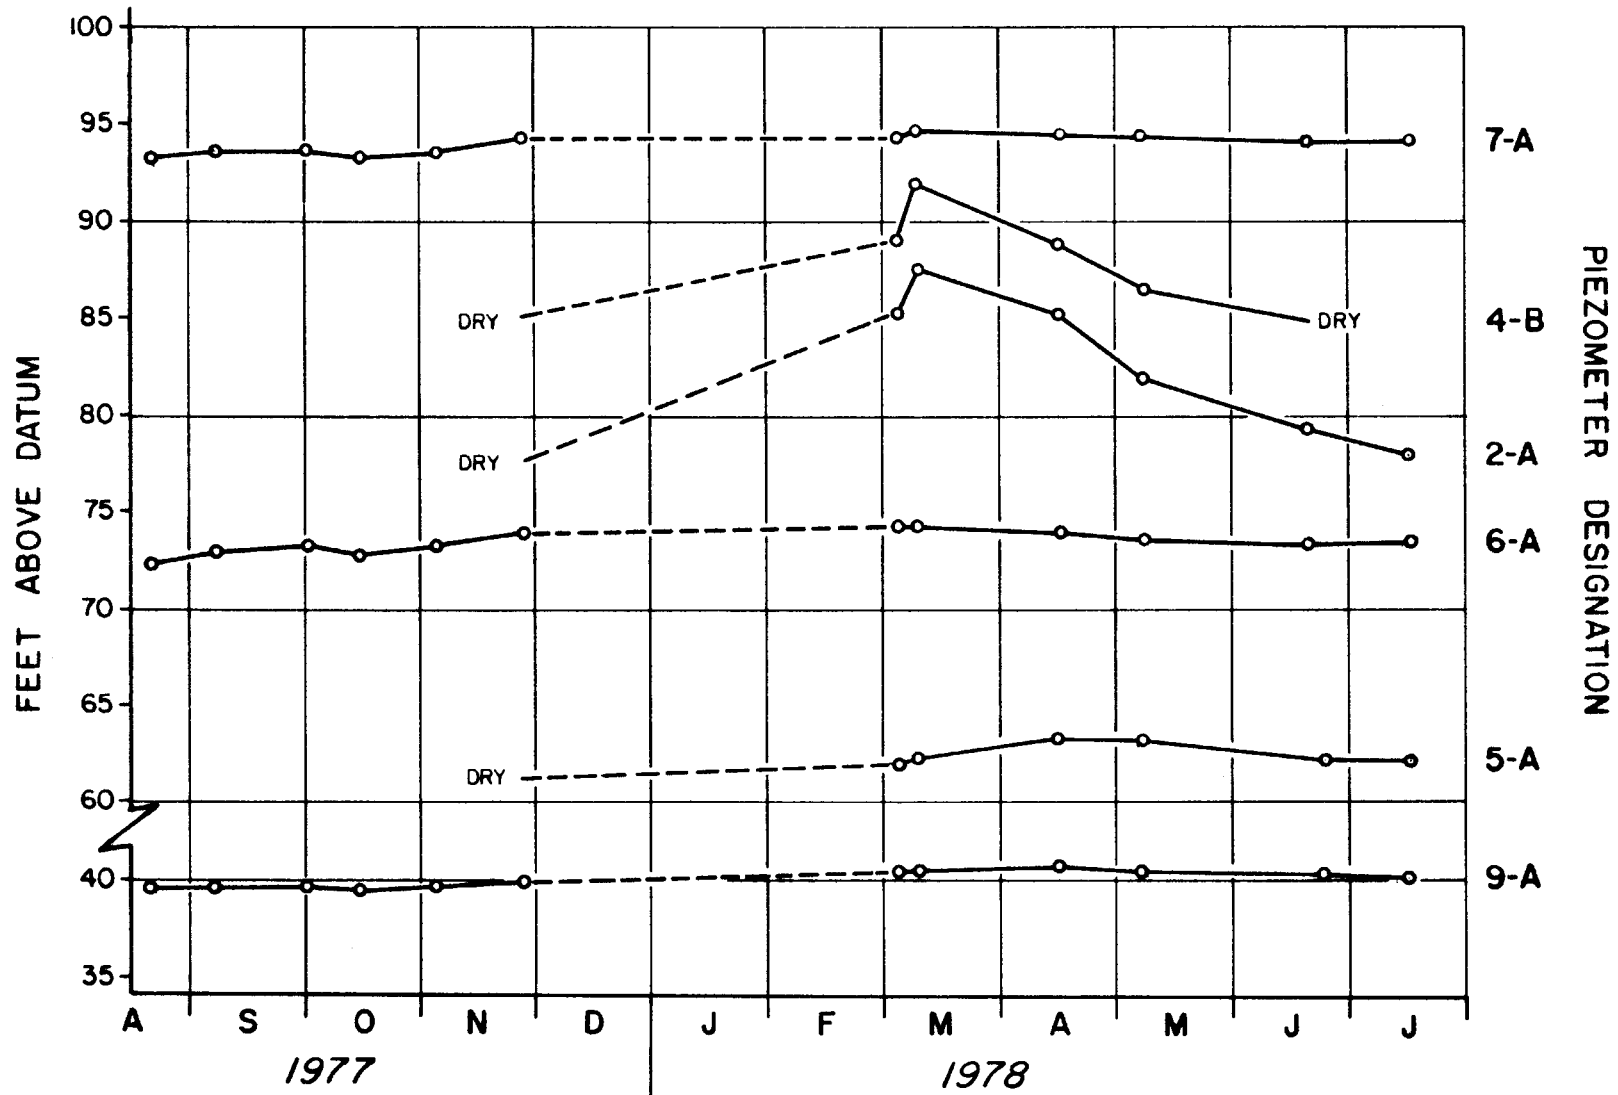
Figure 6. WATER LEVELS IN GALENA TAILING IMPOUNDMENT No. 3 PIEZOMETERS

Subsurface Hydrology. Piezometers were installed using either a portable 4-inch (10 cm) diameter auger or 2¼-inch flush-coupled casing with machined plastic drive points as described by Morilla (1975) and Norton (1979). All piezometers were constructed of 3/4-inch PVC with screened perforations along the bottom twelve inches (30.5 cm). Clean washed sand was used to backfill holes around screening, and bentonite seals were placed on top of each sand pack and at the ground surface. Figure 5 indicates piezometer positions on the pile surface and below the embankment toe. Water levels were measured using steel tape and chalk on twelve occasions during the summer and fall of 1977 and in the spring and summer the following year. See Figure 6 and Table 3.

Seasonal fluctuations are evident in all piezometers. Melt water from the winter snowpack on the pile surface and on the hillside tributary

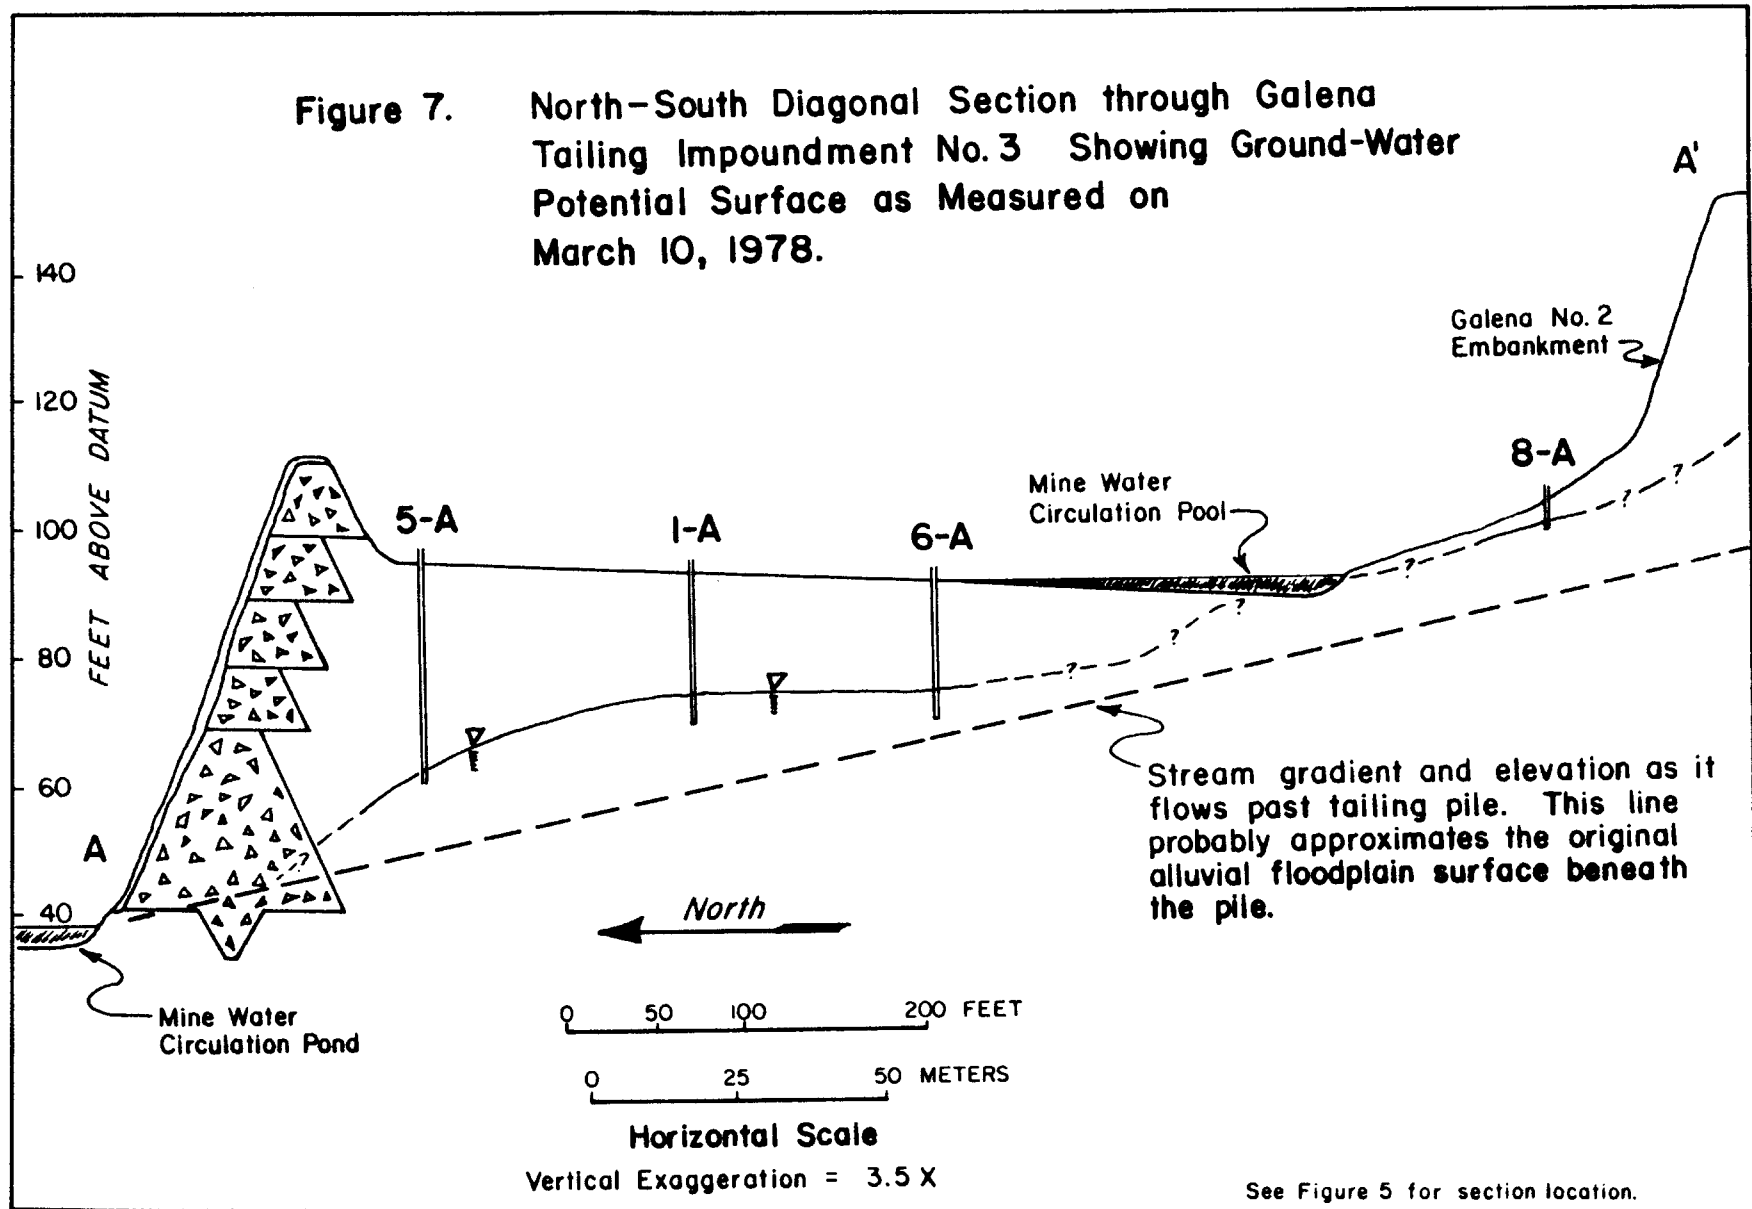
Figure 7. North-South Diagonal Section through Galena Tailing Impoundment No.3 Showing Ground-Water Potential Surface as Measured on March 10, 1978.

Some water probably enters the tailing pile as ground water recharge from Lake Creek as it reaches the pile. The permeable nature of the embankments allows movement of water into the less permeable tailing material within the pile, where ground water levels respond to seasonal changes in the flow of Lake Creek as well as to vertical recharge from precipitation. Figure 7 illustrates how this could occur. The position of Lake Creek as it flows past the tailing pile is indicated by a dashed line roughly parallel to the indicated phreatic surface. Lake Creek was displaced from the valley center when the tailing dikes were constructed, so a high-permeability zone of gravel and boulders can be expected somewhere under or inside the embankments. Ground water would be free to move along such a channel, and probably is recharged by infiltration losses from the upper section of Lake Creek along and above Impoundment No. 3. Ground water movement probably occurs from beneath Impoundment No. 2 as well.

No springs are visible along Lake Creek, but the coarse rip-rap lining the channel could allow ground-water discharge to occur undetected. Seeps are present along the downstream toe of the pile, discharging into the lower mine water circulation pond. Figure 8 shows a partly hypothetical view of ground water flow through the pile.

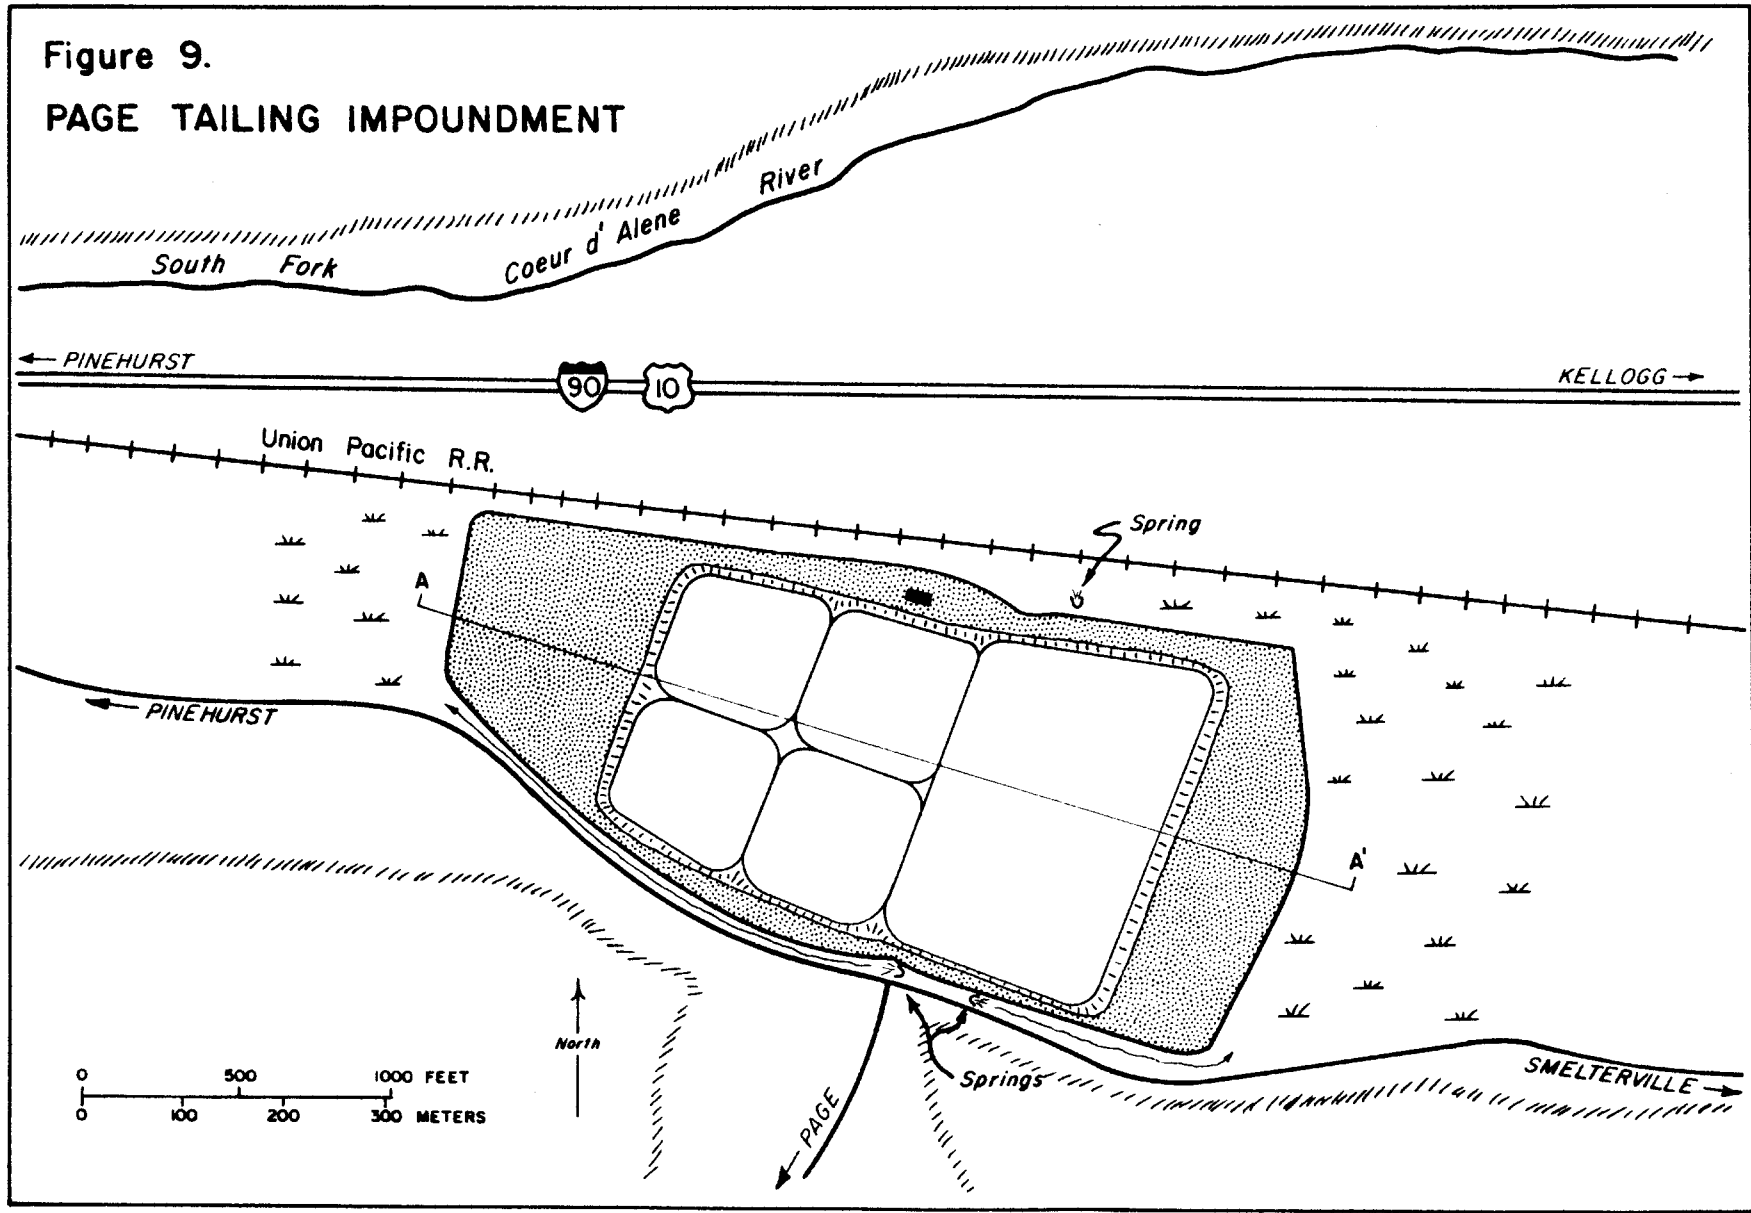
PAGE TAILING IMPOUNDMENT

Of more concern is the presence of a very wet zone within the embankment approximately 3 feet (1 meter) above the toe in the vicinity of the springs south of the pile (Figure 9). This could signal a rise in the phreatic surface within the embankment.

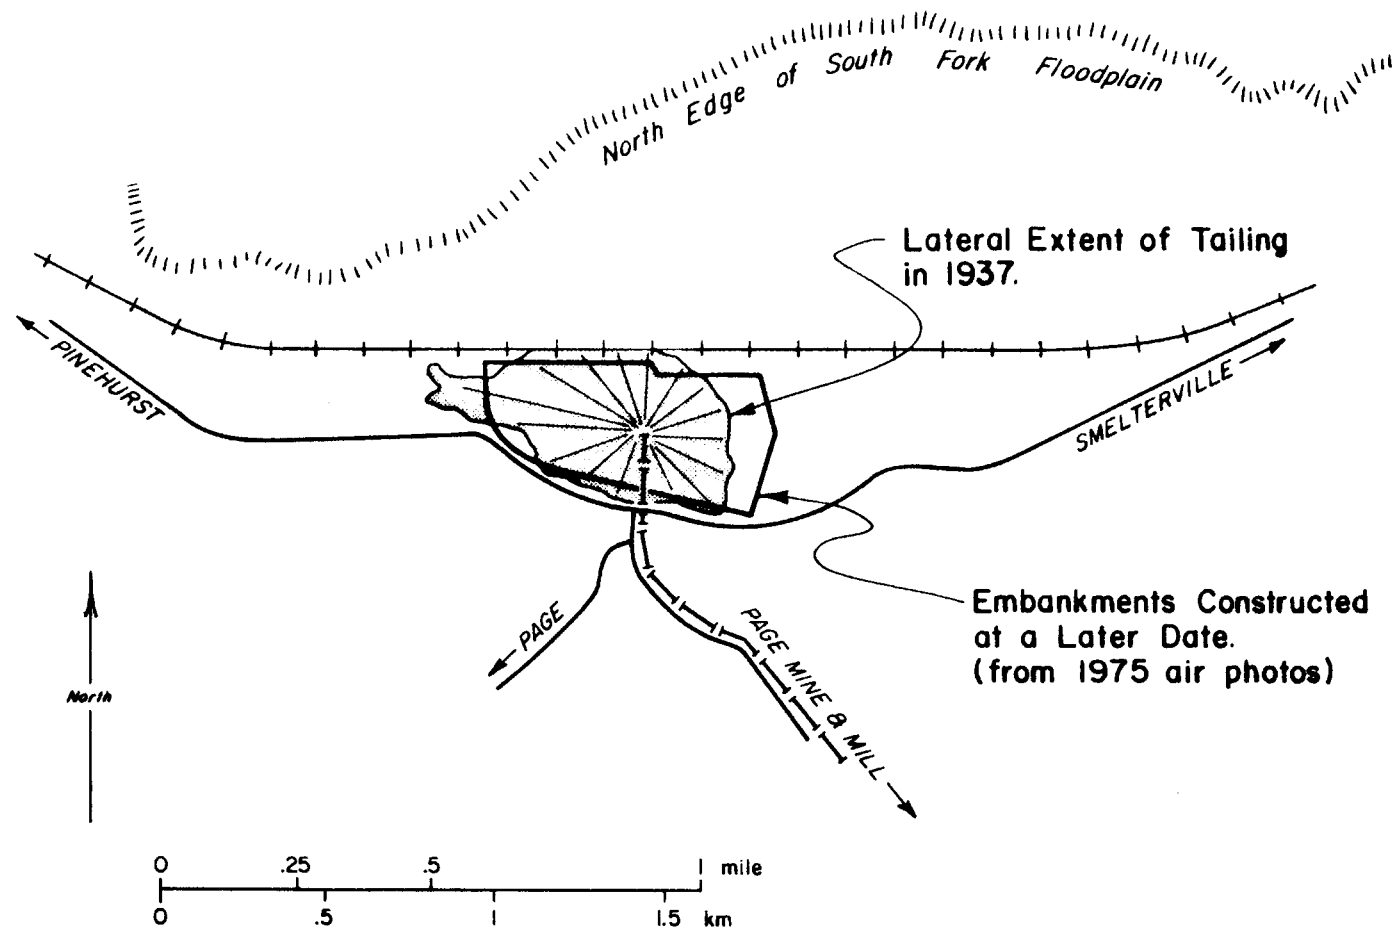
Figure 10. Location and Extent of Page Mill Tailing Prior to Embankment Construction.

The Page tailing pile, as it was abandoned in 1968, can be divided into two parts, east and west. A road separates the sections and forms the west embankment of the east pile. In 1948 embankments for enlarging

the west portion of the pile had been completed, and that section was used almost exclusively. The center embankment corresponds with the earlier location of the slurry pipeline and single-point discharge in 1939. Because sandfill was not used until 1956, it seems likely that the center portion of the entire Page tailing site is underlain by relatively permeable sand-size tailing. The dividing embankment and road were apparently built across this material.

Sand backfill was initiated in the operation of the mine in 1956. The tailing slurry reaching the impoundment since 1956 has been primarily a slime mixture as compared to the sandy slime mixture deposited earlier. Most of the east part of the pile and the bottom of the west pile are believed to be composed of coarser materials than the top of the west pile because of deposition prior to the initiation of sandfill operation (Morilla, 1975).

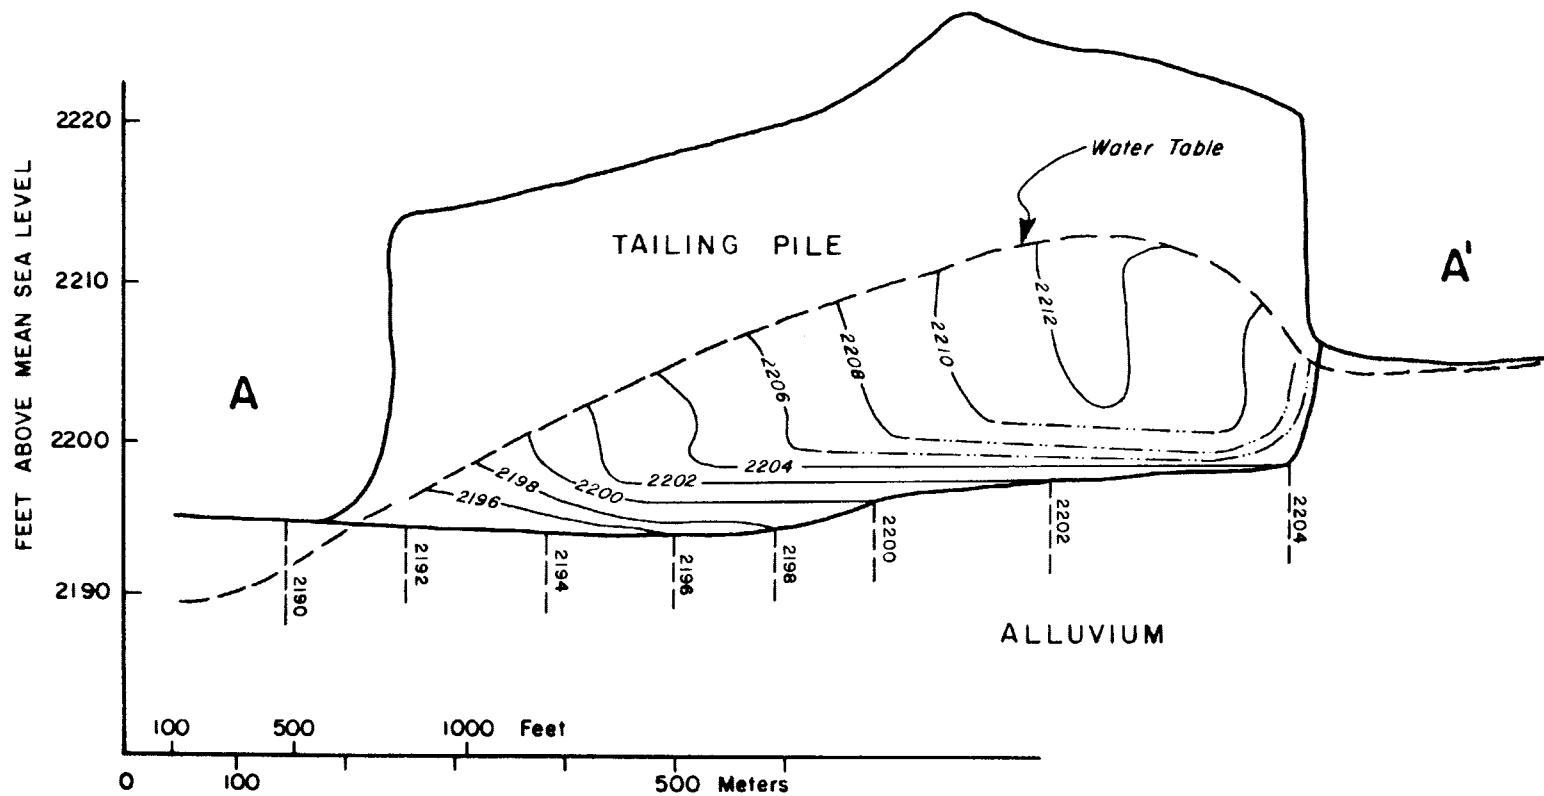
Figure II.

Ground-Water Potential Distribution within and below the Page Tailing Impoundment, 1974
Along East-West cross-section A—A'

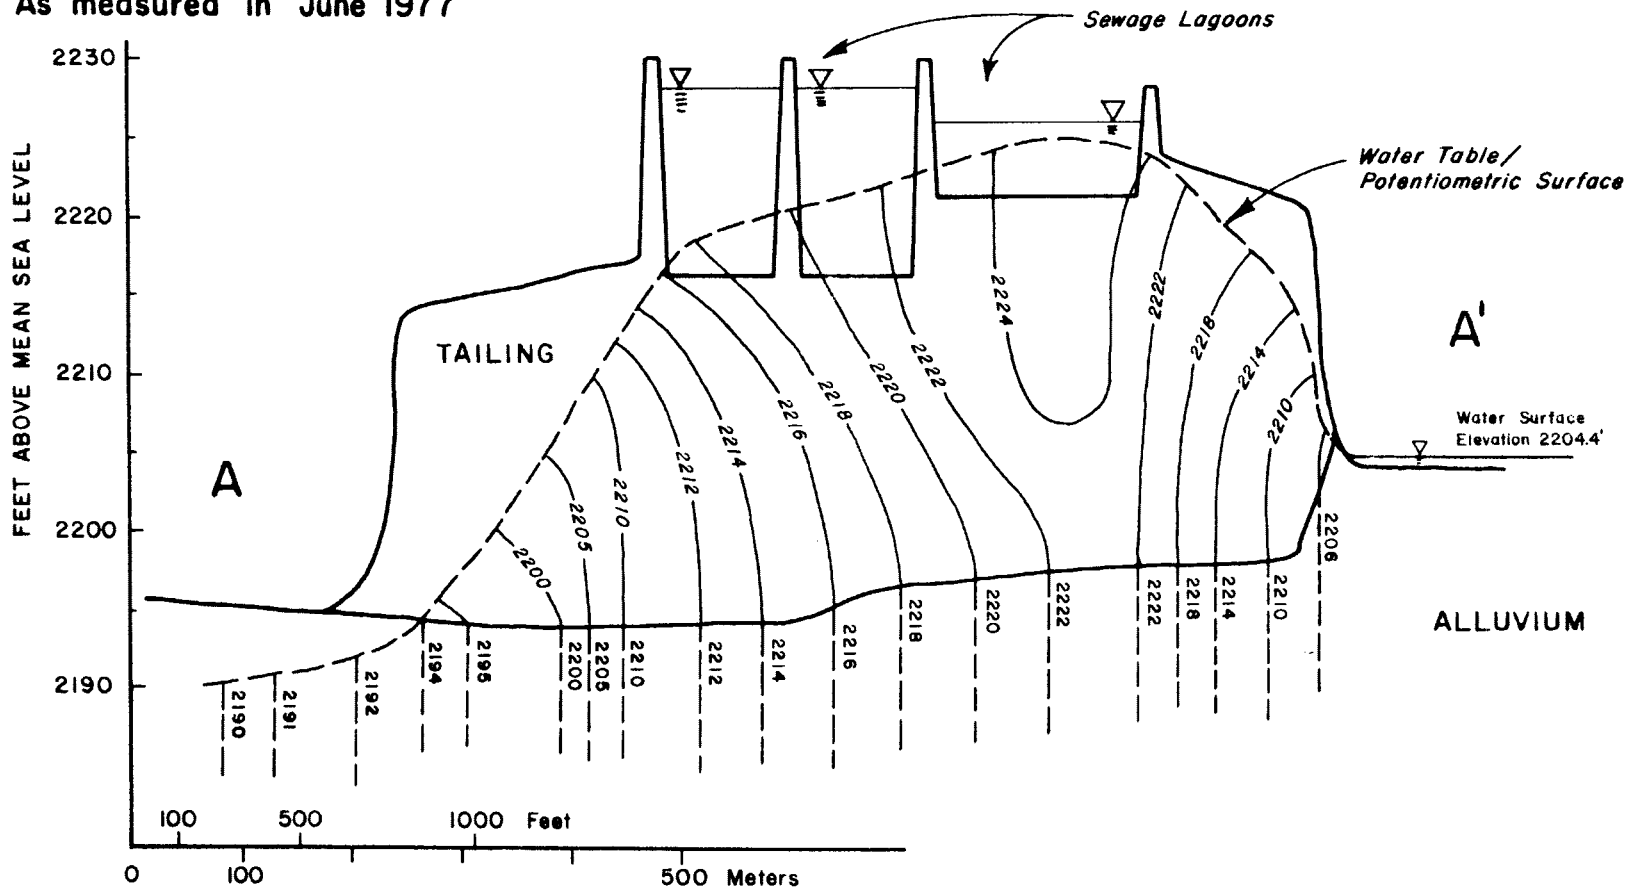
Figure 12.

Piezometers remaining on the pile surface and surrounding area were reexamined in June of 1977, and water levels were recorded. An inspection of ditches to the south and north of the pile revealed ground water discharges. Springs in the southern ditch contained fine tailing material which "boiled" at the discharge point and created underwater mounds. (See Figure 9.) Seeps were noted at and above the toe of the southern tailing embankment. These seeps contain some gray tailing and have precipitated an iron stain at the embankment toe just east of the access road and gate. Red stain also appears at the single spring below the north embankment. Figure 12 shows the potential surface as measured in June of 1977, reflecting the changes made by the construction of the treatment plant. The phreatic surface within the pile rose between 12 and 16 feet (3.7 meters and 4.9 meters) from 1974 to 1977. The potentiometric surface of water in the alluvium beneath the tailing pile rose a maximum of 20 feet (6.1 meters) during the same period.

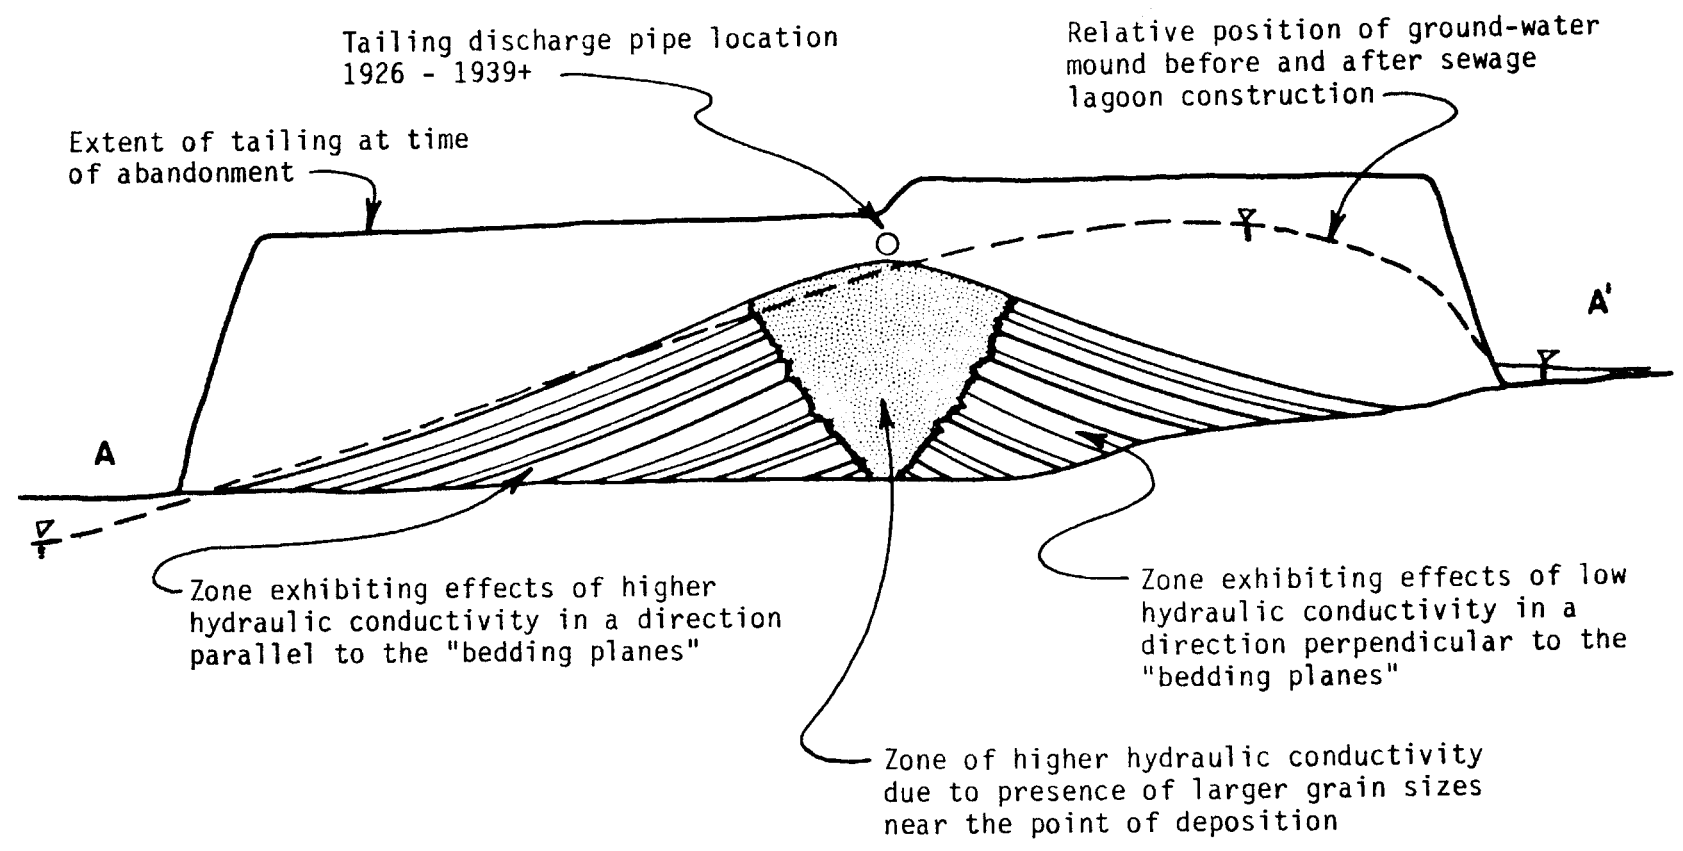
Figure 13. Generalized West-East Cross-section through the Page Tailing Pile Showing Changes in Hydraulic Conductivity.

Because of the technique of deposition of tailing in the early years of the pile's history, a mound of coarser tailing exists within the center of the present pile structure and exhibits some unusual hydraulic characteristics. (See Figure 13.) A cone of tailing was built up with a series of deltaic deposits which originated at the single-pipe discharge point. This would have resulted in a decrease in sediment grain size with distance in all directions from the apex, and probably in a "layering" effect as the cone grew. Alternating thin (1 cm to 10 cm) layers of fine sand and slimes (minus 200-mesh), if deposited in a flat environment, would tend to exhibit a horizontal hydraulic conductivity which may be much greater than the vertical hydraulic conductivity. Transferring this concept to the mounded tailing situation, the hydraulic conductivity in a direction normal to the "bedding planes" in the mound would be expected to be lower than the hydraulic conductivity of tailing in a direction parallel to the dip, or along any line drawn from the slurry discharge point. Morilla (1974) only measured vertical hydraulic conductivity using laboratory techniques, and assumed a constant value for this parameter throughout the pile.

The ground water mound under the eastern portion of the pile may be explained as a "ponding" of water against the relatively low-vertical-conductivity outside the slope of the original tailing cone. As the water reaches an elevation where coarser materials are encountered, the "ponded"

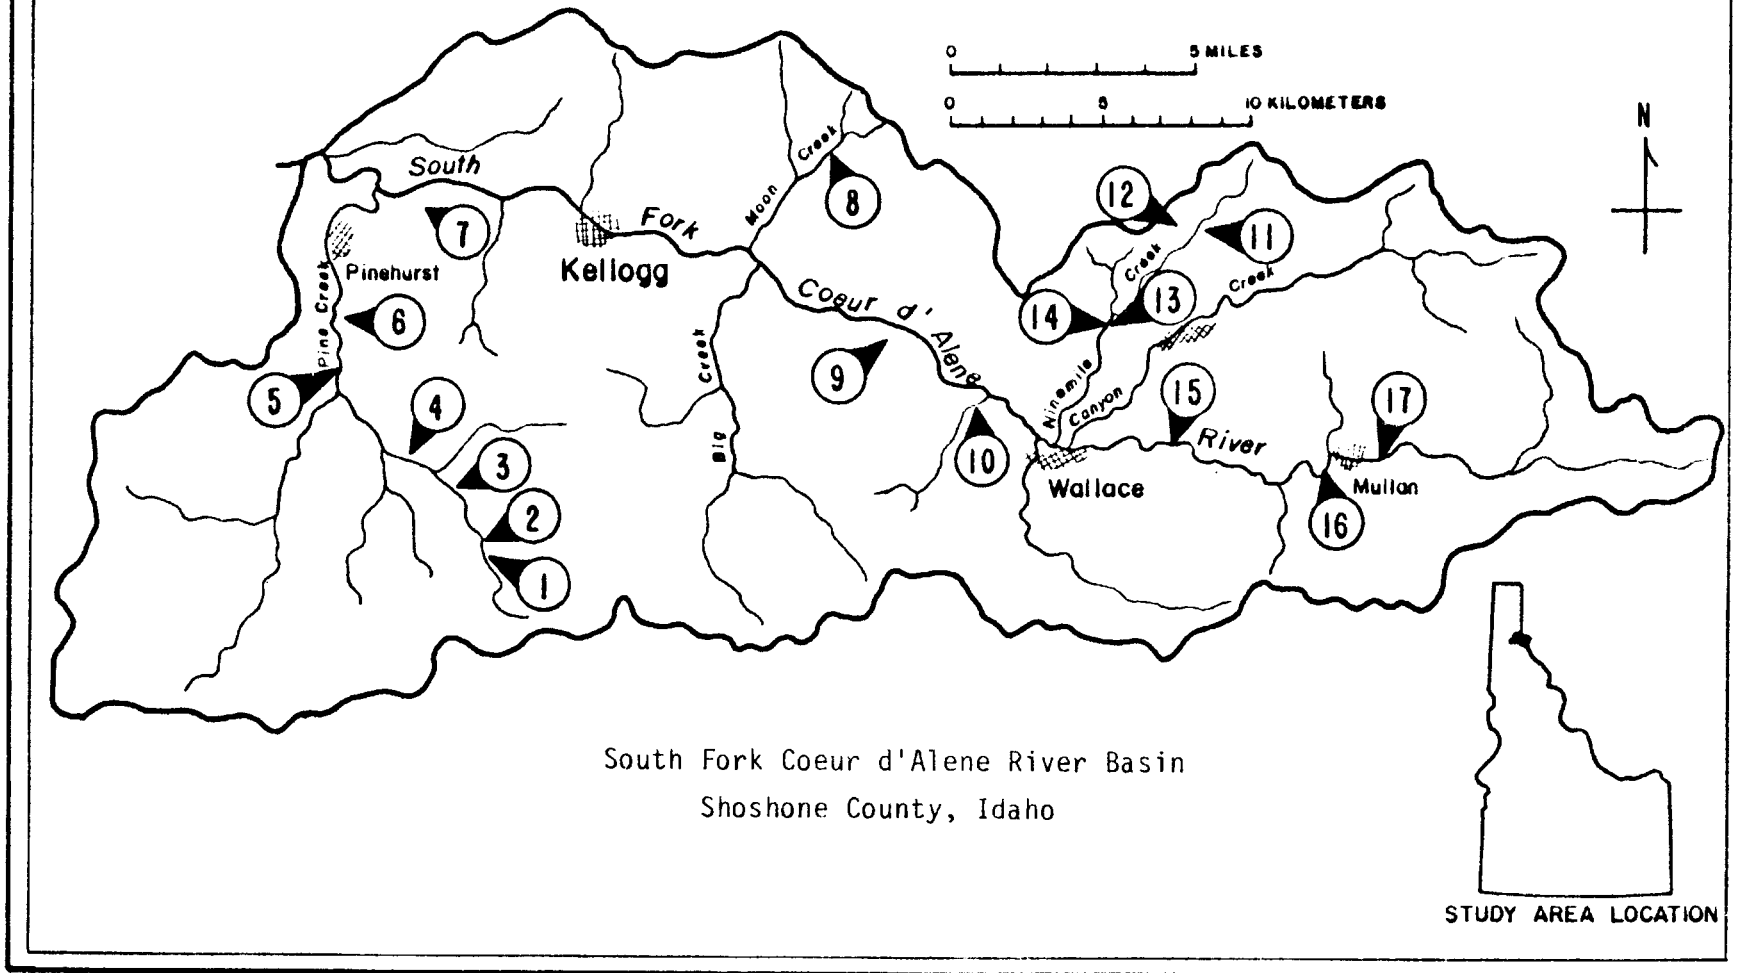
Figure 14.

An examination of the South Fork of the Coeur d'Alene River and its tributaries was conducted during the summer of 1978 to locate and identify all abandoned controlled tailing sites. Ground transportation, old air photographs and aircraft were employed to locate a total of seventeen sites (See Figure 14). These sites are examples of various degrees of site

abandonment. Sites 10 (Galena No. 3) and 16 (Lucky Friday No. 1), which were selected for detailed study, have recently raised embankments and are ready to receive tailing. Both serve active mills which have alternate tailing disposal sites, but neither had received tailing on a regular basis for at least a year prior to June 1977. These sites remain "abandoned" only until the mining companies require their use. Representing the other end of the spectrum is Site 4, which is a small accumulation of tailing in the braided floodplain of the East Fork of Pine Creek. Whatever mill produced the tailing no longer stands, and only faint remnants of embankments have survived the series of seasonal floods from which the site has no protection. This site is not likely to be of any use for future tailing disposal, due to its precarious location. The tailing would be of little economic interest to a mining company, even if metals concentrations were high, because of the small volume involved.

Remaining sites vary widely in size, color of material, slope stability, proximity to actively eroding streams, vegetative cover, potential for structural failure, and evidence of water quality degradation. Detailed descriptions and locations for each site included in the inventory are given in Appendix A.
