PAYETTE NATIONAL FOREST

EVALUATION OF
MCCALL DISTRICT ADMINISTRATIVE SITE

DOCUMENTATION AND
DETERMINATIONS OF ELIGIBILITY

FINAL REPORT

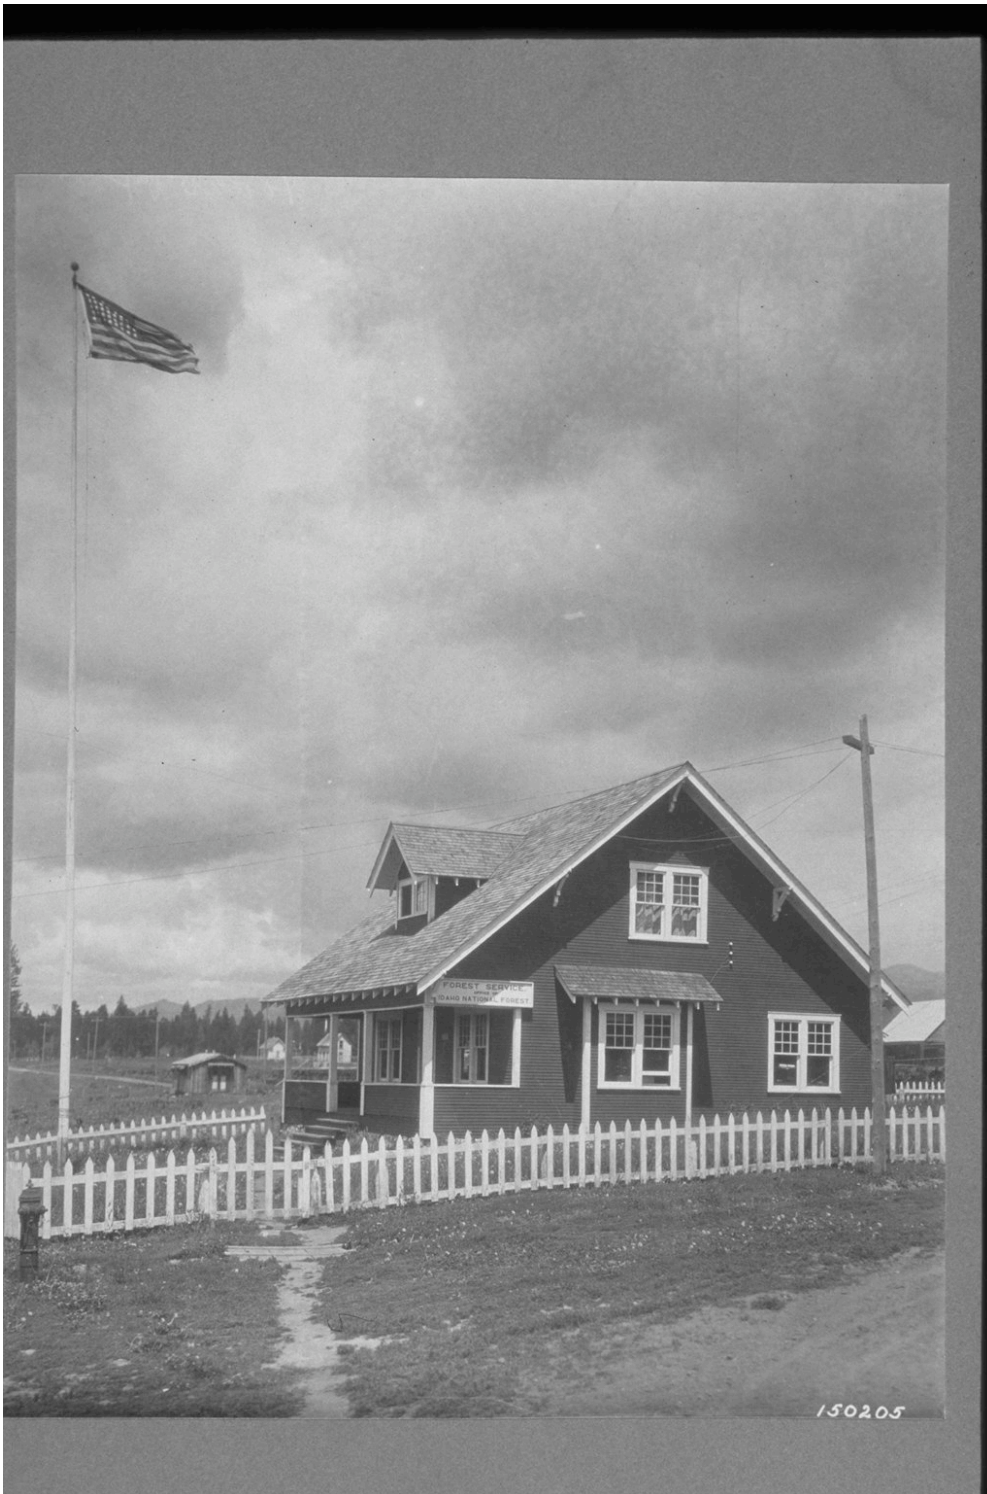
Figure 3. The first Supervisor's Office on the McCall site, c. late 1920s. This building was removed or relocated in the mid-1930s.

Beginning in 1933 several structures were built at the McCall District Administrative Site. Earlier structures were removed, replaced or upgraded. The original office [see Figure 3] was replaced in 1936. During 1936 through 1939 CCC workers helped build a barn, warehouse, machine shop, and cellar. CCC labor was also used to construct a water system and landscape the grounds. By 1956 two CCC built structures had been moved to the McCall Administrative site from the Price Valley Ranger Station (Heritage Program 1991: Section 8 pp. 3-4).

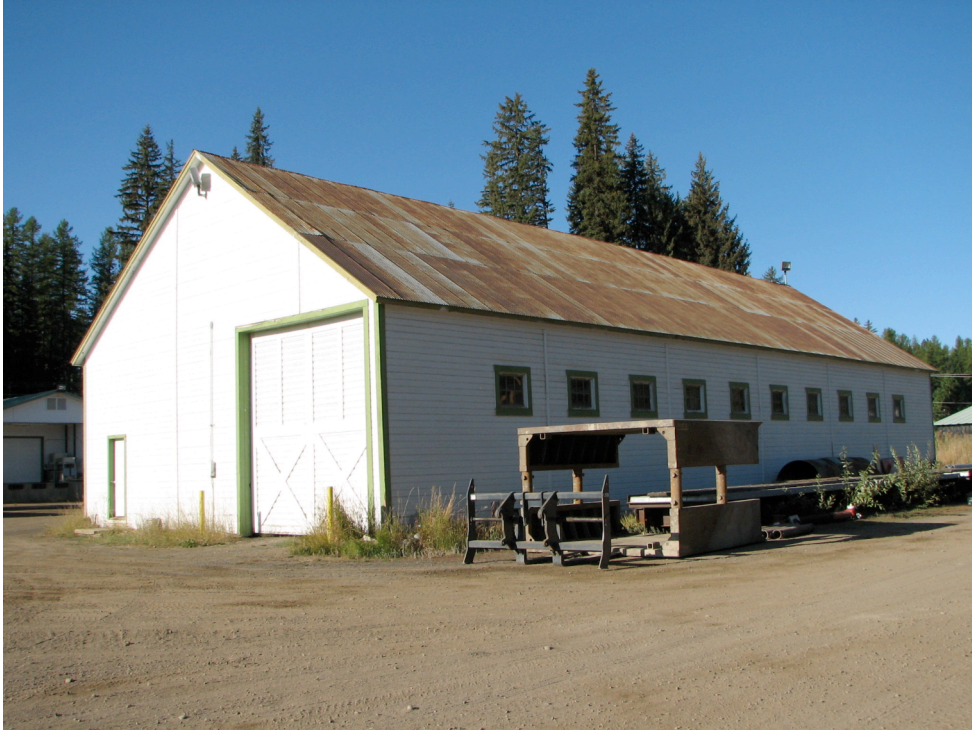
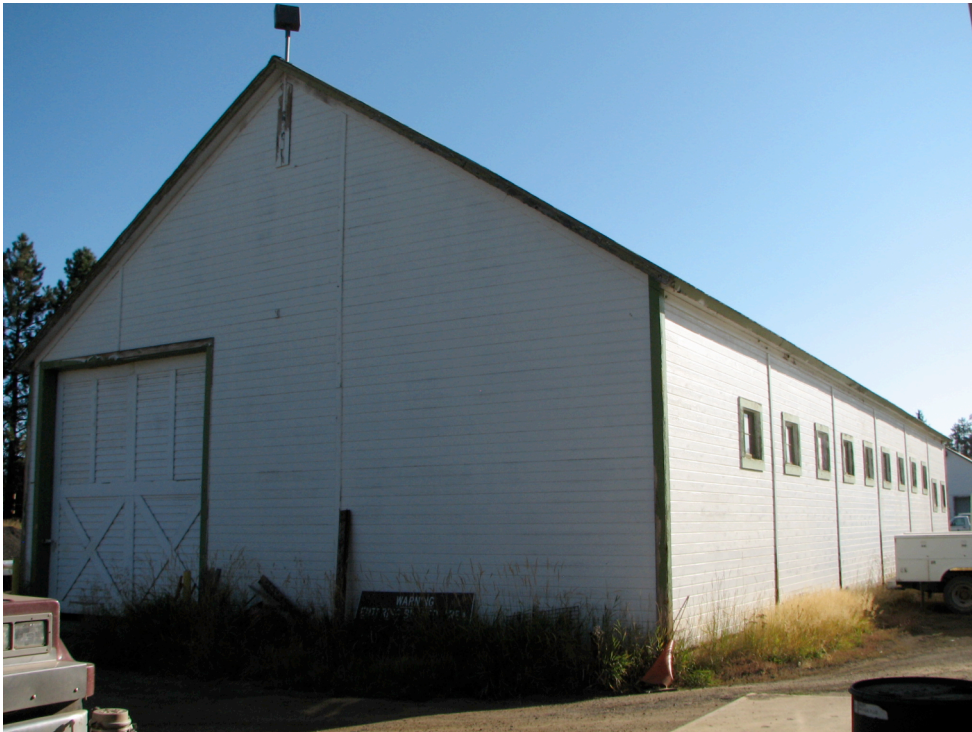
Figures 4a and 4b. The east and north sides (top) and the west and south sides (bottom) of Building A, the Hay Barn (#1320), McCall District Administrative Site, 2008.

Building A, the Hay Barn, is located near the center of the western boundary of the McCall District Administrative Site (see Figure 2). The one-story, rectangular, wood-framed building was constructed in 1934 and was considered a contributing resource to the NRHP site in 1991. Since then, the original wooden novelty siding has been encased in Masonite siding with battens over vertical joints and the window and door casings have been deepened as a result of the increase in wall thickness. However, the treatment is reversible and the building otherwise retains integrity of location, setting, and feeling. Integrity of materials and workmanship is intact for all building elements except the siding. Thus the Hay Barn remains a contributing resource to the site in 2008.

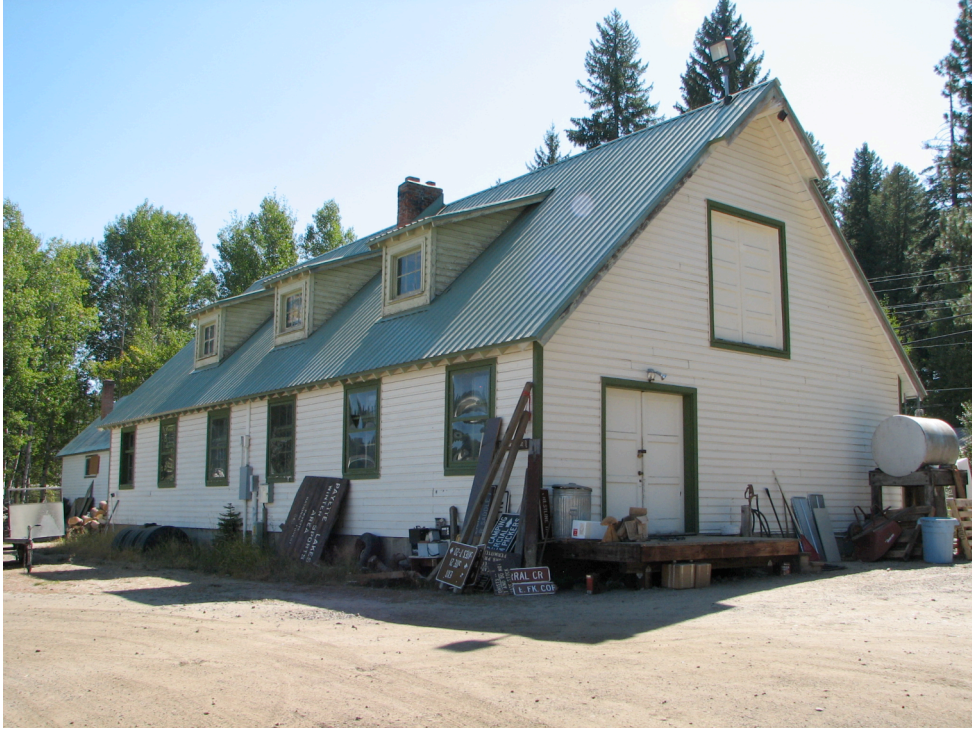
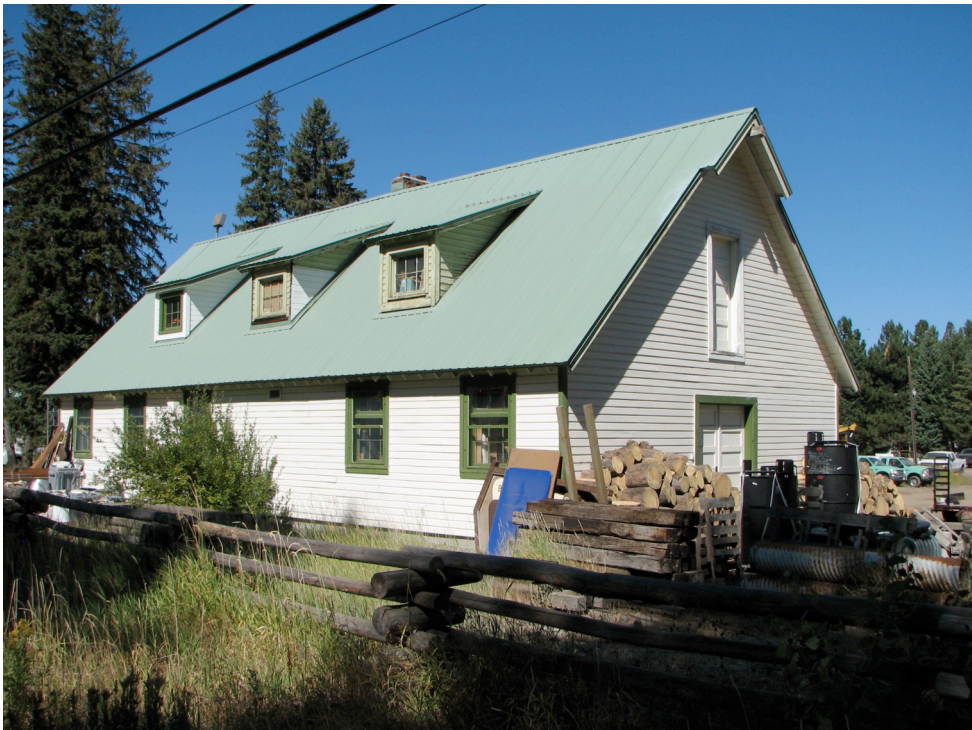
Figures 5a and 5b. The north and west sides (top) and the south and east sides (bottom) of Building B, the McCall District Warehouse (#1503), McCall District Administrative Site, 2008.

In 1991, the McCall District Warehouse had been relatively unaltered since it was moved to the site in 1961, when the open nursery bays were enclosed. Despite this major change, the building was deemed a contributing resource to the historic McCall District Administrative Site. Regarding changes since 1991, encasing the original (and/or 1961) siding and its lead-based paint in like material complies with the recommendations of the *Secretary of the Interior's Standards for Rehabilitation*. The use of Masonite siding to encase one and one-half of the dormers and to box an originally open eave does not comply with *Standards* but these are relatively minor, reversible changes that do not significantly diminish the material integrity of the building. The replacement of the corrugated metal roof with a green, ridged metal roof again does not comply with the *Standards* but the material and style of the original roof covering (and whether or not the corrugated metal roof had achieved historic status in its own right) requires further research, and the diminishment in material integrity is not sufficient to change the status of the building from a contributing to a non-contributing resource. Importantly, the PNF's approaches are reversible: the original novelty siding remains beneath the present mixture of wood and Masonite siding and in the future it can be re-exposed and repaired. Also, evidence of earlier roof coverings probably remains under the present metal roof and, with research, the original roof covering can be recreated in the future. The warehouse otherwise retains integrity of design, setting, feeling, and association, and also integrity of materials and workmanship for all building elements except the siding (i.e., 1961 foundation, 1939 eaves, doors, and windows).

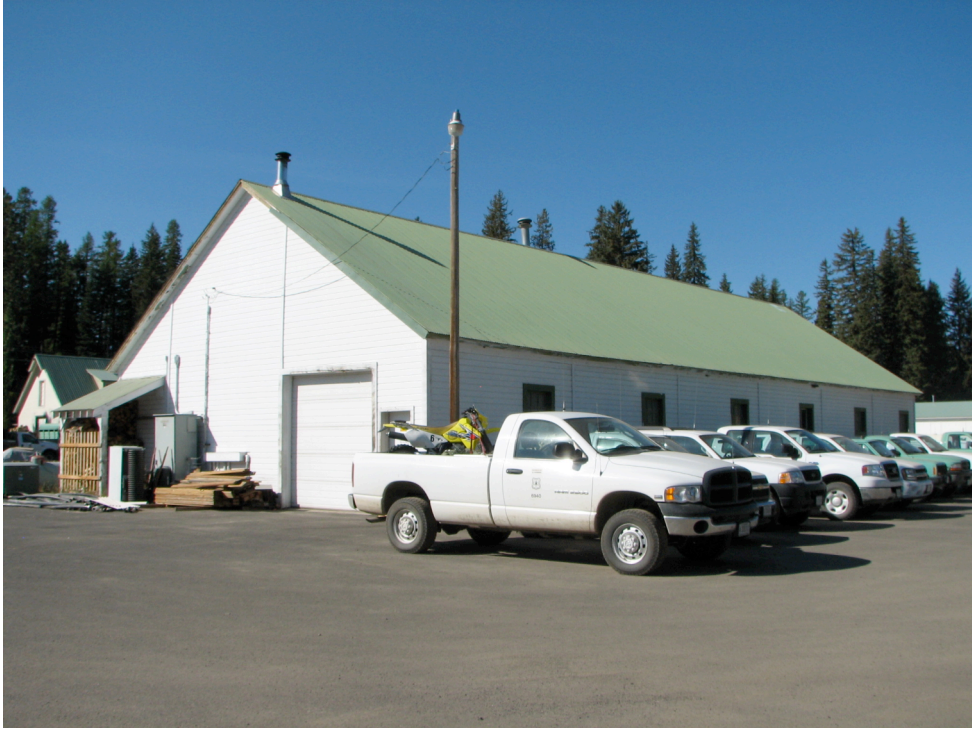
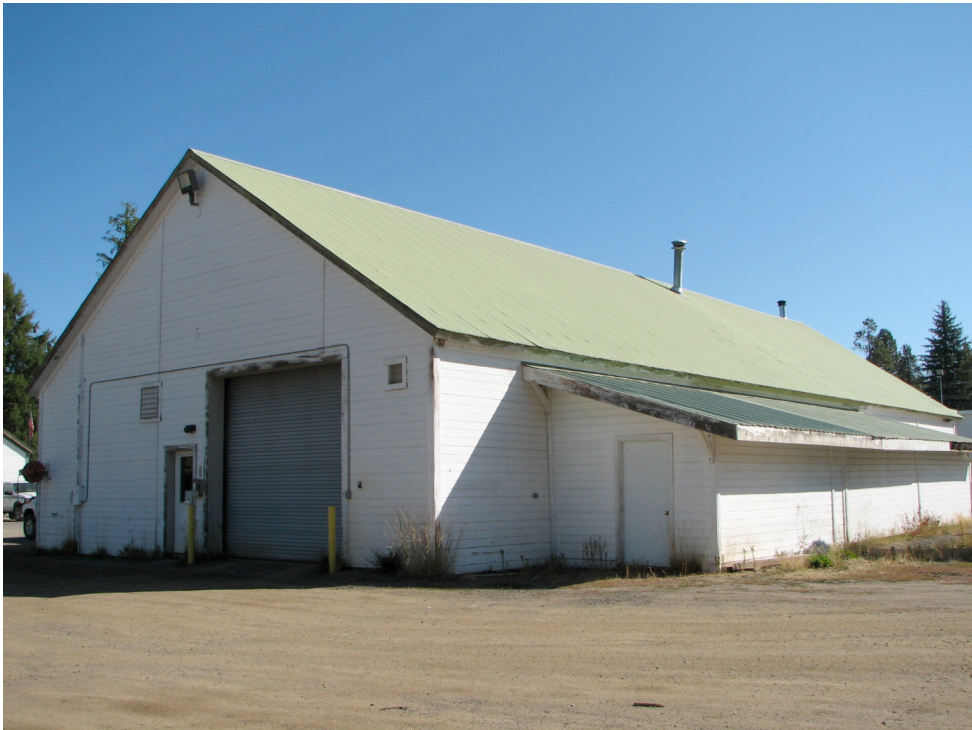
Figures 6a and 6b. The east and north sides (top) and the west and south sides (bottom) of Building C, the Carpenter Shop (#1336), McCall District Administrative Site, 2008.

siding and in the future it can be re-exposed and repaired. Also, the Carpenter Shop retains integrity of location, other important elements of design, setting, feeling, and association. The new siding and metal roof on the south shed addition has helped to make the addition more compatible with the original building. Thus, despite significant alterations, the Carpenter Shop remains a contributing resource to the historic McCall site in 2008.

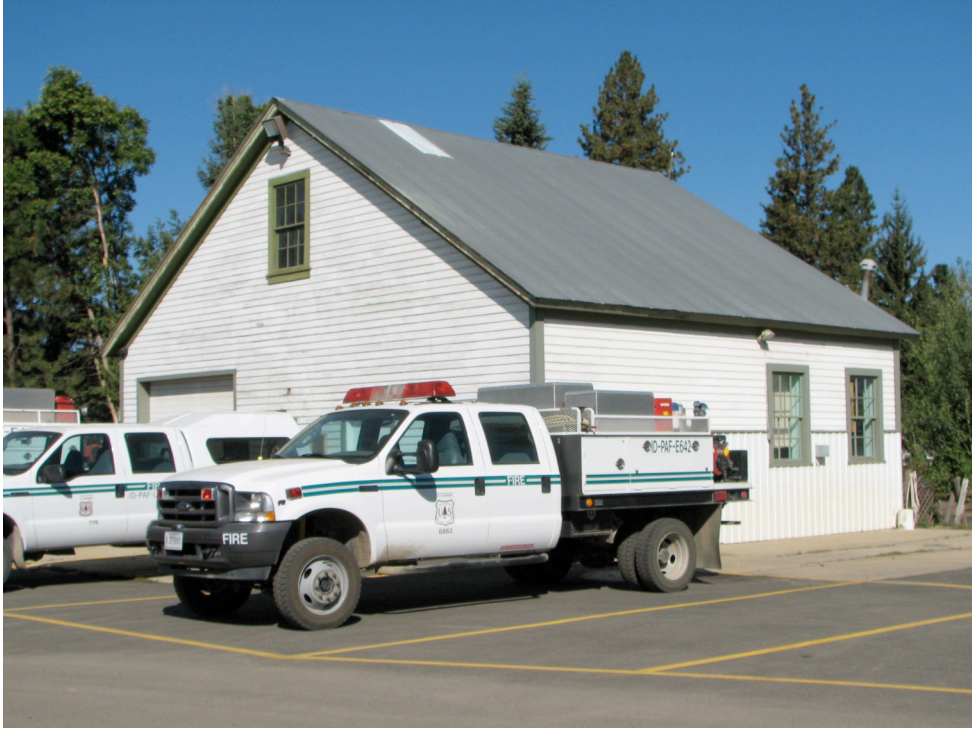
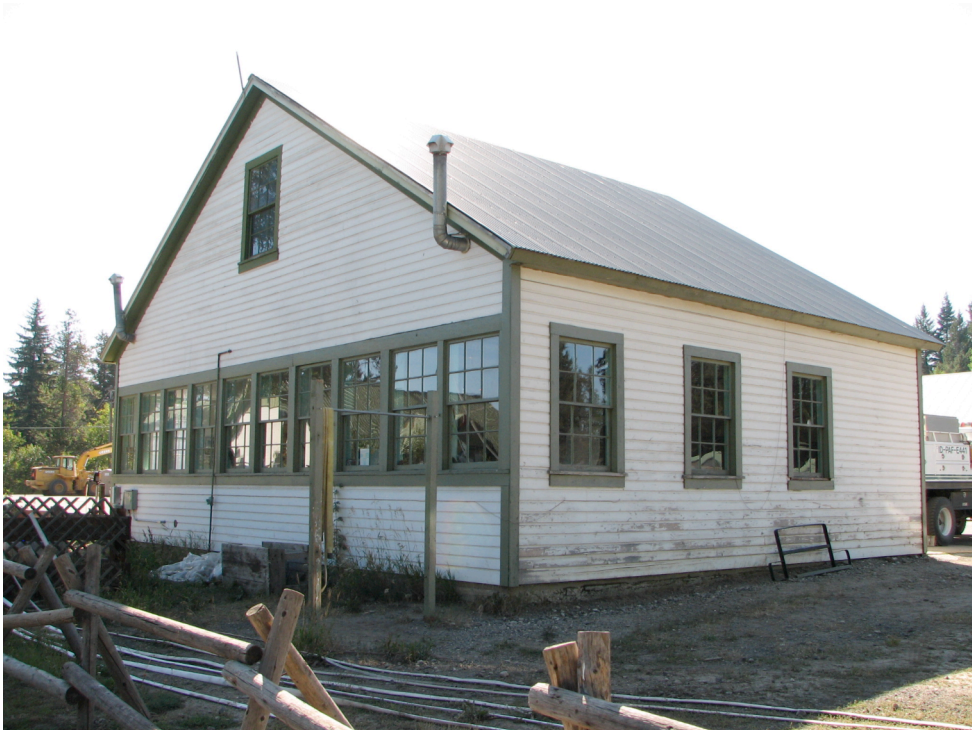
Figures 7a and 7b. The south and east sides (top) and the north and west sides (bottom) of Building D, the Engineering Facility (#1504), McCall District Administrative Site, 2008.

By 1991, the Engineering Facility had been significantly altered from its original design with the removal of one garage door on the south side and its replacement with two man doors, as well as the removal of a window on the east side. However, the building retained enough integrity to be considered a contributing resource to the historic McCall District Administrative Site. Since 1991, changes have been limited to encasing the original wood siding with like material, protecting the east side wall base with metal paneling, and removing the non-historic cinderblock chimney. The Engineering Facility retains integrity of location, design, setting, materials, feeling, and association, and remains a contributing resource to the historic McCall site in 2008.

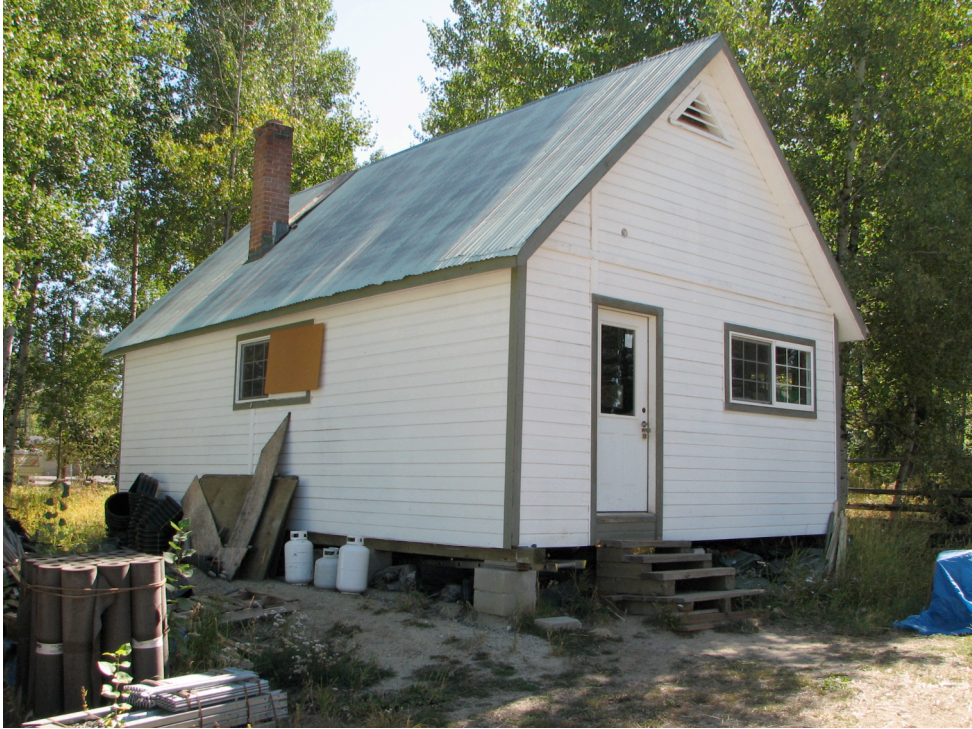
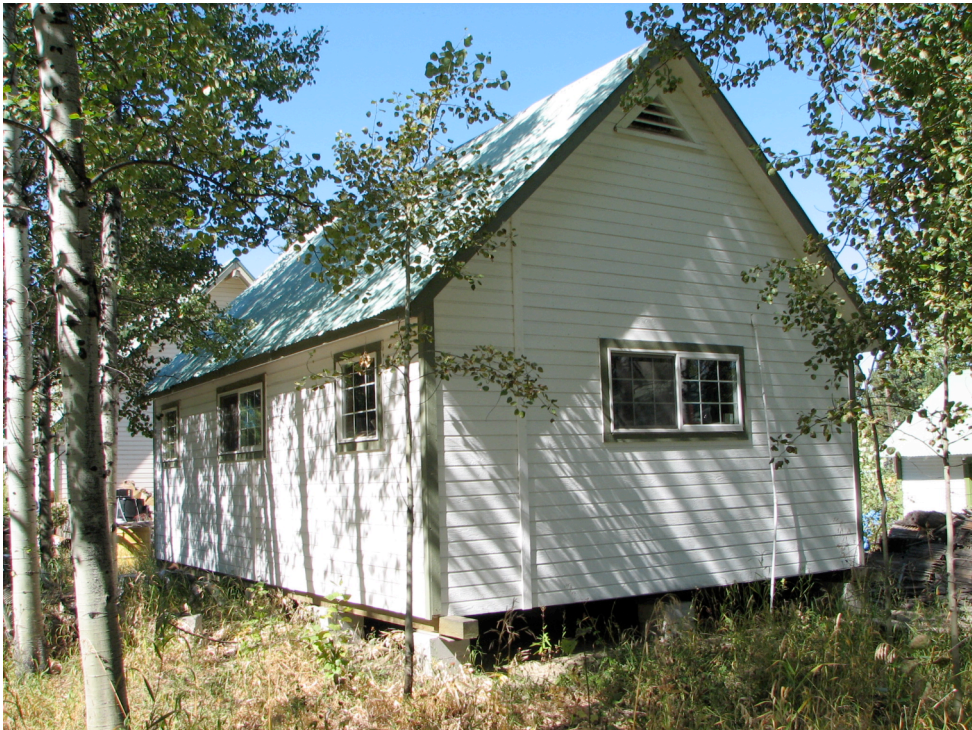
Figures 8a and 8b. The north and west sides (top) and the south and east sides (bottom) of Building E, the Krassel Warehouse (#1205), McCall District Administrative Site, 2008.

In 1991, the Krassel Warehouse had been relatively unaltered since it was moved to the site in 1952 (which may have been the time when the porch was enclosed, the door and windows on the façade were brought forward into the new wall, and the side door was converted to a window) and the building was deemed a contributing resource to the historic McCall District Administrative Site. The relocation of the building in 1996 had no adverse effect on its contributing status. However, changes since 1991 have had a significant impact on the building's integrity of materials, workmanship, and feeling. The *Secretary of the Interior's Standards for Rehabilitation* recommend the repair of deteriorated material rather than replacement, meaning that the most appropriate treatment for the siding, windows, and door would have been the removal and abatement of the lead paint, the repair of deteriorated sections of wood, and repainting with historically accurate colors. But the costs associated with lead abatement prohibited this type of treatment; encasement of the damaged and hazardous historic siding and removal and replacement of the door and windows was the chosen option. When replacing historic materials (and, by extension, encapsulating them), the *Secretary's Standards* call for replacement "in kind," meaning that to retain the integrity of the Krassel Warehouse, the original lap siding (or more likely beveled lap siding) should have been encased in wood lap siding to match the original and joints should have been staggered (rather than aligned and then covered with battens). As well, the windows should have been replaced with six-light wood windows, with wood casings recessed in the wall plane and trim to match the original. The door should have been replaced with a wooden, glazed door of like appearance (or with a wood door matching that drawn in the standard plan if research revealed that the plan had been followed).

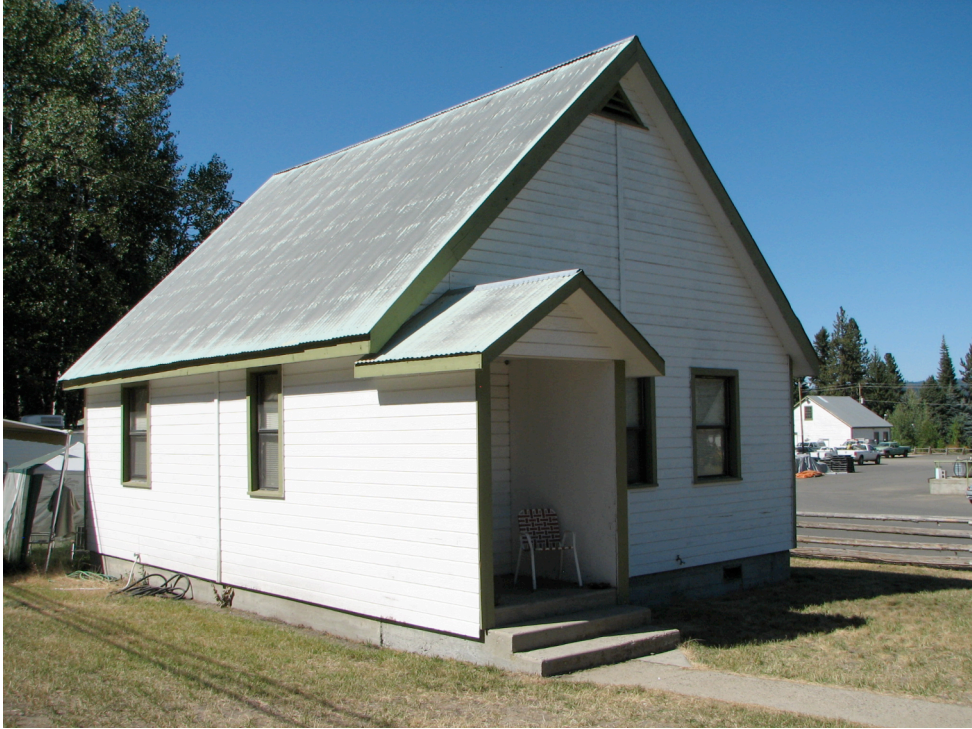
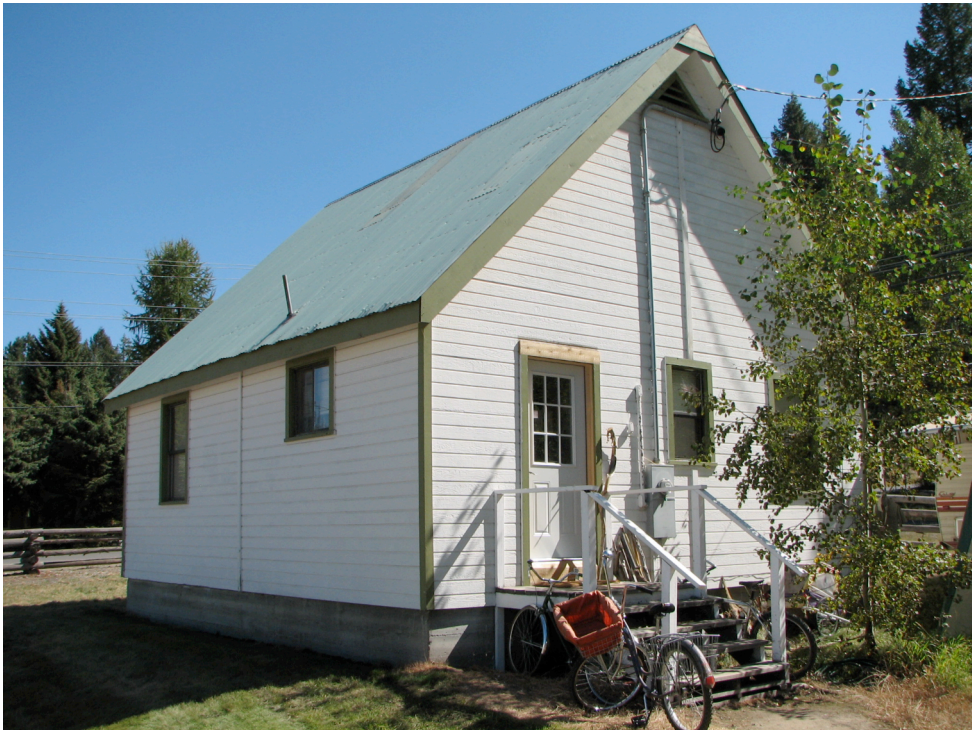
Figures 9a and 9b. The south and east sides (top) and the north and west sides (bottom) of Building F, the Bunkhouse (#1135), McCall District Administrative Site, 2008.

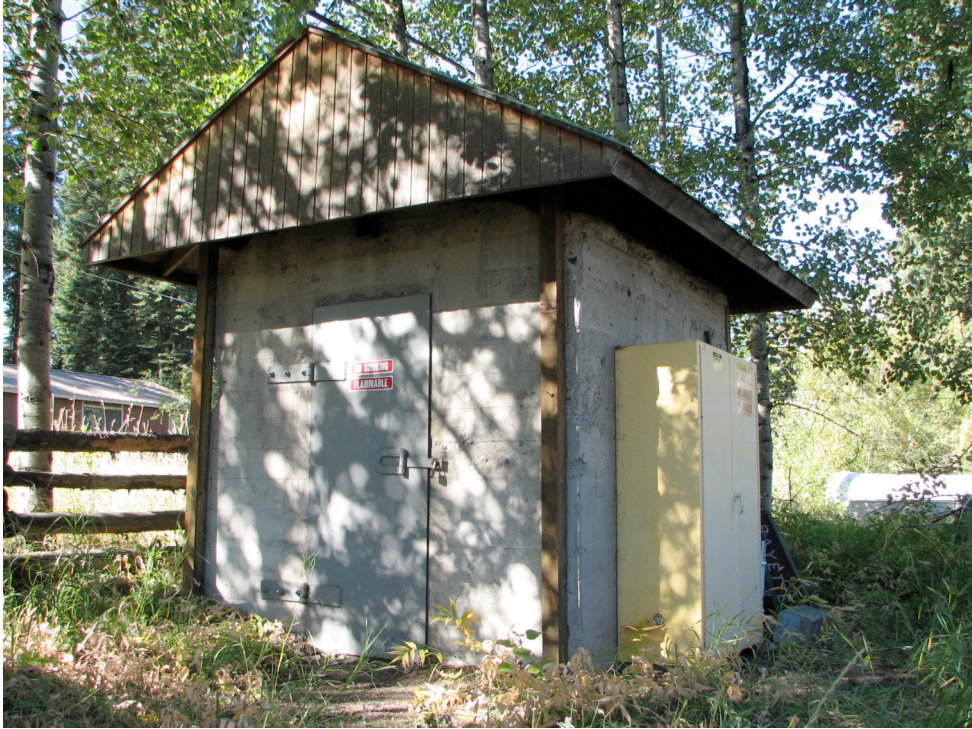
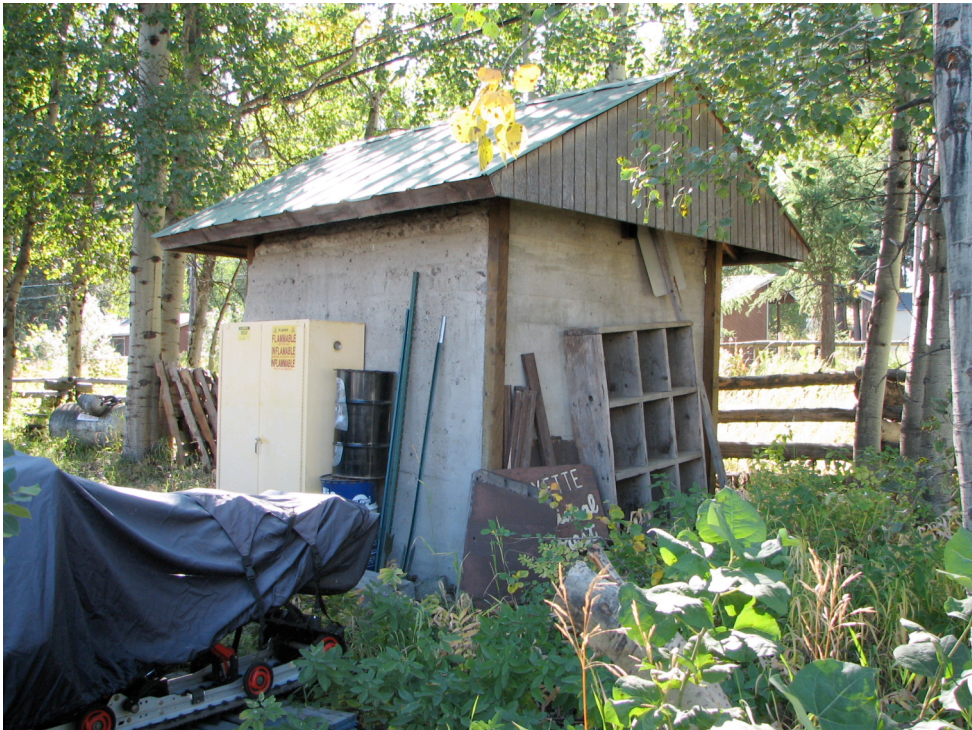
Figures 10a and 10b. The east and north sides (top) and the north and west sides (bottom) of Building H, the Cap House (#1378), McCall District Administrative Site, 2008.

In 1991, the Cap House was considered a contributing resource to the historic McCall site. The only significant change since then has been the addition of a gable-roofed shelter over the building. While this diminishes the historic feeling of the building and partially obscures its design and materials, it is a necessary and reversible interim measure to preserve and protect the deteriorating concrete. The building otherwise retains integrity of location, design, setting, materials, workmanship, and association, and it remains a contributing resource to the McCall site in 2008.

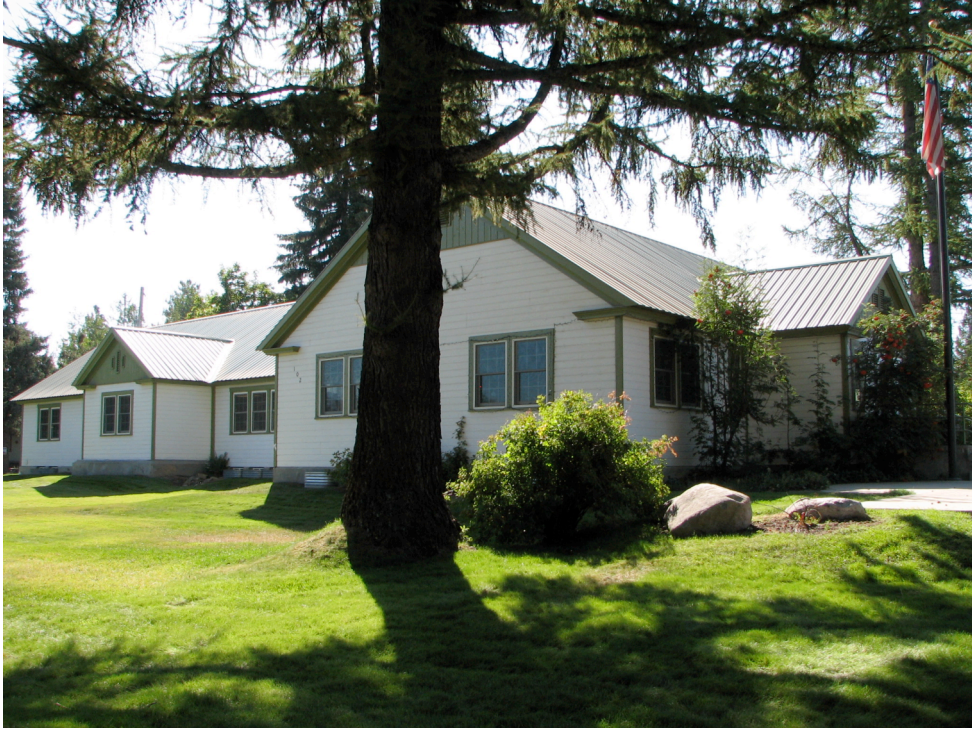
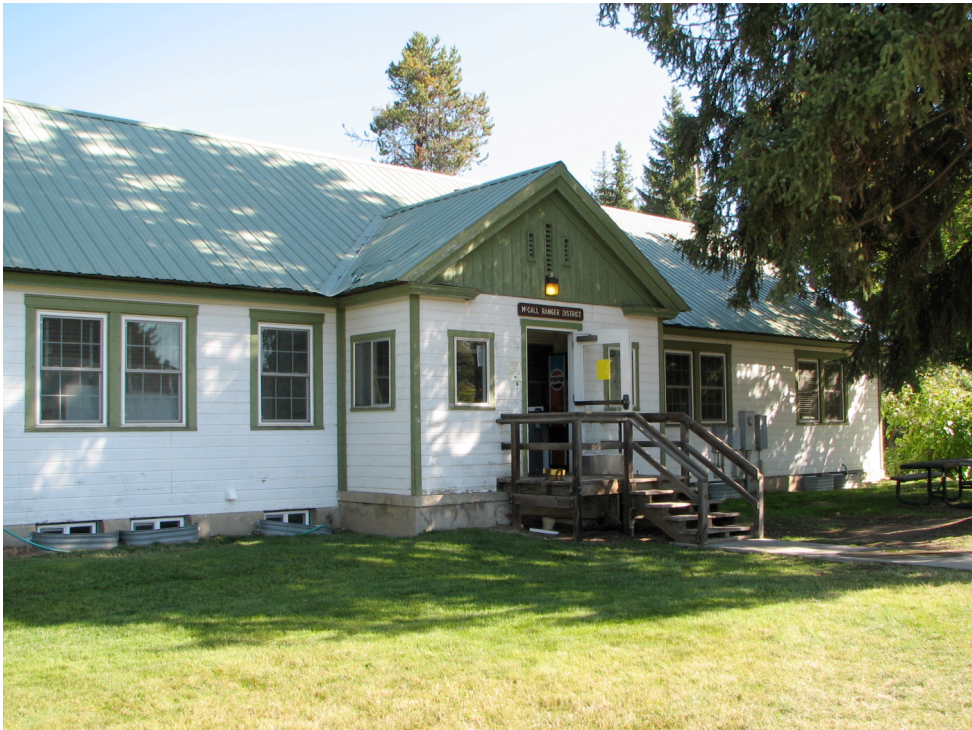
Figures 11a and 11b. The north and west sides (top) and the south side (bottom) of Building I, the McCall District Office (#1201), McCall District Administrative Site, 2008.

In 1991, Building I was considered a non-contributing resource to the McCall District Administrative site due to significant non-historic alterations, including the enclosure of the north and south porches, the installation of composition or asbestos clapboard siding in place of the original novelty siding, and the removal of the pine tree-logo shutters. The building has retained its non-contributing status throughout subsequent Section 106 evaluations, and recent alterations and additions have further distanced the building from its original appearance. Significant changes since 1991 include the construction of a small east addition and a large west addition, the replacement of the original north entry with windows, and the shifting of the main entry to the west addition. The McCall District Office remains a non-contributing resource on the McCall site in 2008.

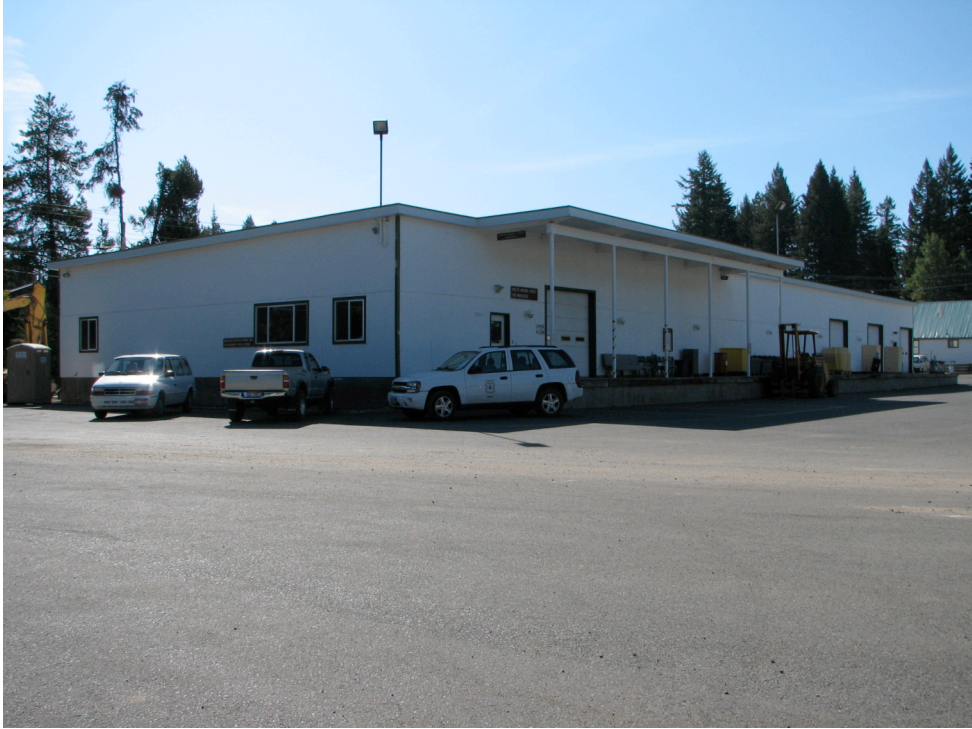
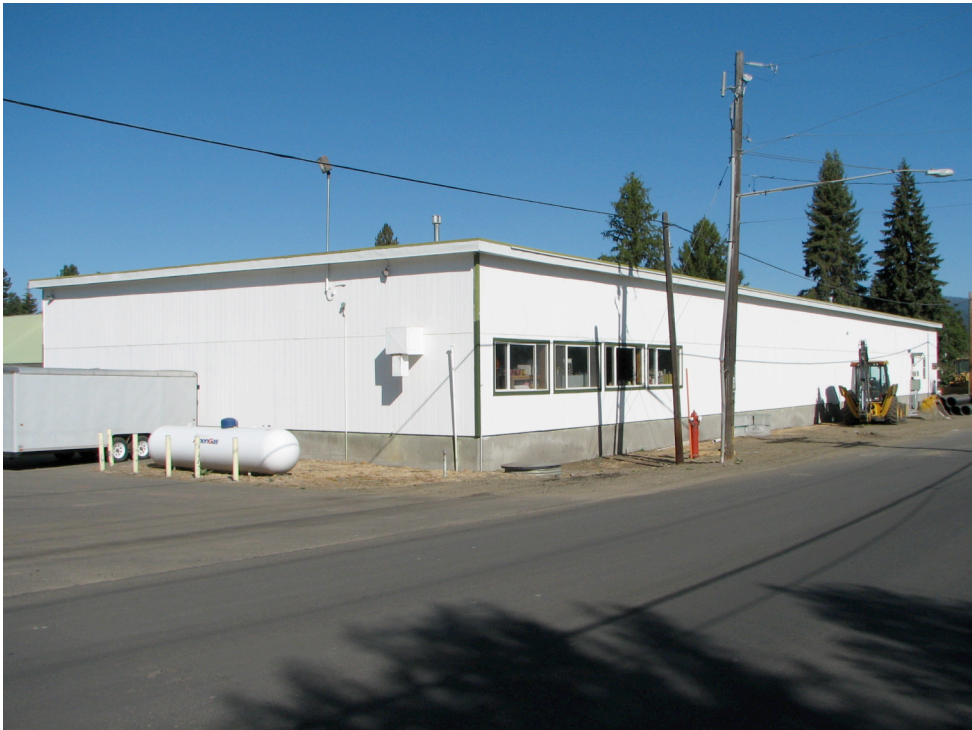
Figures 12a and 12b. The north and west sides (top) and the south and east sides (bottom) of Building J, the Fire Warehouse (#1304), McCall District Administrative Site, 2008.

The Fire Warehouse was considered a non-contributing resource to the McCall site in 1991 due to its recent date of construction. Today, the building is nearly of historic age and falls just within the second period of significance for the site (1942-1961), but it was extensively altered in 1993. What was once a characteristically mid-20th century modern building, with multi-level flat roofs, multi-paned metal casement windows, and asymmetrical but rhythmic bands of doors and windows, has been converted into a uniform box. Thus the Fire Warehouse is considered a non-contributing resource to the site in 2008 due to its loss of integrity in terms of design, materials, workmanship, feeling, and association.

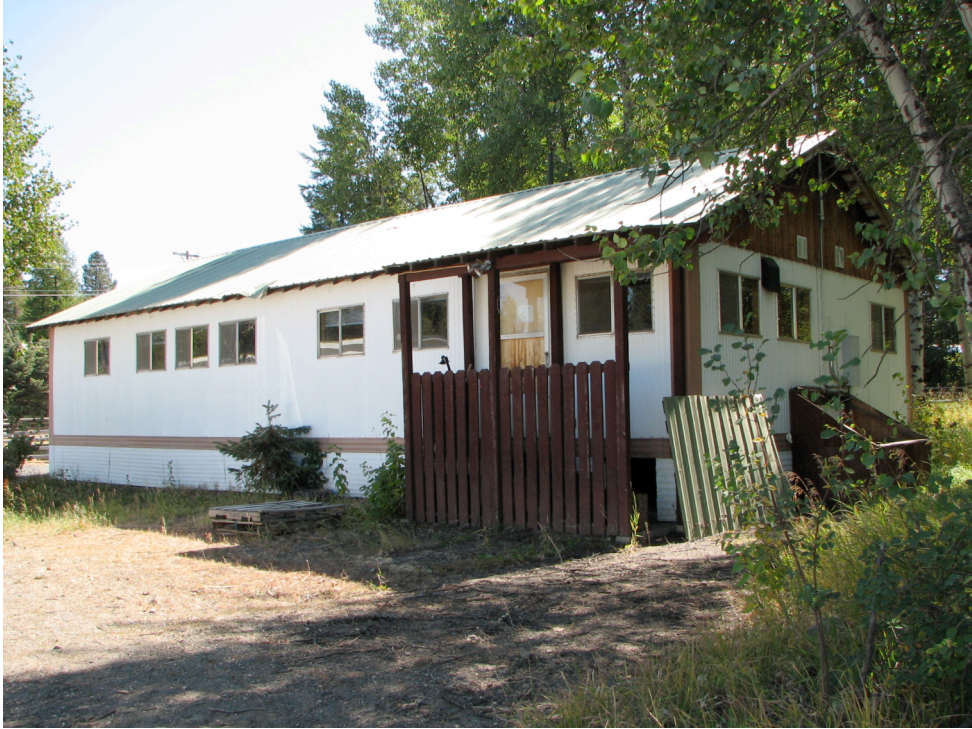
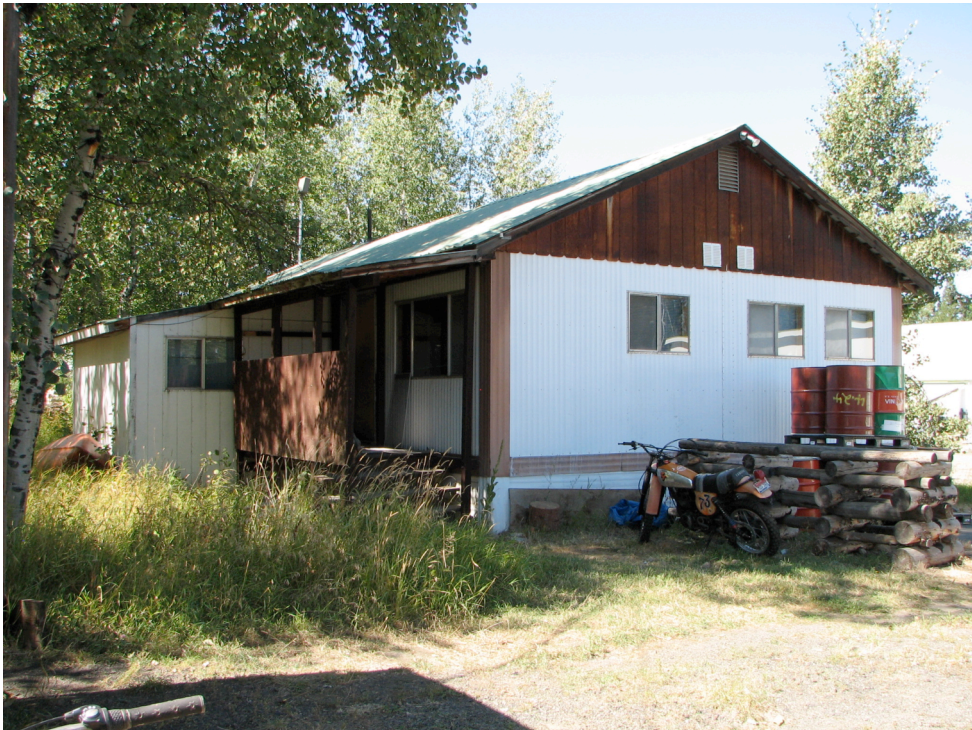
Figures 13a and 13b. The north and west sides (top) and the south and east sides (bottom) of Building K, the Land Line Surveyor's Building (#1212), McCall District Administrative Site, 2008.

The building was considered a non-contributing resource to the McCall site in 1991 and again in 2007 due to its recent date of construction. As of 2008 it may be approaching historic age (assuming it was moved to its present location at the earliest possible date, 1964) but it falls outside the periods of significance for the site and remains a non-contributing resource.

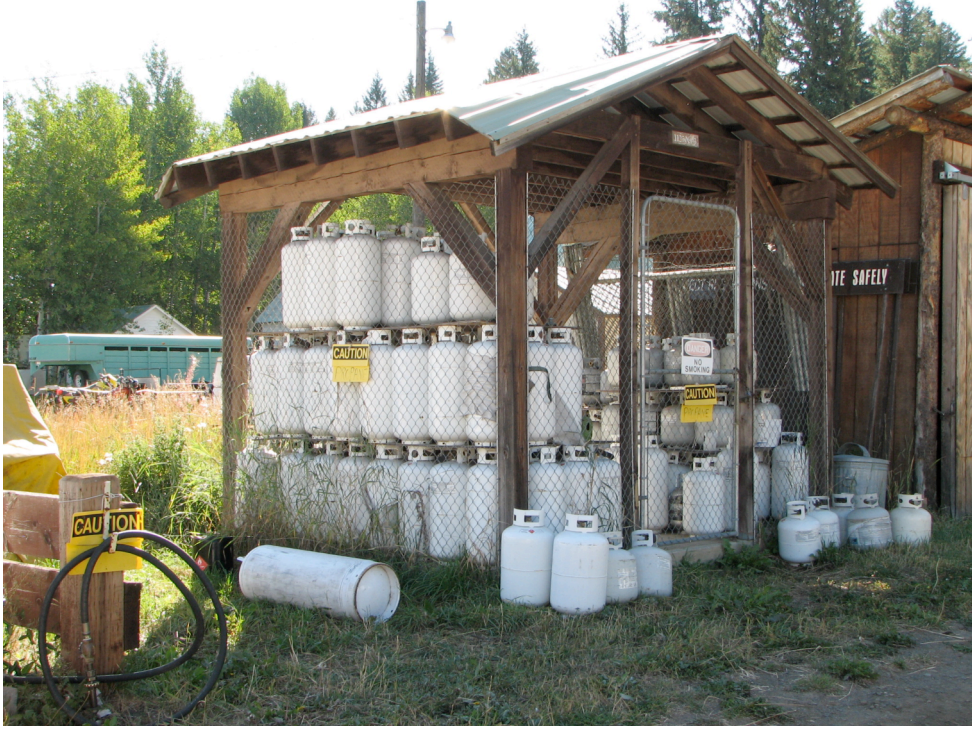
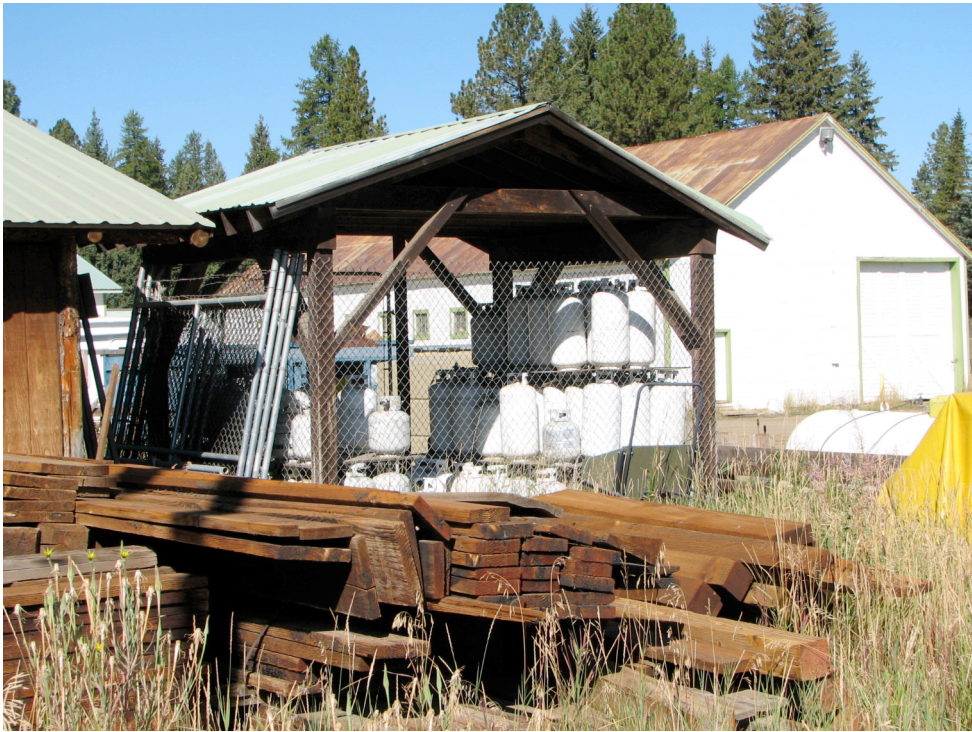
Figures 14a and 14b. The north and west sides (top) and the south and east sides (bottom) of Building L, the Propane Storage Building (#1377), McCall District Administrative Site, 2008.

The Propane Storage Building was deemed a non-contributing resource to the McCall site in both 1991 and 2008 due to its recent date of construction and failure to fall within either period of significance for the site.

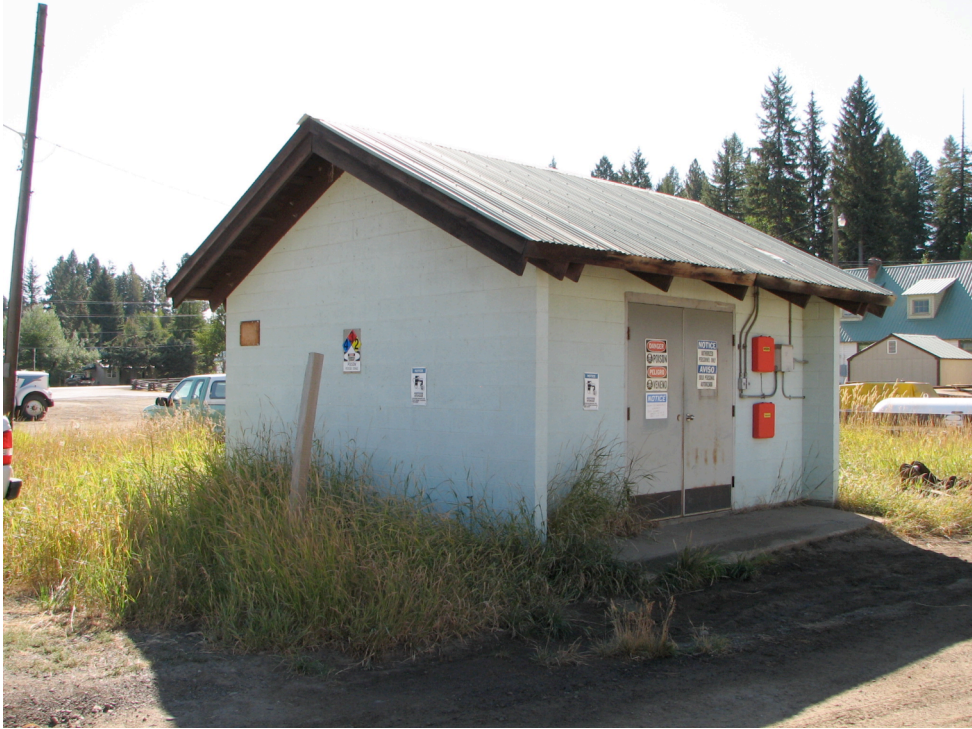
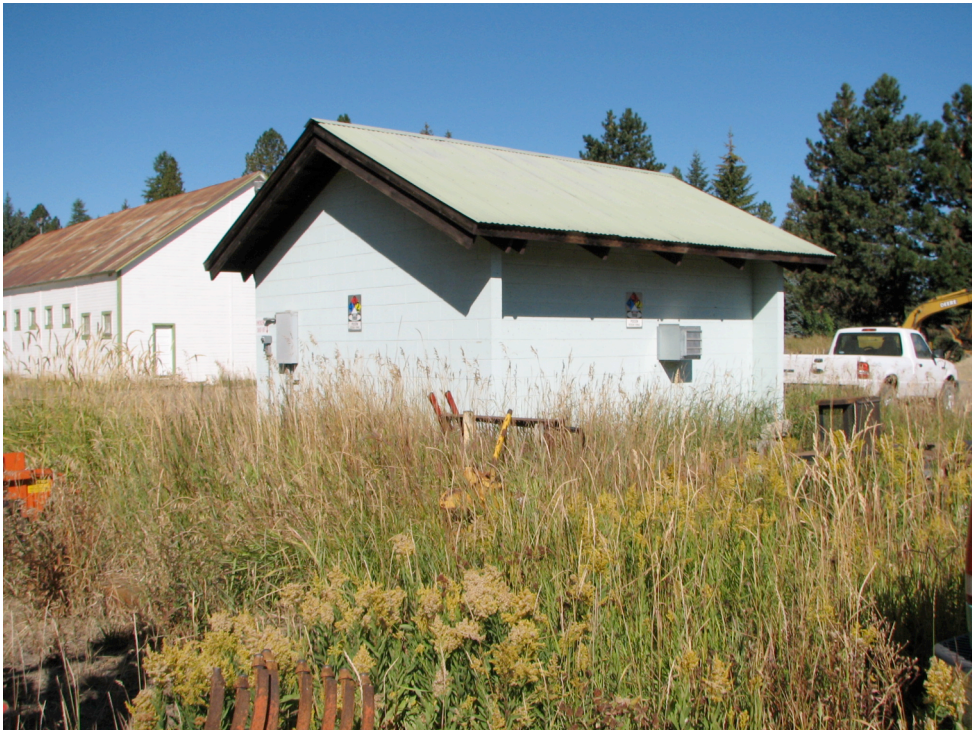
Figures 15a and 15b. The north and west sides (top) and the south and east sides (bottom) of Building M, the Pesticide Storage Building (#1383), McCall District Administrative Site, 2008.
