PAYETTE NATIONAL FOREST

EVALUATION OF
MCCALL DISTRICT ADMINISTRATIVE SITE

DOCUMENTATION AND
DETERMINATIONS OF ELIGIBILITY

FINAL REPORT

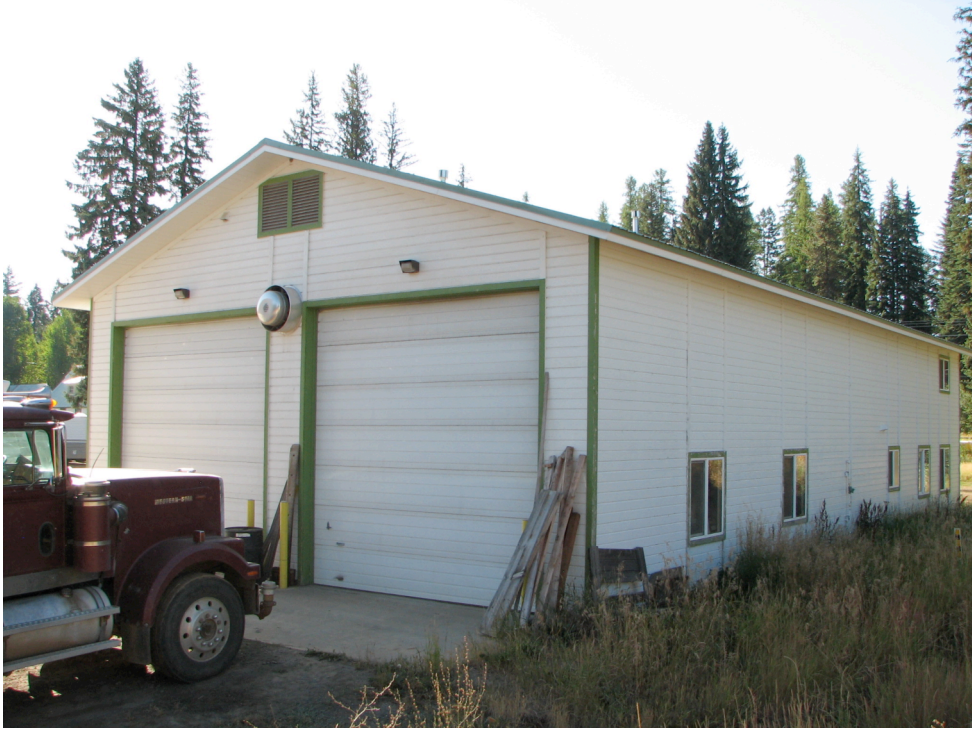
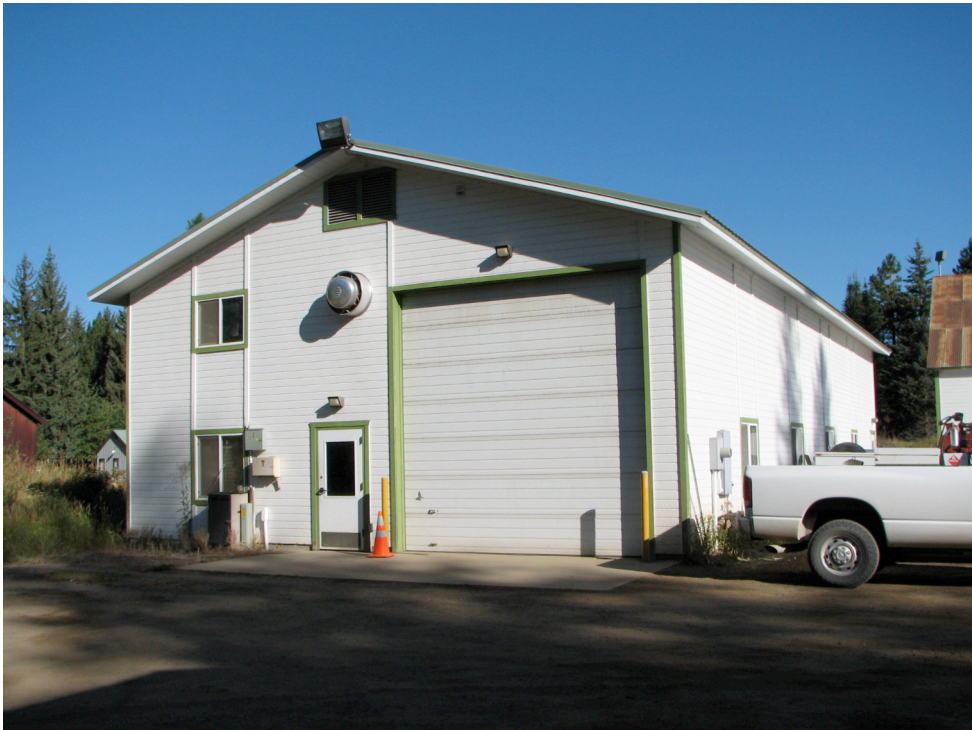
Figures 16a and 16b. The north and west sides (top) and the south and east sides (bottom) of Building 1, the C and M Heavy Machinery Maintenance Shop (#1509), McCall District Administrative Site, 2008.

Building 1 is considered a non-contributing resource to the McCall site due to its recent date of construction. However, the building has a low impact on the integrity of the McCall district due to its reasonable level of compatibility with the historic structures (mainly the adjacent Hay Barn, Building A) in terms of form, scale, and finishes, and its relatively low visibility on the most remote corner of the site.

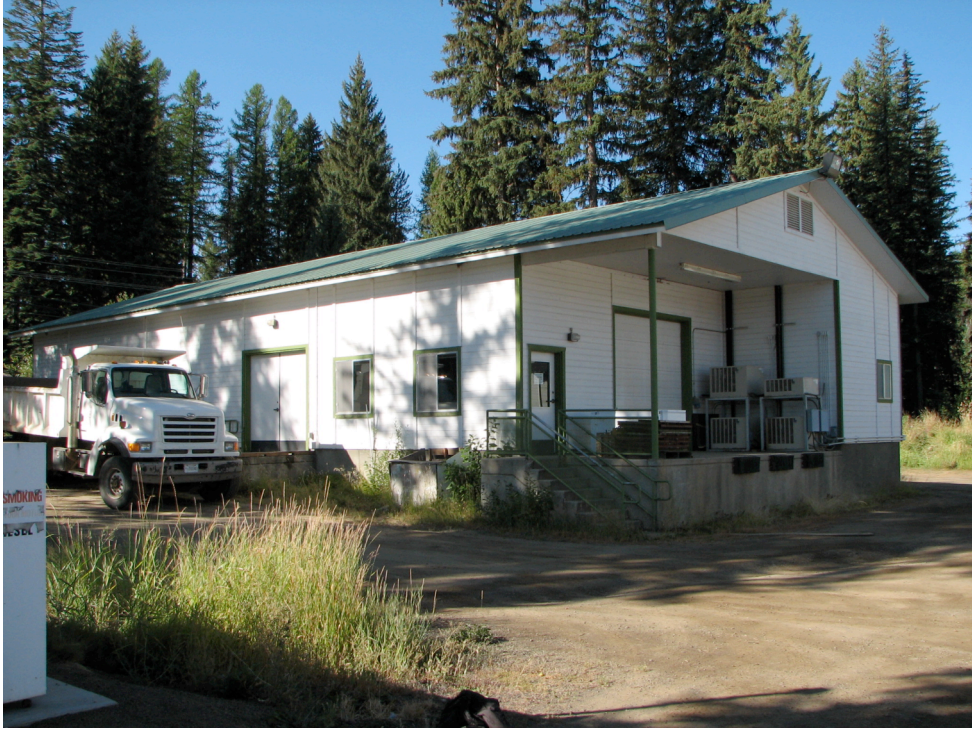
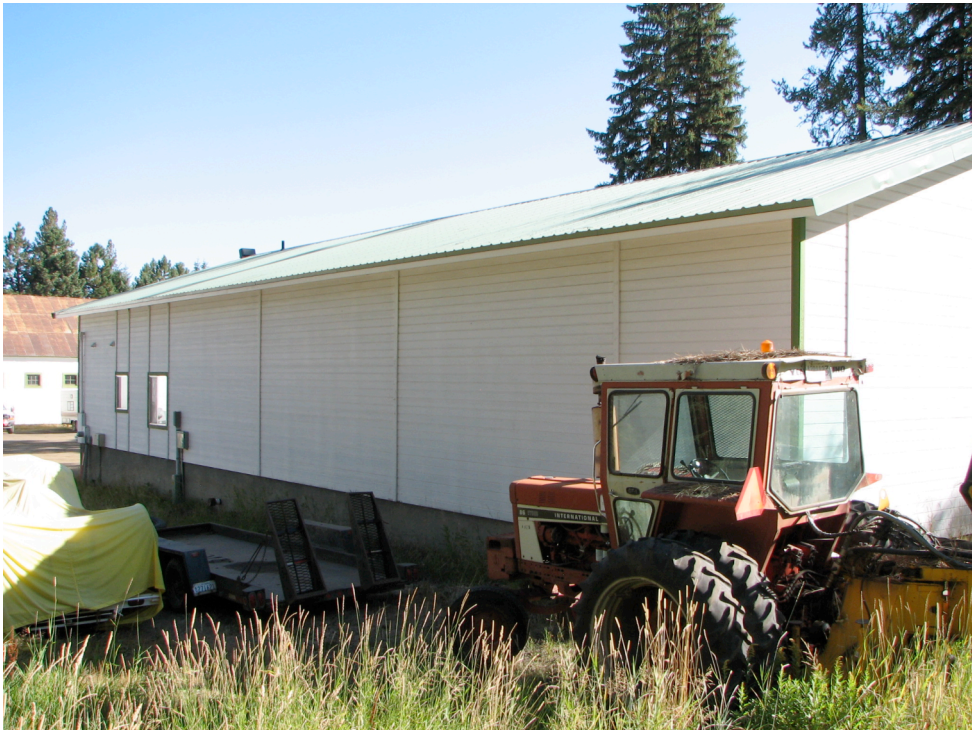
Figures 17a and 17b. The east and north sides (top) and the west side (bottom) of Building 2, the Tree Cooler Building (#1392), McCall District Administrative Site, 2008.

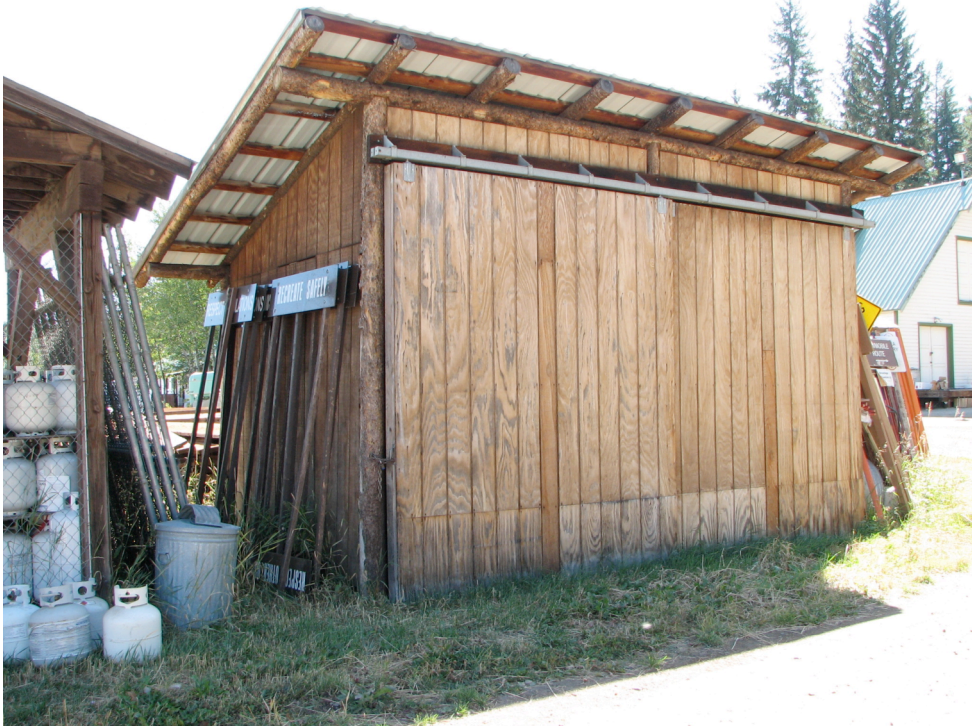
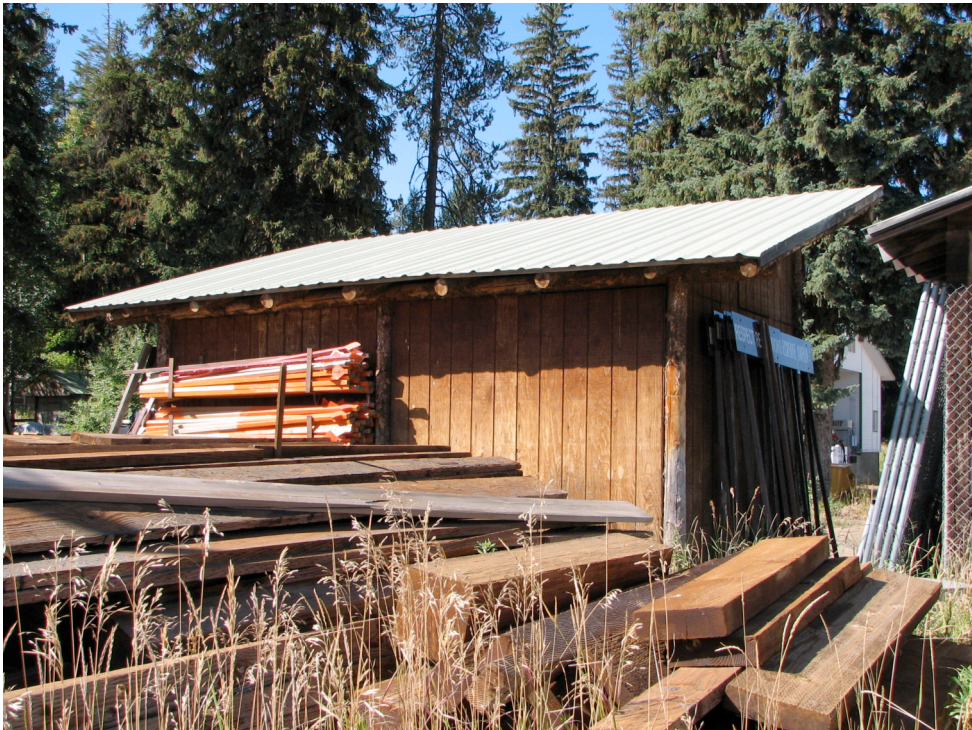
Figures 18a and 18b. The north and west sides (top) and the east and north sides (bottom) of Building 3, the Land Line Surveyor's Shed (#1385), McCall District Administrative Site, 2008.

Building 3, the Land Line Surveyor's Shed, is considered a non-contributing resource to the McCall site due to its recent date of construction. However, the building has a low impact on the integrity of the McCall site due to its small size and temporary nature of construction.

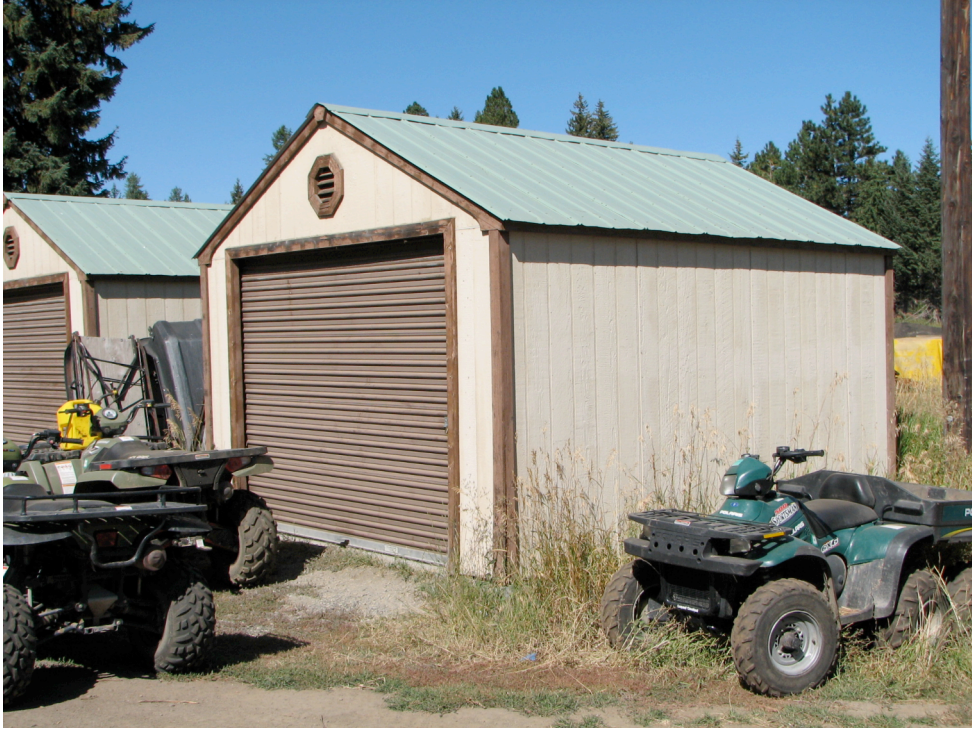
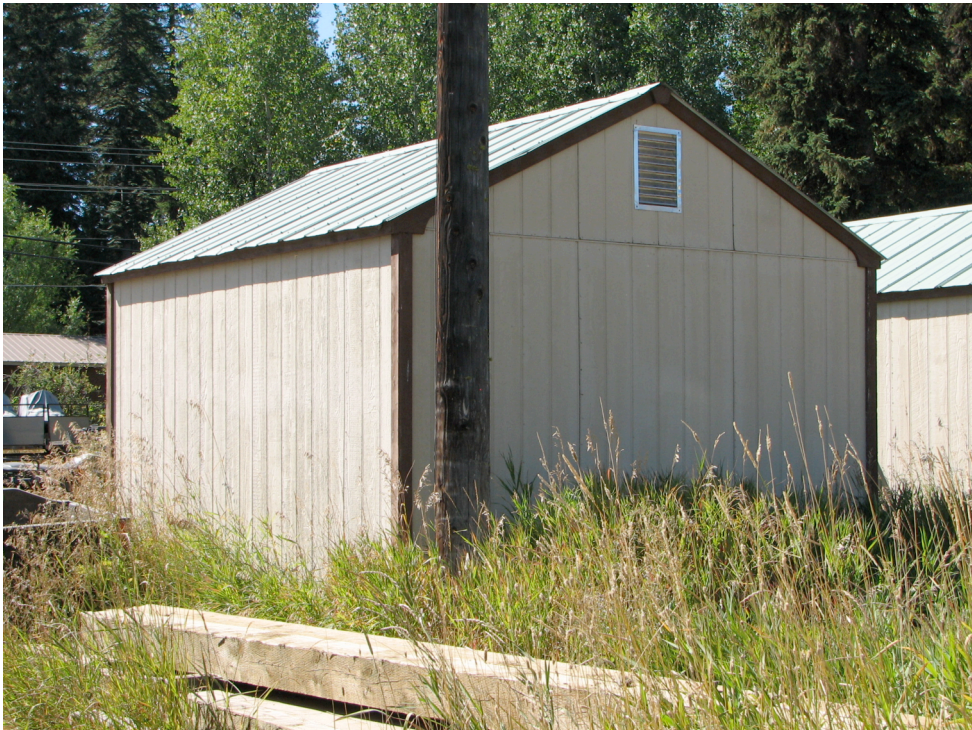
Figures 19a and 19b. The south and east sides (top) and the east and north sides (bottom) of Building 5, the East Storage Building (#1401), McCall District Administrative Site, 2008.

The gable-fronted, one story, rectangular West and East Storage Buildings each measure 12' by 14' and are sited about six feet apart on flat ground just southeast of Building 3, the Land Line Surveyor's Shed. The prefabricated buildings were manufactured by or for "Stor-Mor Systems" of Boise, Idaho. The foundations are poured concrete slabs and the walls, probably wood-framed, are finished with vertical paneling of composite or plywood boards. The cornerboards are of wood. The wood-framed gable roofs are finished with ridged green metal; the eaves are finished with plain board fascias and the gable ends are finished with wood rake boards. Each building has an octagonal, wood-framed, wood-louvered vent on the south gable end and a rectangular, louvered metal vent on the north gable end. The south side of each building is nearly filled by an overhead garage door of ridged brown metal with wood trim.

Buildings 4 and 5, the West and East Storage Buildings, are considered non-contributing resources to the McCall site due to their recent date of manufacture and installation. However, the buildings have a low impact on the integrity of the McCall site due to their small size and impermanent nature of construction.

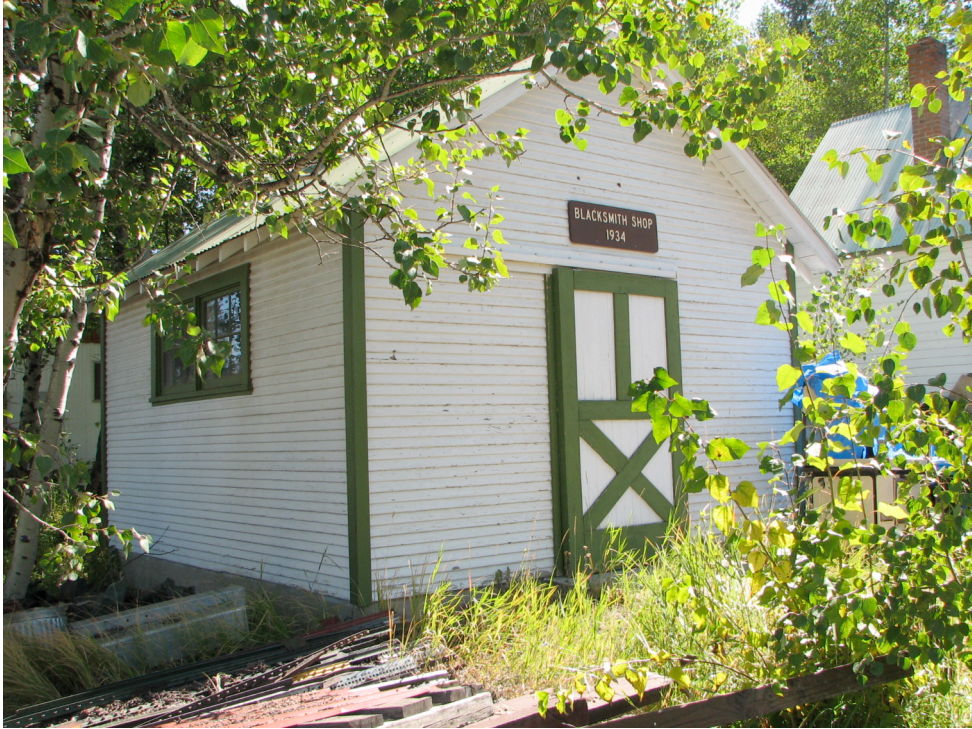
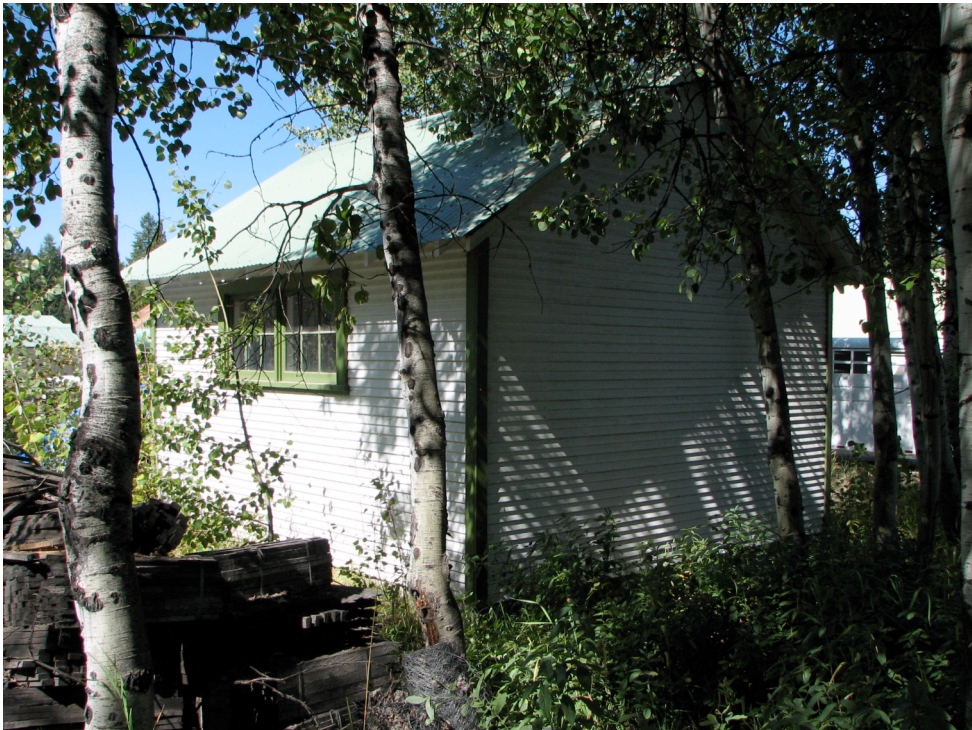
Figures 20a and 20b. The north and west sides (top) and the south and east sides (bottom) of Building 6, the Blacksmith Shop (#1348), McCall District Administrative Site, 2008.

The gable-fronted, one story, rectangular Blacksmith Shop measures 14'3" by 16'2"; it was built to Region 4 Plan 40 (see Appendix I). It is sited on ground sloping gradually to the south amid aspen trees and grasses; Building E, the Krassel Warehouse, is located immediately to the south. The Blacksmith Shop's poured concrete foundation dates from 1996 when the building was moved to the site. The wood-framed walls are clad in double drop siding (horizontal shiplapped boards made to look like beveled lap siding with two "clapboards" per board) with curved bottom edges and a 2" to 2 1/2" exposure; wood corner boards and a wood cornice finish the walls. Presently all wood elements are painted white except for the cornerboards, window sashes, door framing members, and window and door trim, which are painted green. The wood-framed roof has board decking and is finished with green corrugated metal; the open eaves feature exposed rafter tails and fly rafters on the gable ends. On both the south and north walls is a pair of six-paned wood windows with wood trim, casings, sill, and lintel; the lintel ends are slightly angled. A single sliding, wood-paneled door with cross-bracing on the lower half is mounted on a metal track on the west side. The door is approached by a poured concrete stoop.

Since 1934, it appears that very few exterior changes have been made to the Blacksmith Shop other than its relocation and the concurrent pouring of a new foundation. The standard plan called for wood shingles, which were covered in the 1960s with a corrugated metal roof like many buildings on the PNF; it appears that a new corrugated roof was installed after the building was relocated. The standard plan also called for a metal stove pipe and smoke jack toward the present southeast or northeast (rear) corner, stabilized with guy wires, but this had been removed by c. 1995 (and probably much earlier, when the building was re-roofed).

The Blacksmith Shop is a fine example of a Depression-era Region 4 standard plan with a high degree of integrity in terms of design, materials, workmanship, and feeling. The fact that it has been moved from its original location is in keeping with the long-standing practice of the Forest Service. However, the building was moved to the McCall site only twelve years ago and thus lies outside the period of significance for the site that is partially defined by the recycling and relocation of buildings, namely the period from 1942-1961. Thus the Blacksmith Shop is considered a non-contributing resource to the McCall District Administrative Site.

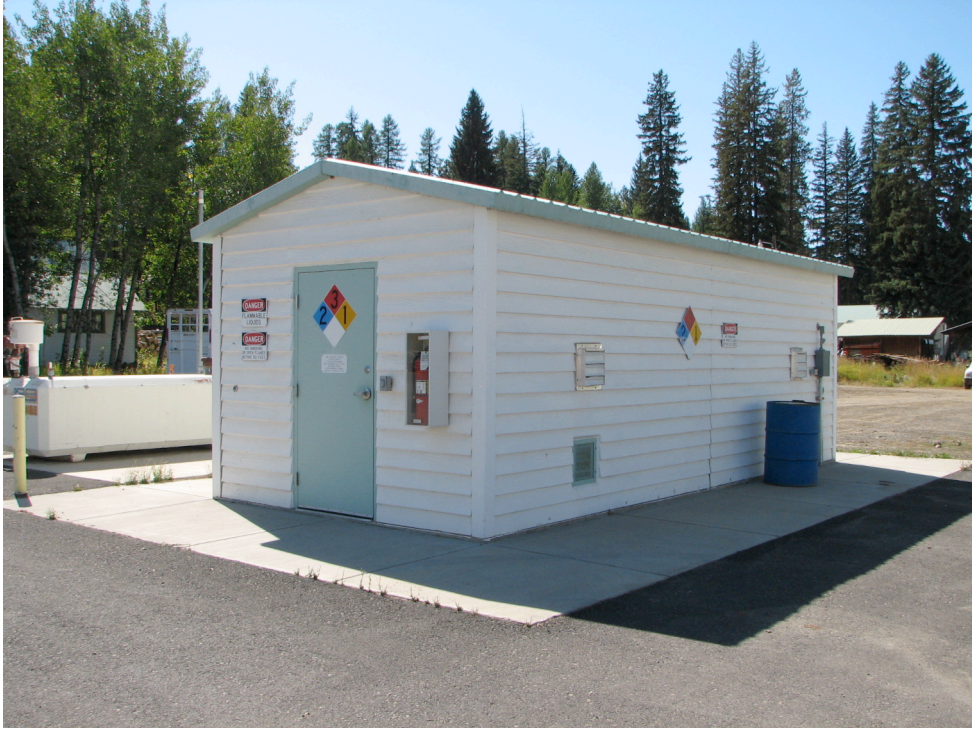
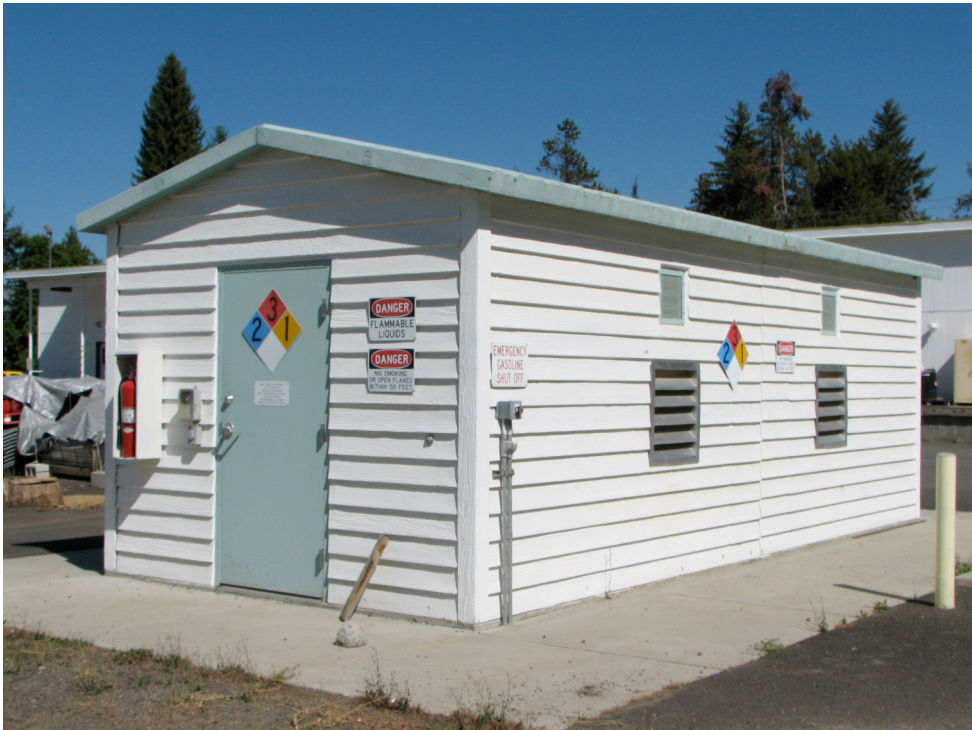
Figures 21a and 21b. The east and north sides (top) and the west and south sides (bottom) of Building 7, the Petrochemical Storage Building (#1431), McCall District Administrative Site, 2008.
