**ASSESSMENT OF MONITORING TECHNOLOGY -
APPLICATIONS TO EARTH
DAM SAFETY**

**R. Hays
T. R. Howard
Geological Engineering**

Submitted to:
Idaho Department of Water Resources

January, 1981

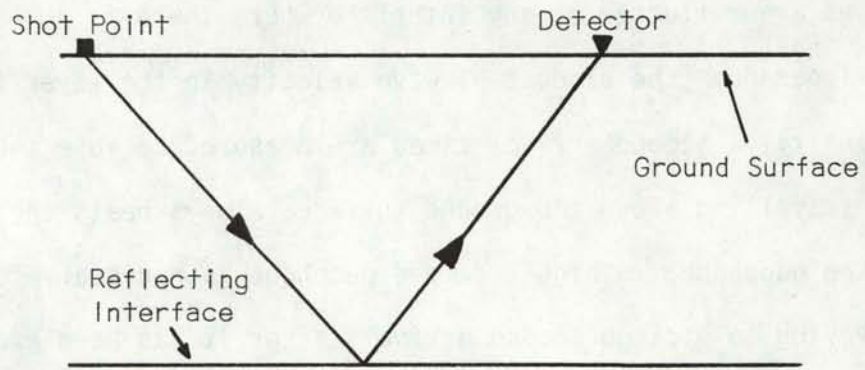
Figure III-2. Wave Path for Seismic Reflection Method.

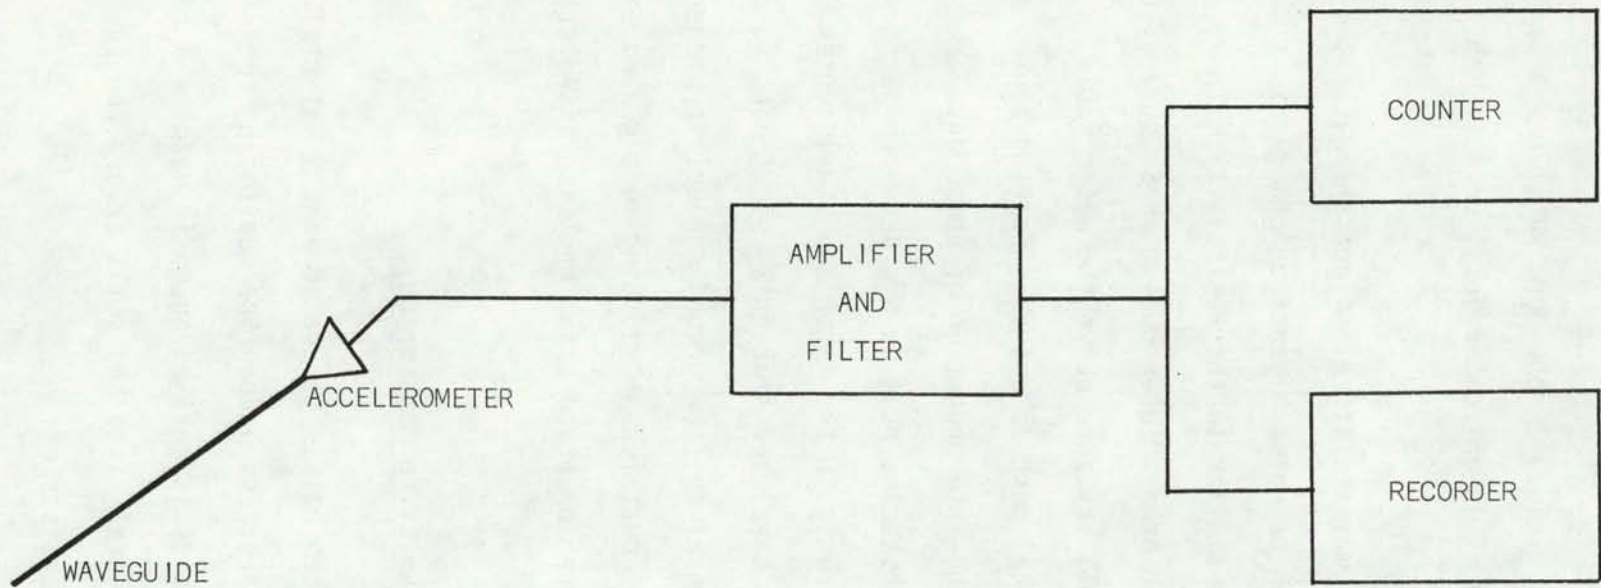
Figure III-4. Schematic Diagram Showing Acoustic Emission Monitoring System.

Acoustic emissions are the noises generated when a material deforms thereby mobilizing some form of stress wave. The monitoring technique that quantifies these stress waves is well advanced in metal and rock testing and has been extended lately into the soils area. The instrumentation, see figure III-4, consists of:

1. A wave guide inserted into the general soil zone being monitored. A wave guide can be any material that is

capable of carrying acoustic emissions from depth to the surface, (i.e., concrete drains, metal pipes, conduits, metal rebar, or metal wire).

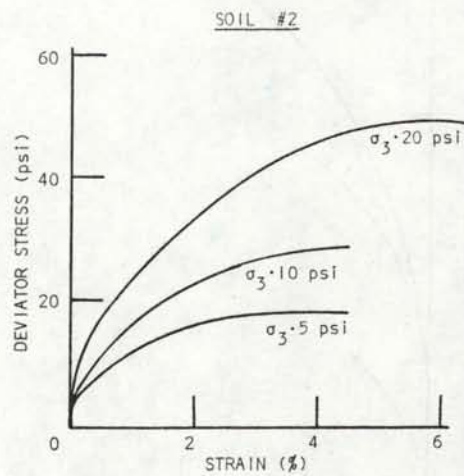
Figure IV-3. Triaxial Shear Test Results (Deviator Stress Versus Strain) for Four Granular Soils Listed in Table IV-2. (Koerner, Lord, McCabe, and Curran, 1976)

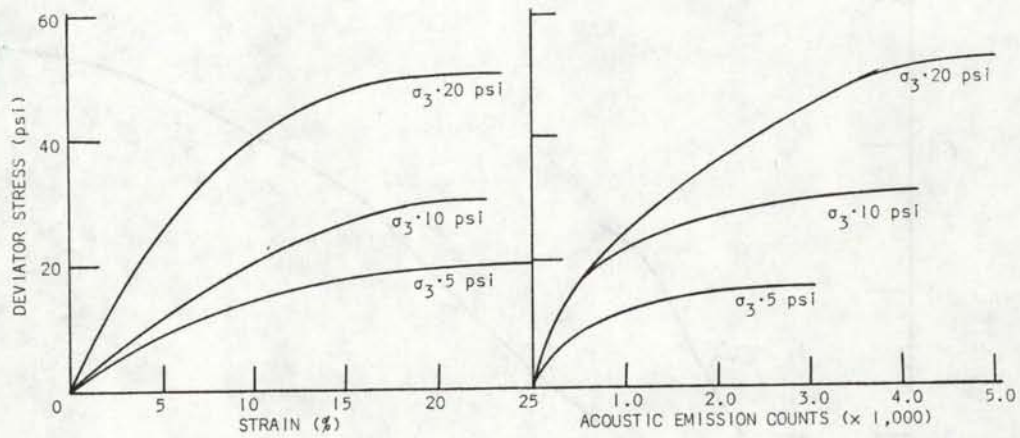
Figure IV-5. Triaxial Creep Response of Clayey Silt (Soil No. 5) at Varying Confining Pressures. (Koerner, Lord, and McCabe, 1977)

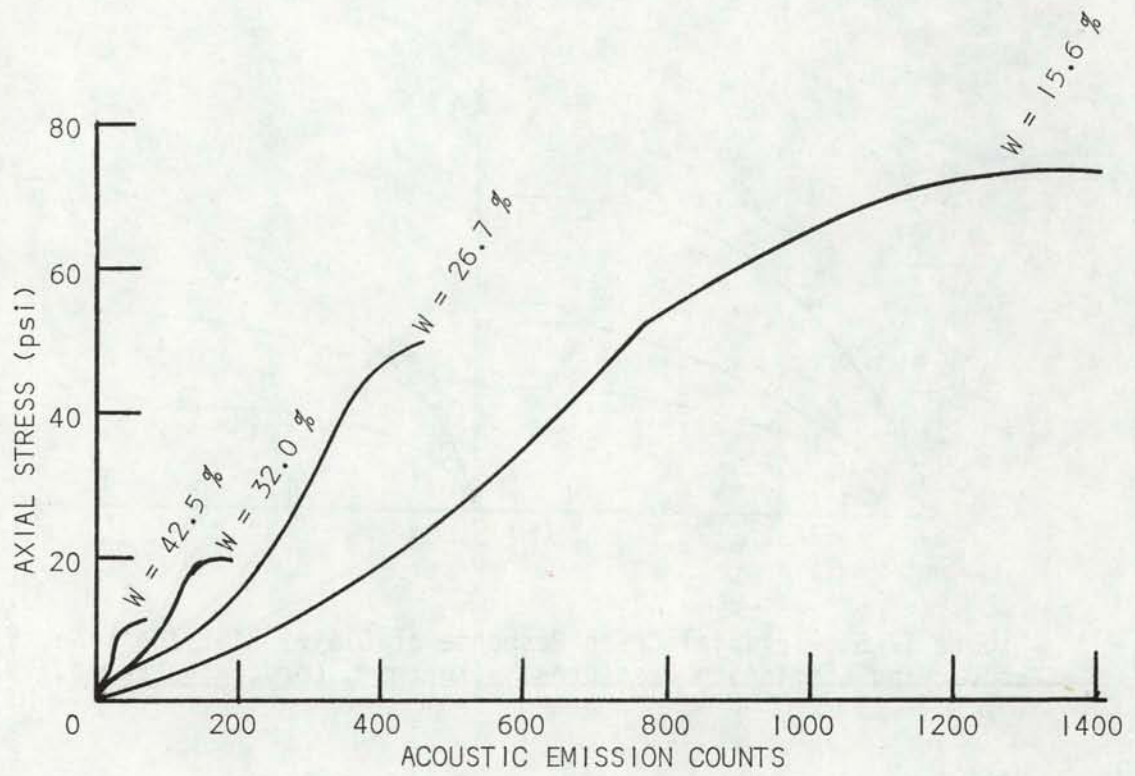
Figure IV-7. Stress/acoustic Emission Response of Clayey Silt (Soil No. 5) at Varying Water Content in Unconfined Pressure. (Koerner, Lord, and McCabe, 1977)

The effect of water content on acoustic emission was conducted on the clayey silt (No. 5). The samples were compacted at different water contents and tested in unconfined compression. Figure IV-7 shows the results, which indicate a decrease in strength and acoustic emissions with increasing water content. The extremely low number of emissions recorded at higher water content approaches the liquid limit of the soil being monitored.
